August 27, 2014

Subject: **Remediation and Closure Report**
Devon Energy
Caswell 23 Federal No. 1H
API #: 30-025-40708
1RP-05-14-3046 & 1RP-05-14-3051

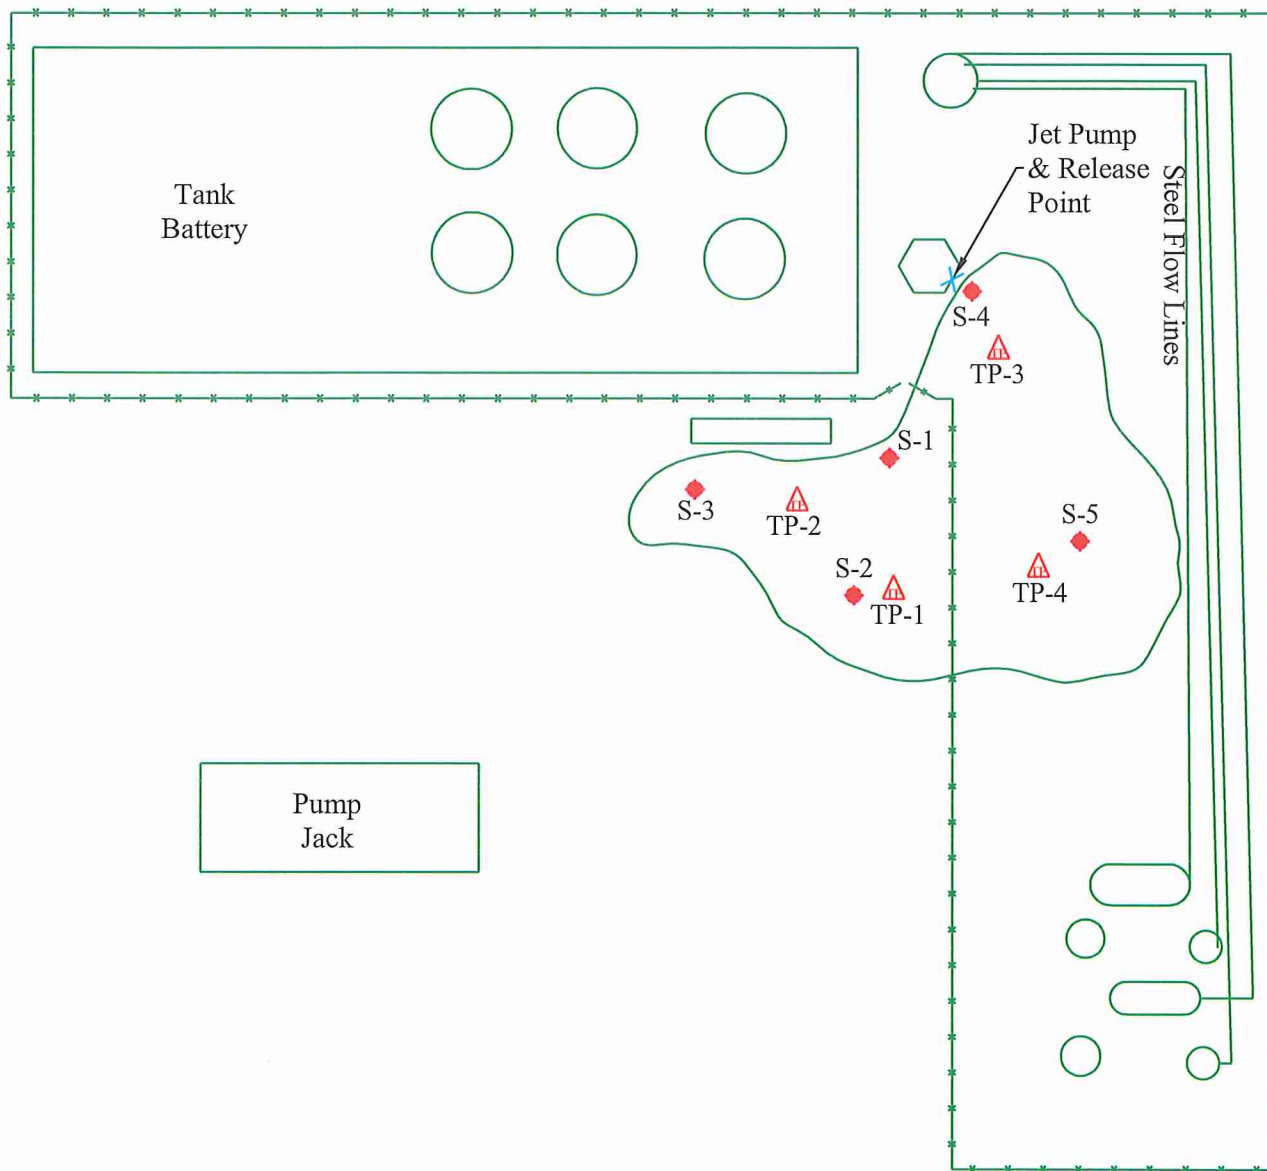
Caswell 23 Fed #1
Devon Energy Corporation
Lea County, New Mexico
Figure 1 - Site Plan

The packing from the jet pump was blown out of the pump causing a release of 15 barrels produced water. The pump was shut off and repaired. A vac truck was immediately called to the location and recovered 10 barrels of produced water. The impacted area measured approximately 150-feet by 60-feet. Both releases were contained within the impacted area on the site map.

The impacted area in the vicinity of sample locations S-1, S-2, S-3, S-5, test pit location TP-1 and TP-2 was excavated to a depth of 1-foot deep. The impacted area in the vicinity of S-4 and TP-3 was excavated to a depth of 0.5-feet deep. The impacted area in the vicinity of TP-4 was excavated to a depth of 2-feet deep in accordance with NMOCD and BLM approved work plan. All the contaminated soil was transported to Lea Land, LLC. The excavated areas were then backfilled with new caliche, machine compacted and contoured to match the surrounding location.
