OXY USA, Inc.
West Dollarhide Devonian Unit #101
Delineation Report and Work Plan

Section 33, T24S, R38E
Lea County, New Mexico

September 24, 2014

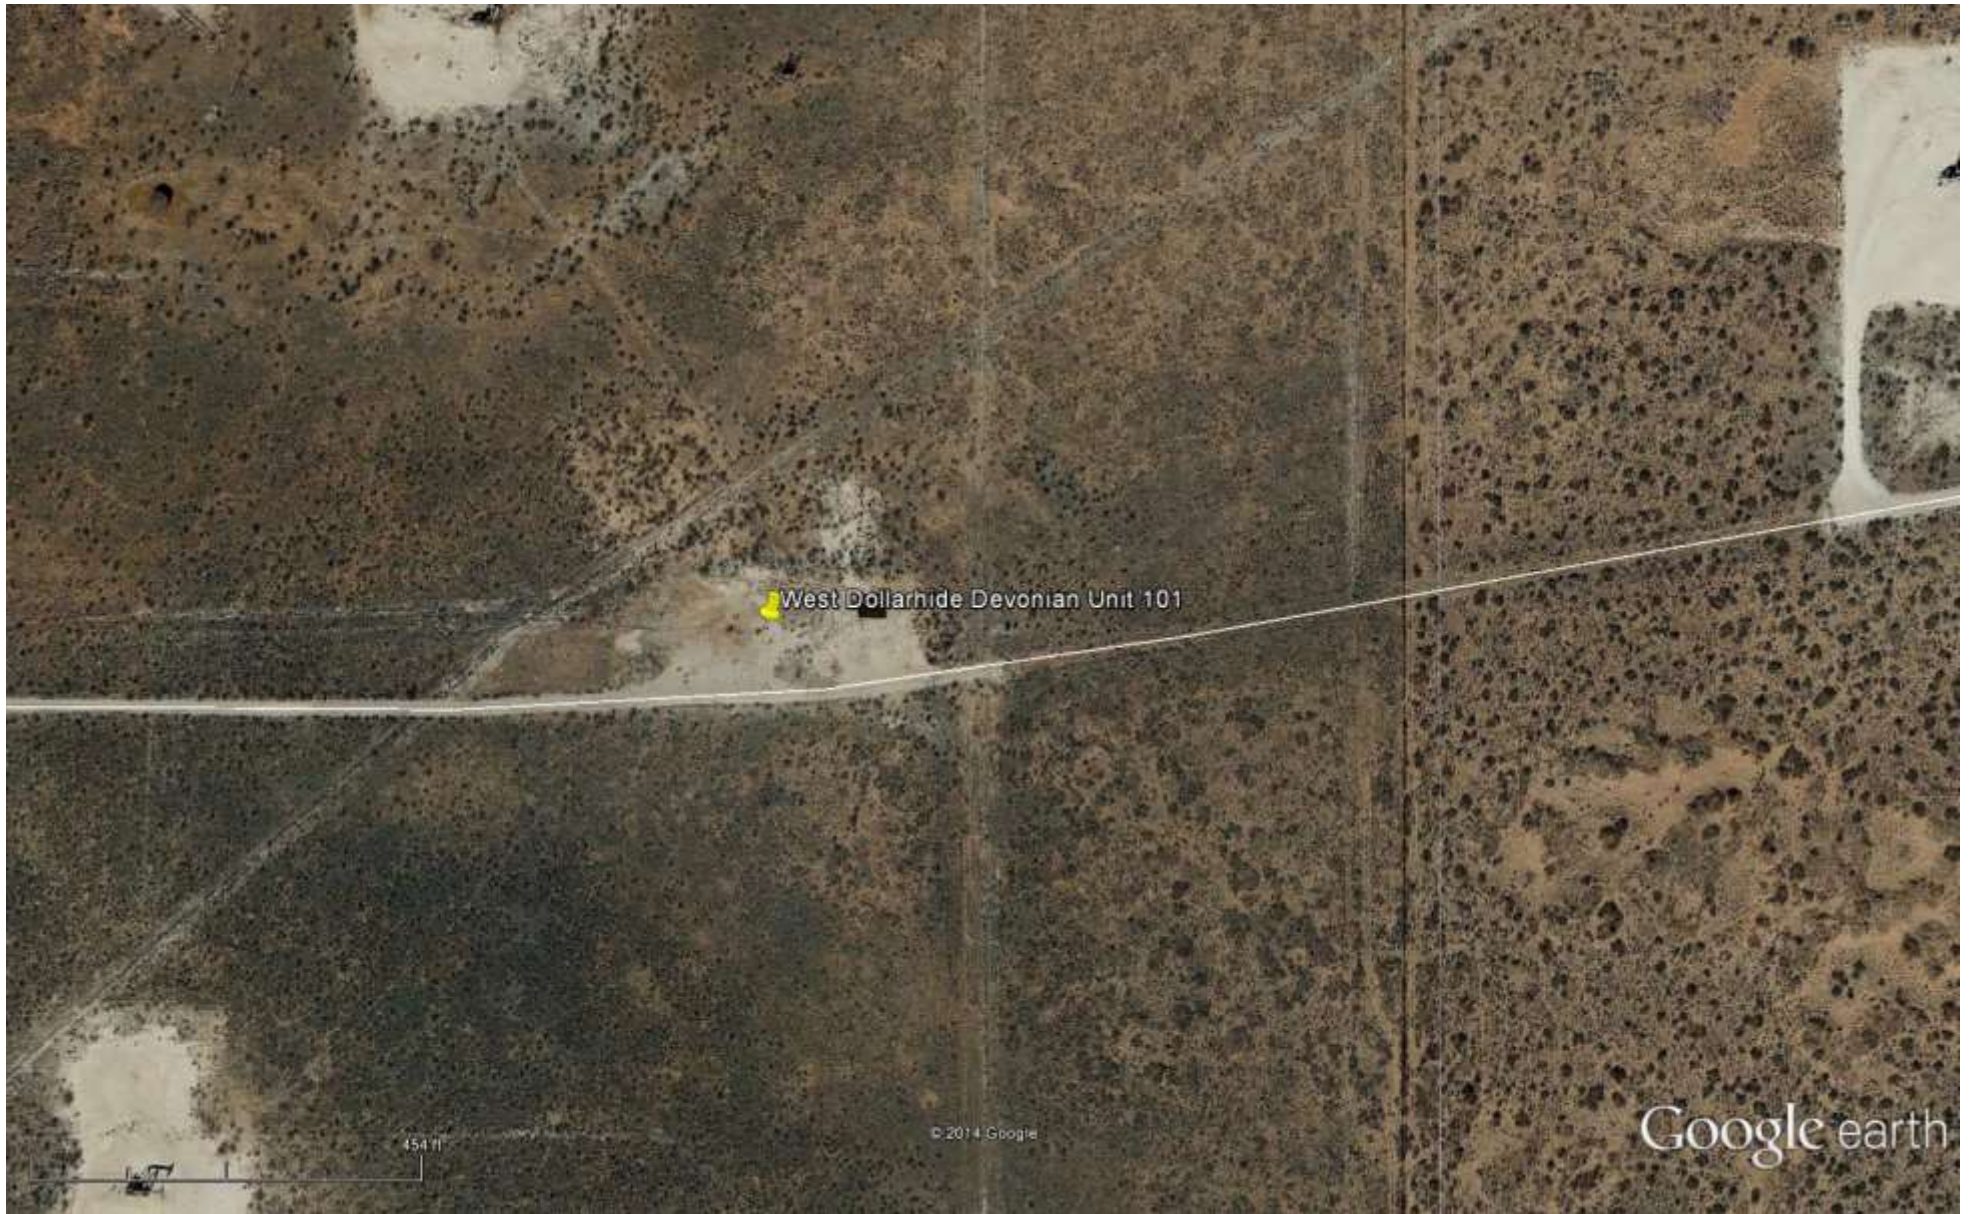
Figure 2
Site Plan

BBC International Inc. was onsite to determine vertical extent of contamination. Samples were taken at site SP1 at the surface and at a depth of 1', 2', 3', 4', 6', 8', 10' and 12'. Samples were taken at site SP2 were taken at 1', 2', 4', 6', 8', 10' and 12'. All samples were properly packaged, preserved and transported to the Laboratory, Hobbs New Mexico and analyzed for Benzene, Toluene, Ethylbenzene, Xylenes, Total BTEX and

The sample results indicate that the chloride concentration at 12' BGS is still between 2200ppm and 2600 ppm.

The sample results indicate that the vertical extent of contamination was determined to be between 45' & 55'.

1. Excavate 18"-2' remove all contaminated soil transport to an approved NMOCD facility for disposal.
2. Install Liner
3. The excavated area will be backfilled with caliche and returned to grade.
4. A closure report and a final C-141 will be filed upon completion of the above work.
