December 18, 2013

RE: NABORS HOBBS RECLAMATION PLANT INVESTIGATION, LEA COUNTY, NEW MEXICO – Address questions in Mr. Leking email of October 30, 2013.

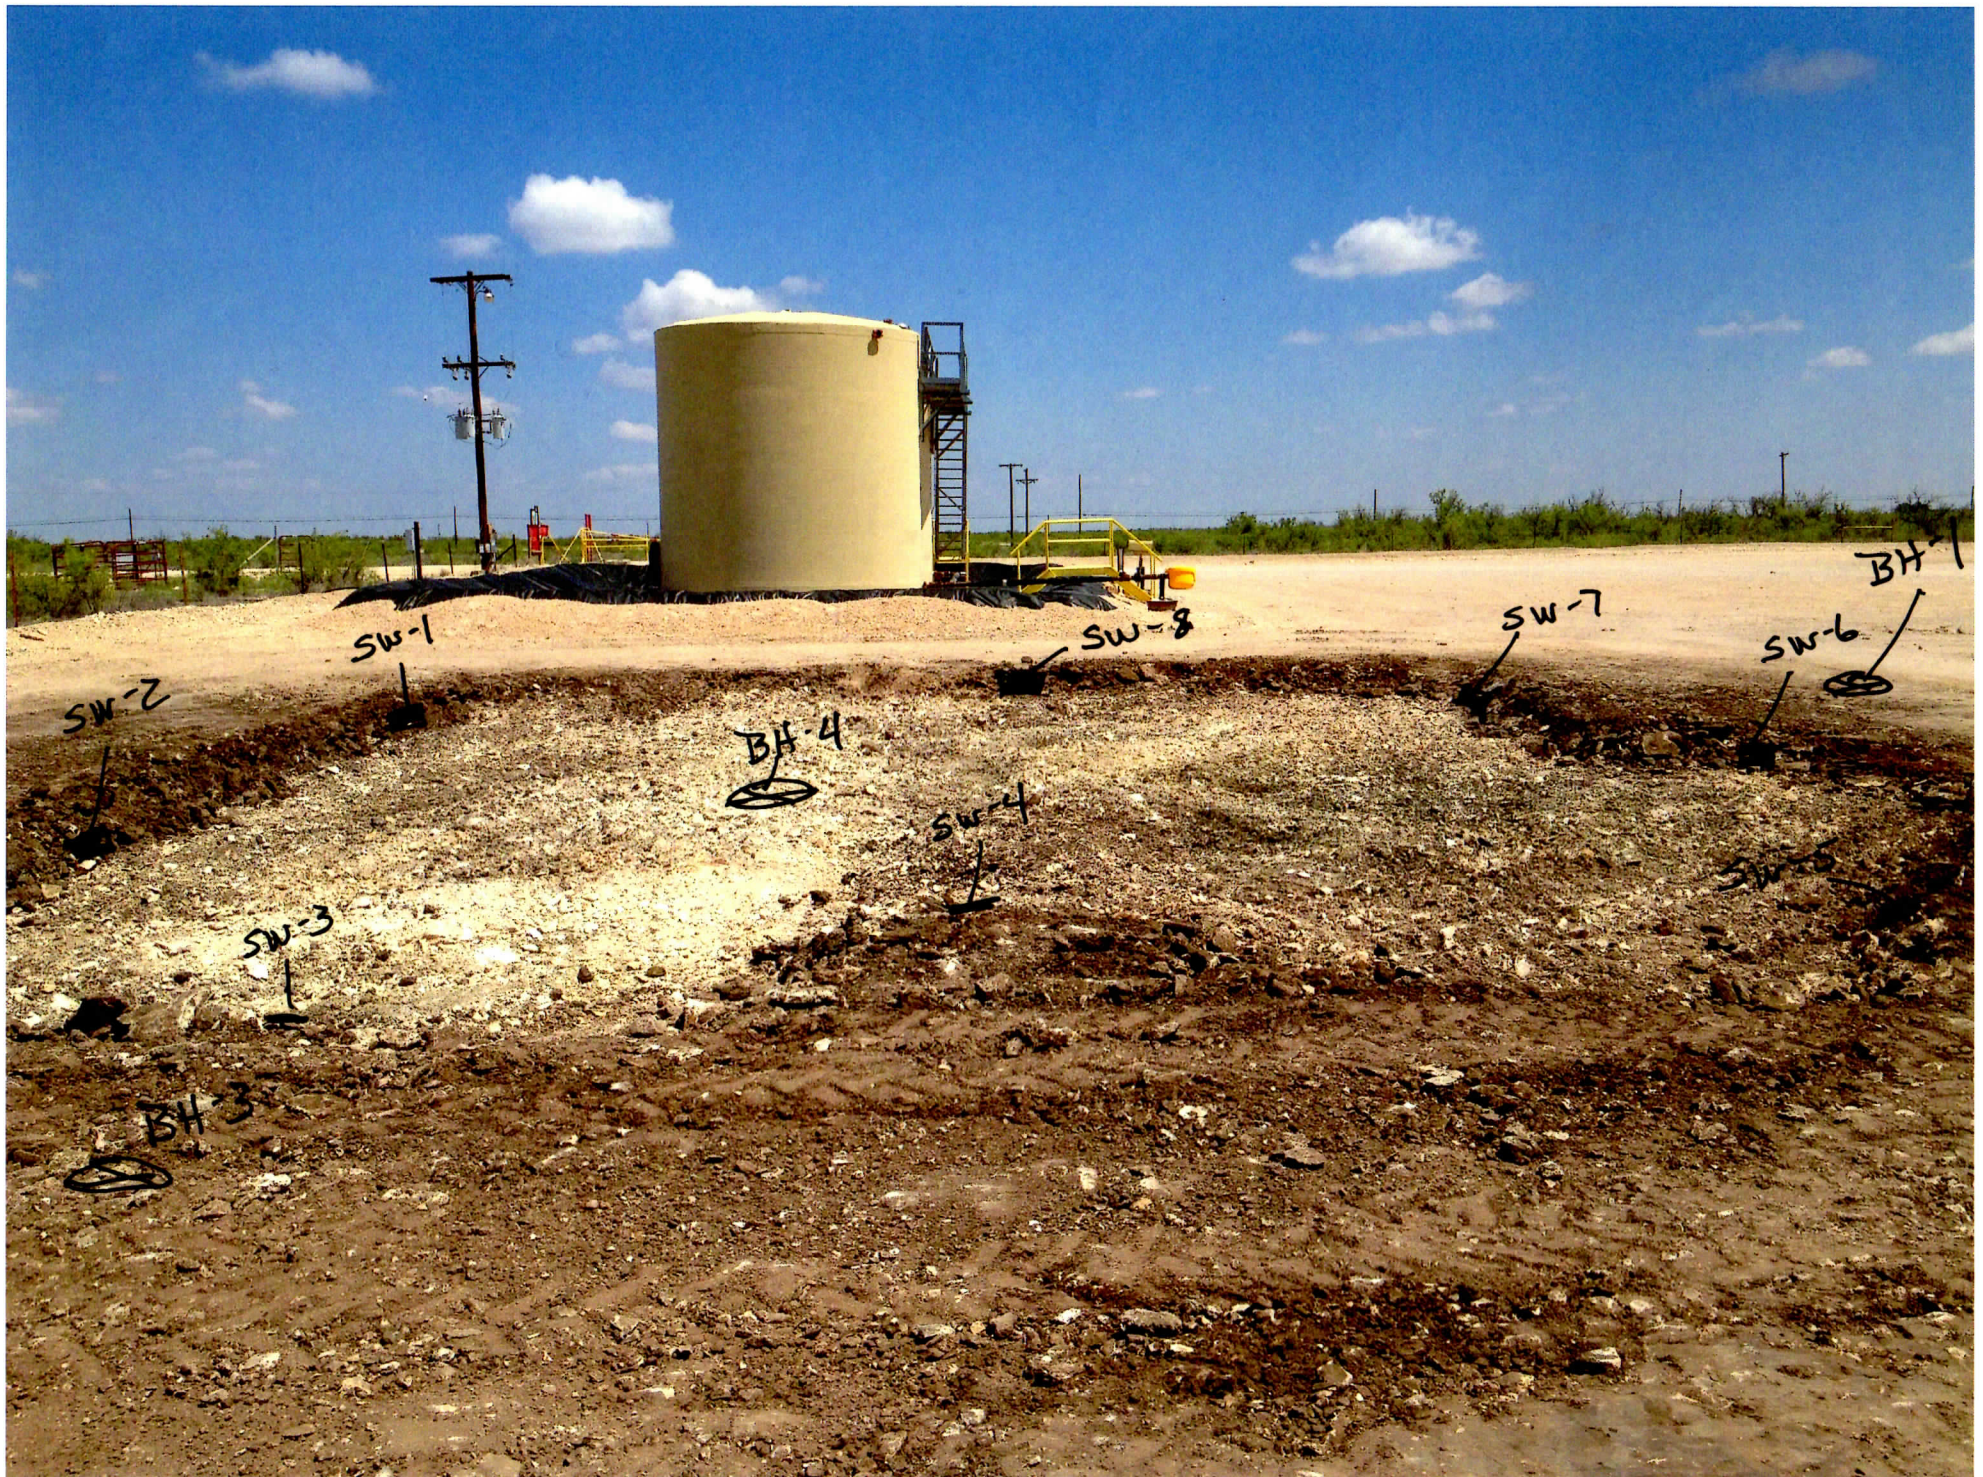
Photo 1 – Sample locations

The excavation was approximately 1-2 feet deep where the massive caliche cap rock was encountered. The boring log for Nabors water well report indicated this caliche layer is 16 feet thick. During the excavation photographs were taken. Photographs are enclosed in Attachment A. **Photo 1**, depicts the excavation and location of sidewall samples and shallow borings BH-1 through BH-3, which were

collected after removal of the surface pea gravel. These samples were scraped from the top of the hard caliche cap rock. The depth of BH-1 through BH-3 were 6-9 inches deep, as the pea gravel was thinner in outer section of the pea gravel base on which the tanks were originally located. All samples were collected following New Mexico Oil Conservation Division's (NMOCD) stated limit in their "Guidelines for Remediation of Spills, Leaks, and Releases", when screening with an OVM and removing affected soils with OVM readings above 100 ppm. These samples were initially collected to delineate the horizontal extent of contamination. As the OVM readings were well below 100 on the sidewall samples and BH-1 through BH-3 sample, we anticipated the analytical results would be below regulatory limits. Upon receipt of laboratory analytical results with TPH-DRO concentrations ranging from less than the detection limit to 752 mg/kg, we then dug the perpendicular trenches to further delineate horizontal limits of contamination away from the main excavation. The location of these trenches were specifically chosen to further delineate areas of contamination above 400 mg/kg TPH-DRO. The results of the samples collected at the end of these trenches were all below 100 mg/kg TPH-DRO. The green area in **Figure 3** is the extra excavation that we have proposed so that contamination identified in the initial samples can be remove to a point where TPH concentration are below 100 mg/kg at the end of the trenches. This should allay your fears that there are not more samples on the periphery besides BH-3.

BH-4 was taken in the middle of the excavation at a depth of approximately 2 feet. It too was a sample of the hard caliche cap rock. A photograph log of other pictures is enclosed in Attachment A. Initially a backhoe was used however, it was replaced with an excavator to complete the perpendicular trenches.

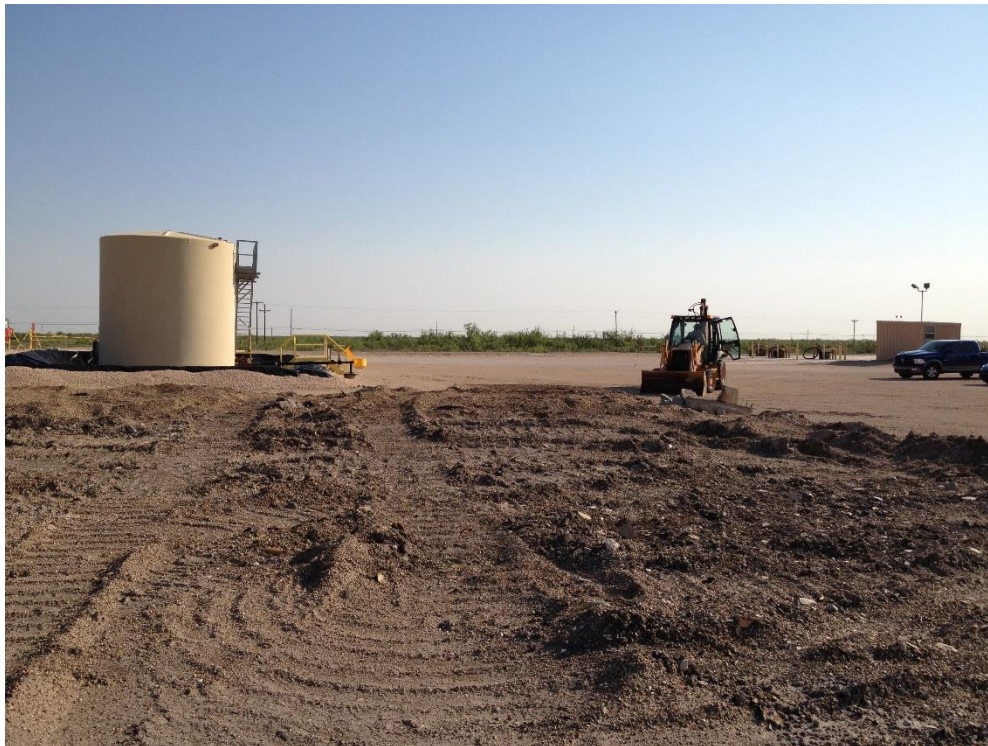
Photograph 1. Looking North at site before starting remediation. Tank in background is a fresh water tank.

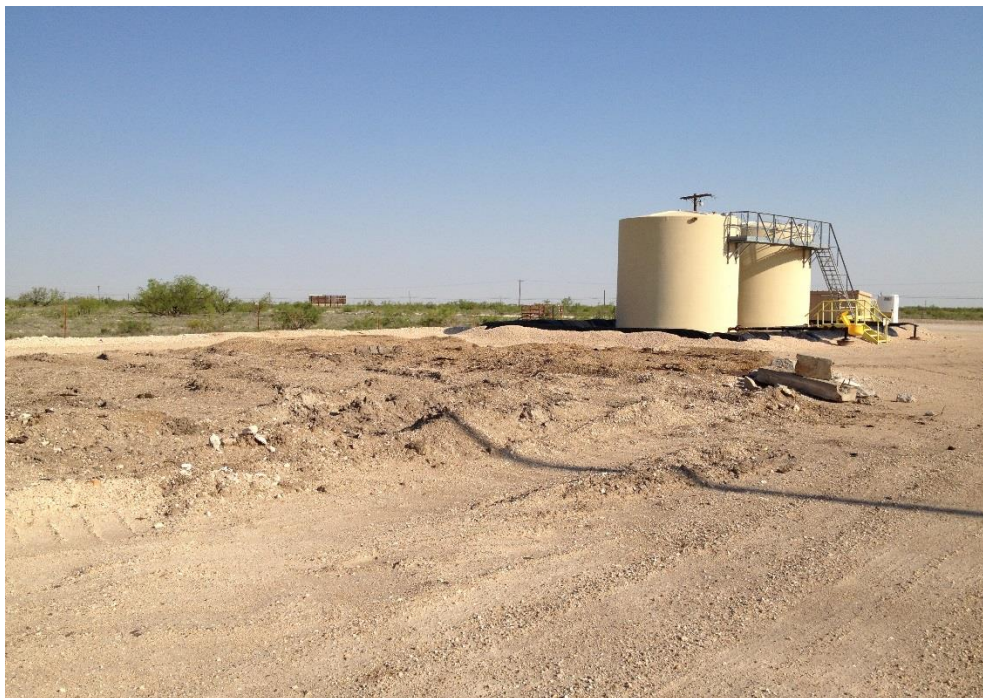
Photograph 2. Looking Northwest at site before work begins with fresh water tanks in background.

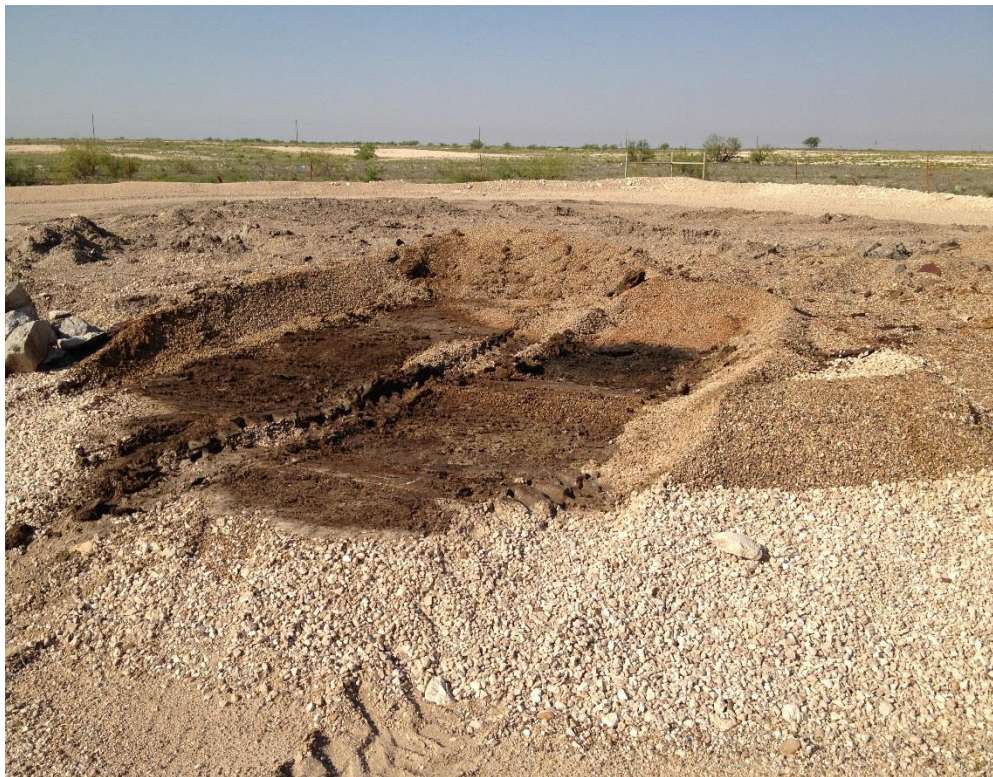
Photograph 3. Looking west with affected soil near the middle of site.

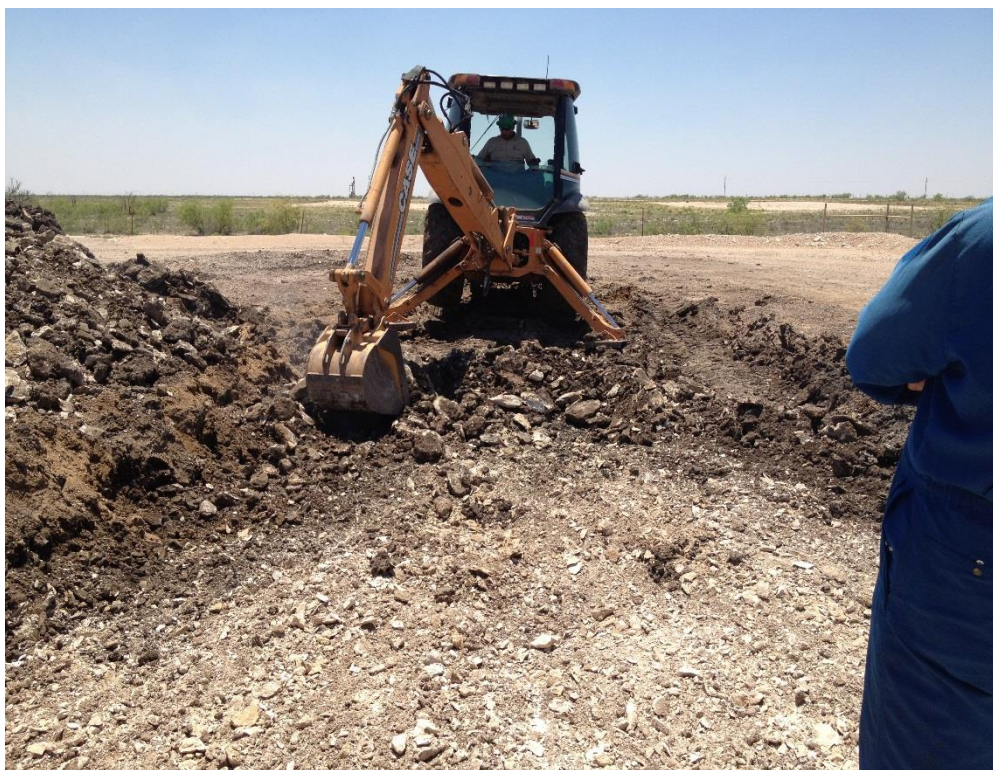
Photograph 4. Looking south at backhoe digging in caliche. Caliche was hit at about 1 foot.

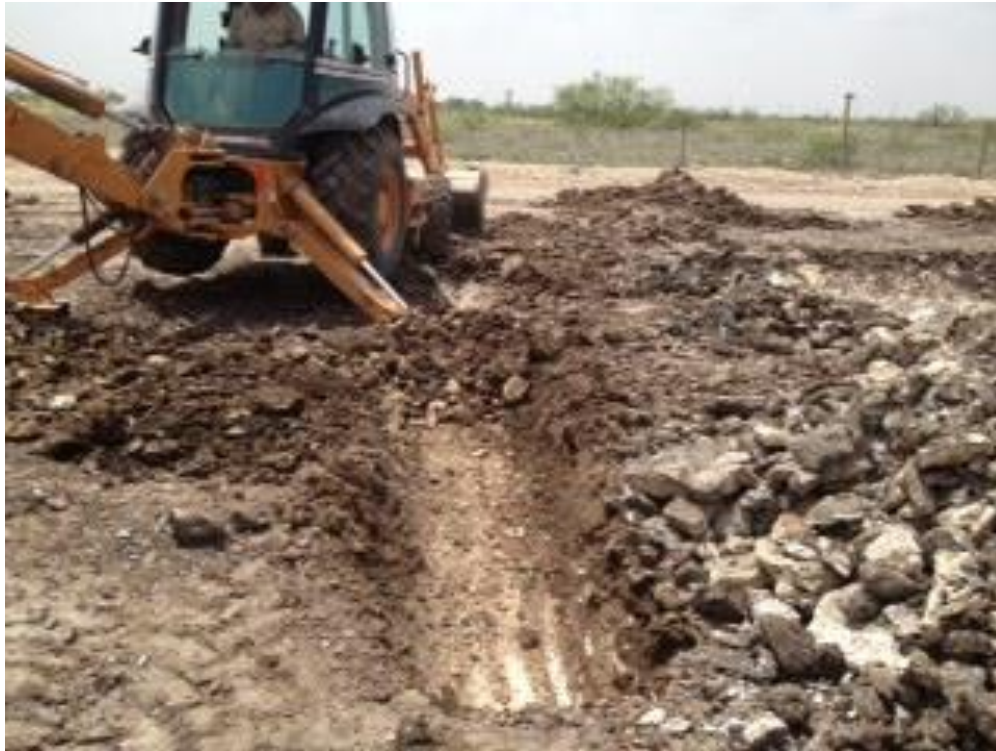
Photograph 5. Looking West at backhoe digging along south edge..

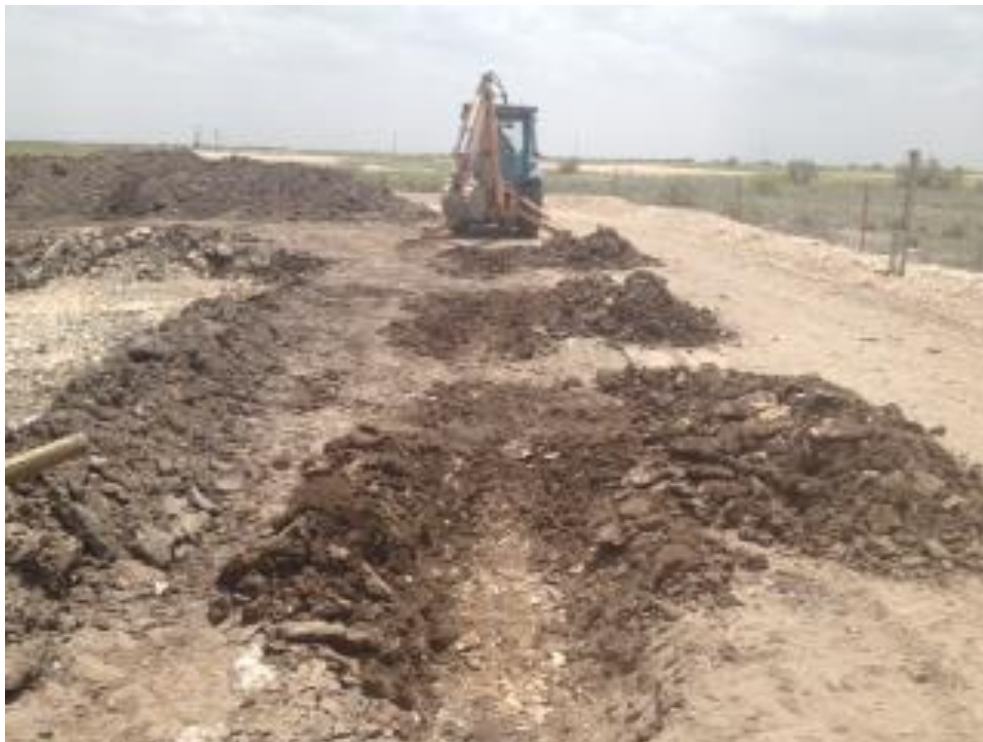
Photograph 6. Looking south at backhoe digging along west edge. These trenches were used to delineate the edge of contamination. Not to be confused with perpendicular trenches that were dug later.

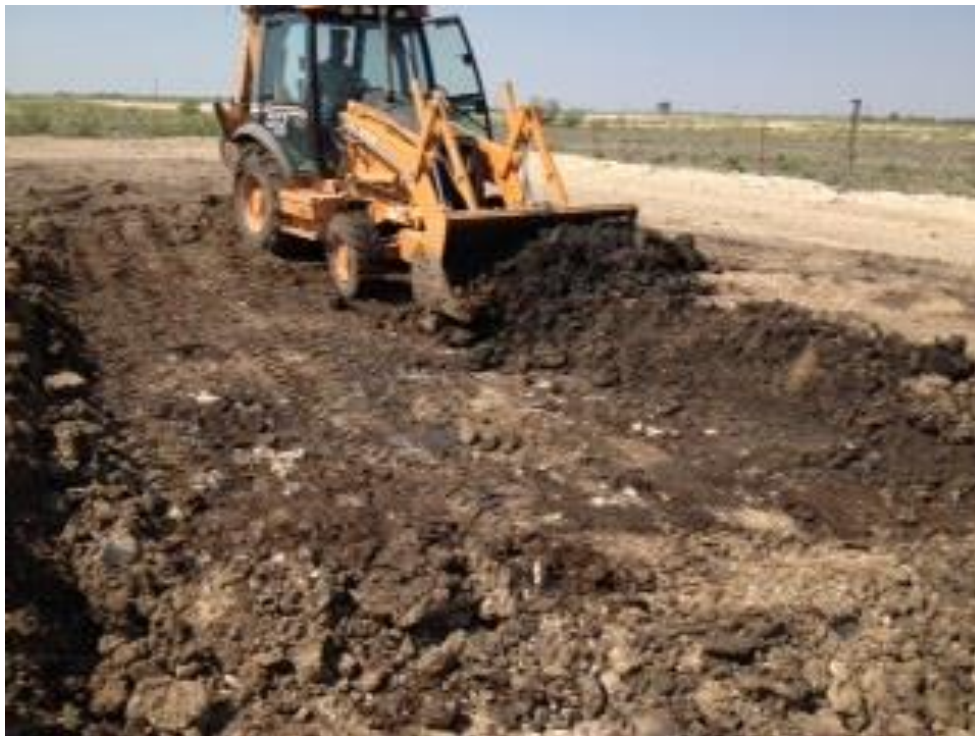
Photograph 7. Looking south at backhoe digging inside contaminated area.

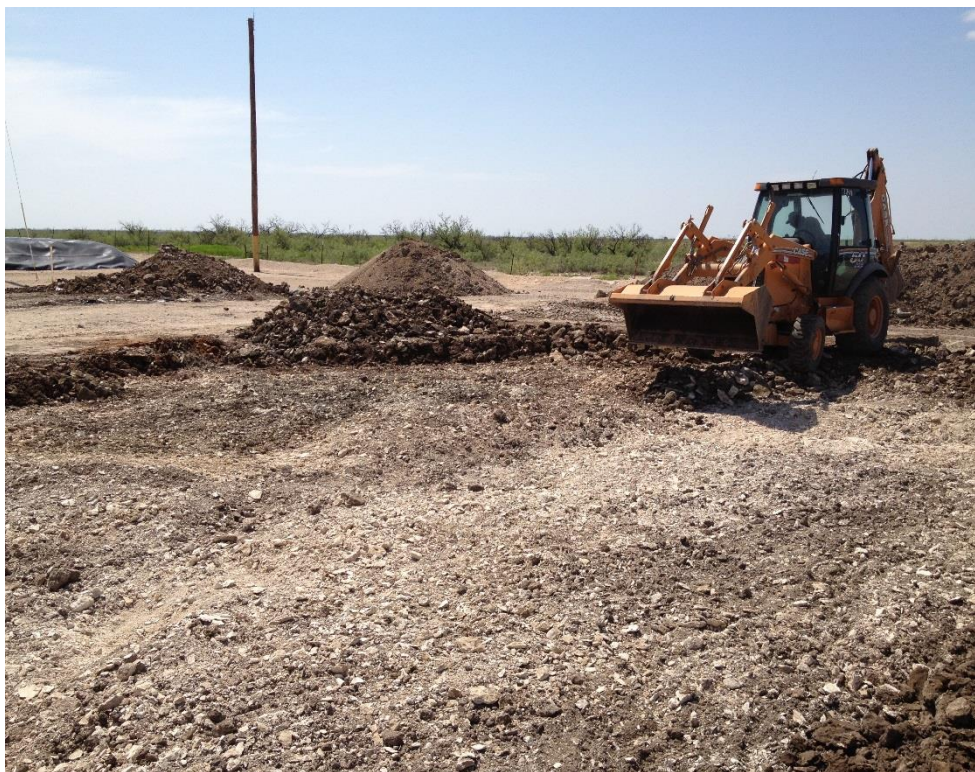
Photograph 8. Grading site after excavation of affected soil.

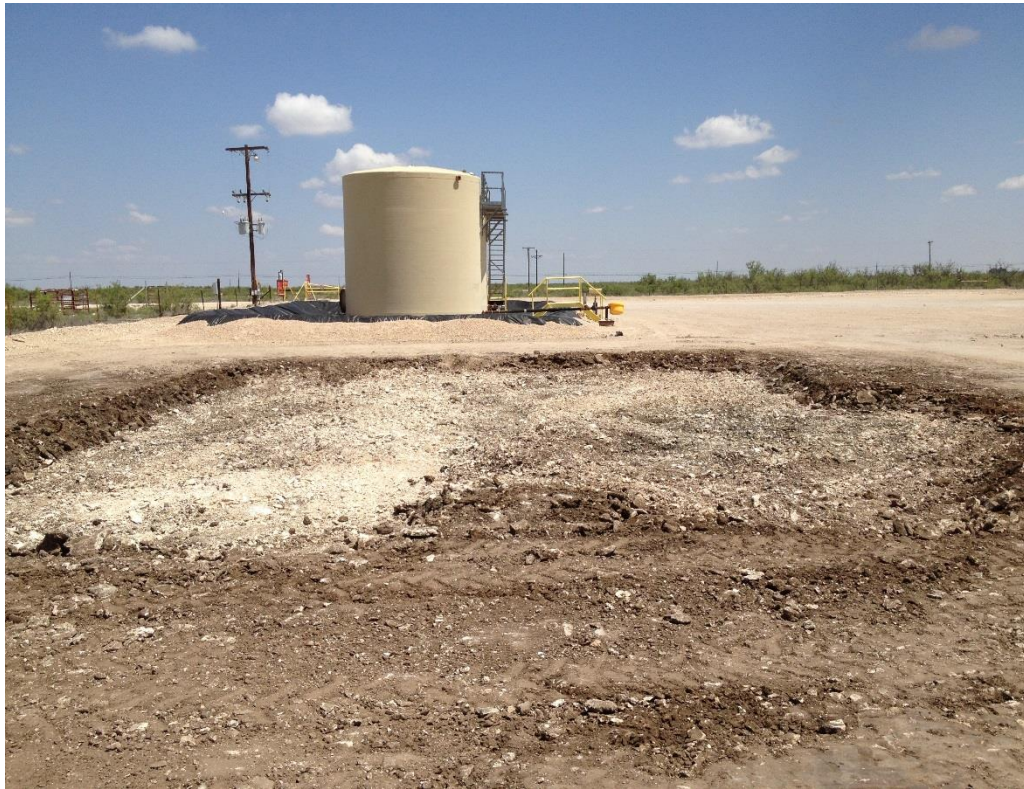
Photograph 9. Looking North at Site after excavation activities.
