Release Notification and Corrective Action

☐ Initial Report ☒ Final Report (1RP-3641)

Name of Company	Rice Operating Company	Contact	Katie Jones Davis
Address	122 W Taylor, Hobbs, NM	Telephone No.	575-393-9174
Facility Name	EME K-33 SWD	Facility Type	SWD

EME K-33 SWD (1RP-3641)
Unit Letter K, Section 33, T19S, R37E

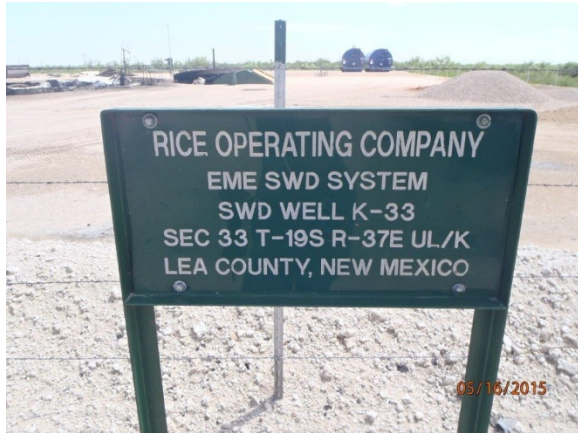
All produced water contained within the berm
5/16/2015
