Subject: Final Report
EOG Resources, Inc.
Shinnery Fed #1
1RP-3161 (API 30-025-30247)
Lea County, New Mexico

On behalf of EOG Resources, Inc. (EOG), CH2M HILL Engineers Inc. (CH2M) performed a remedial action at Shinnery Fed #1 (site). Results of the previous soil assessment and subsequent remediation activities are summarized below.

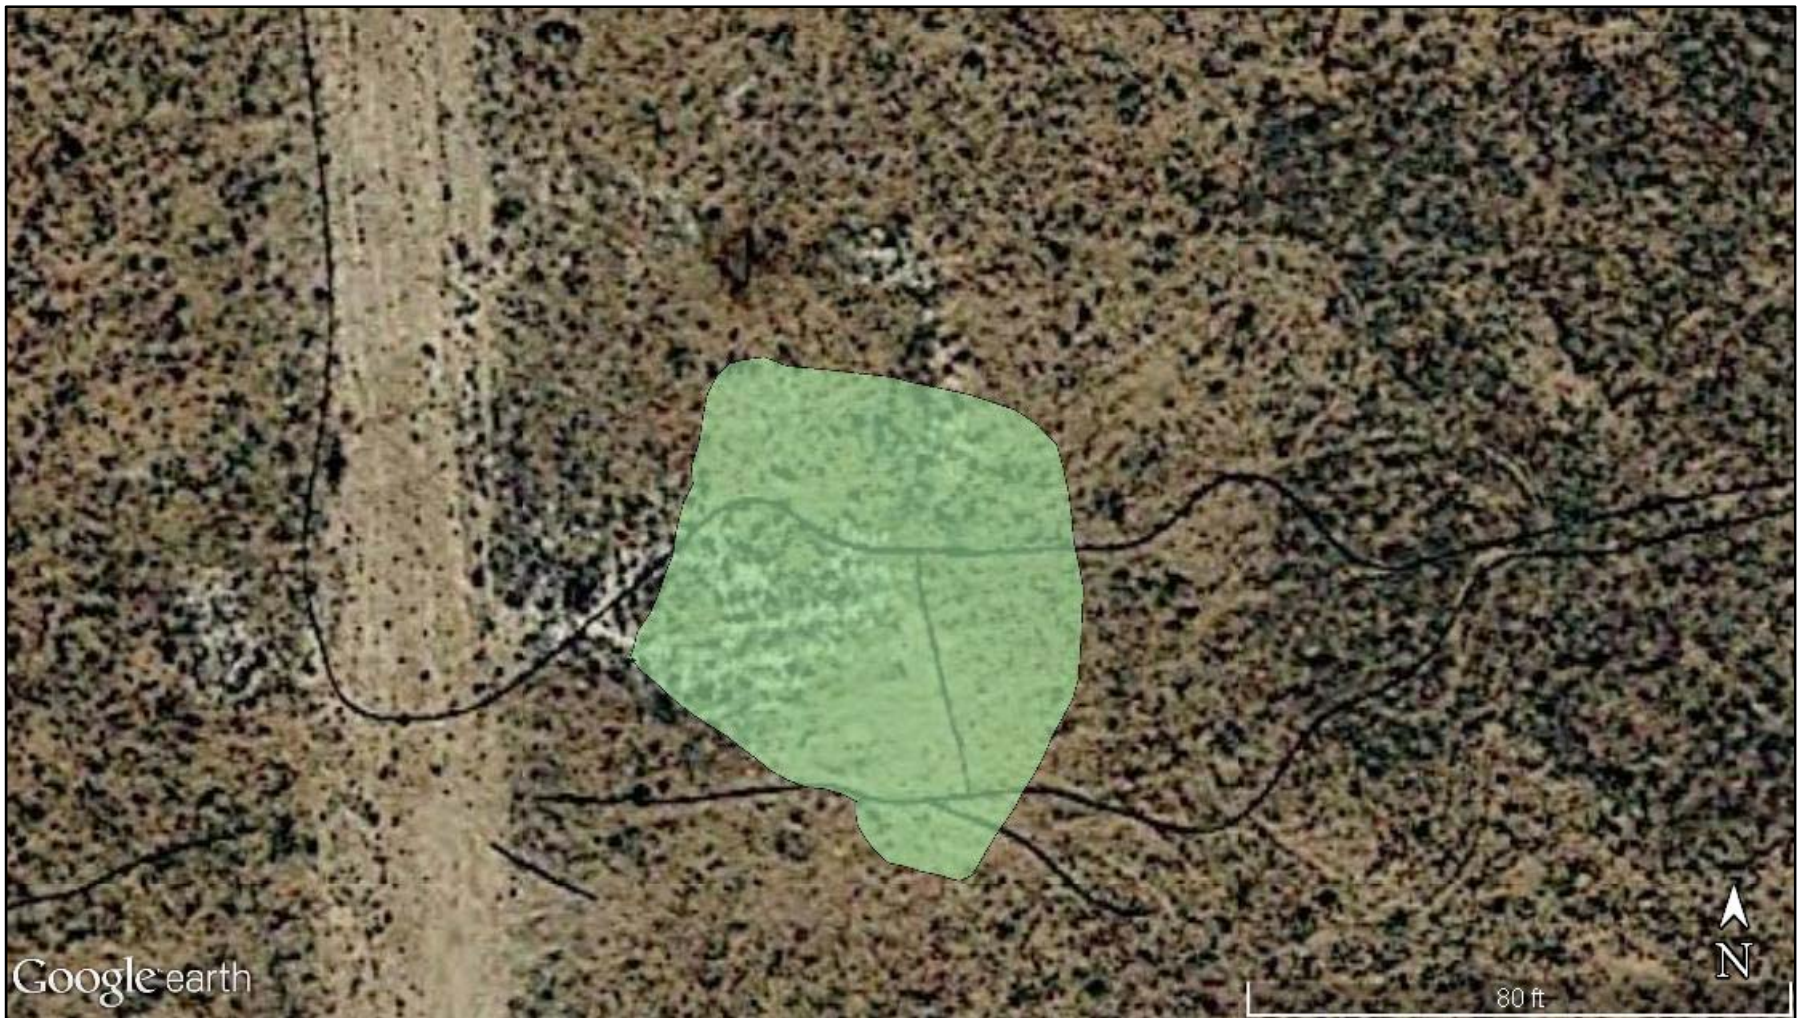
FIGURE 3
Excavation Limits
EOG Resources - Shinnery Fed #1
Final Report (1RP3161)
Lea County, New Mexico

- Approximate limits of excavation and subsequent liner installation
(Appendix B contains figures depicting historical sample locations)

- In support of a NMOCD- and BLM-approved work plan, dated December 8, 2014, impacted soils to a depth of 5 feet below ground surface (bgs) were removed from the site, a polyethylene liner was installed, and non-impacted backfill was placed over the liner by Watson Construction.

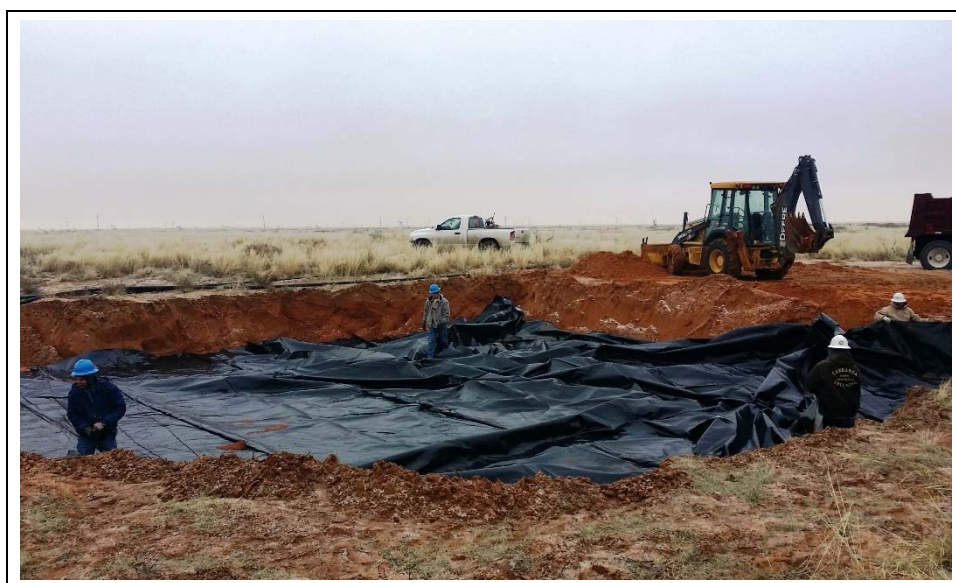
Liner Installation

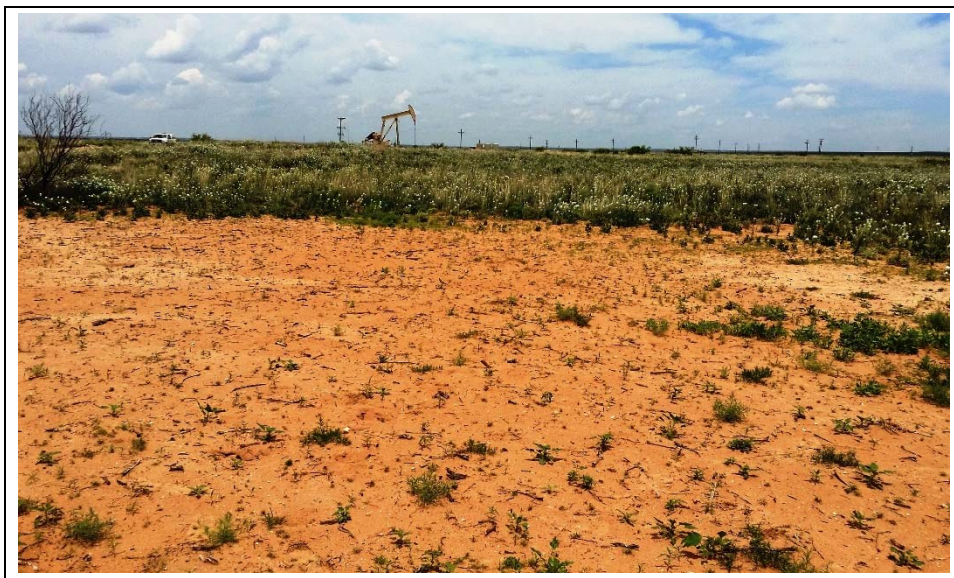
Post liner installation, looking north.

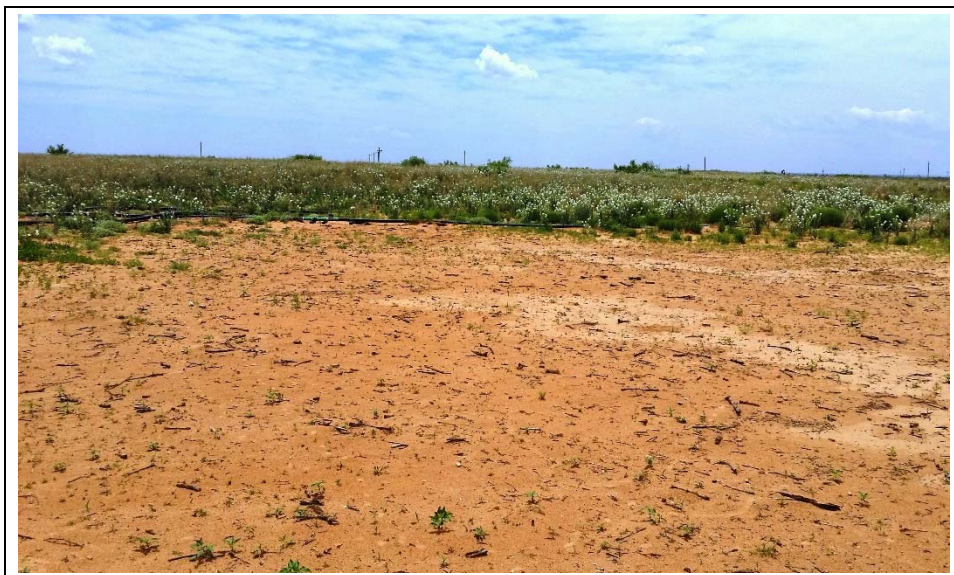
Post liner installation, looking south.

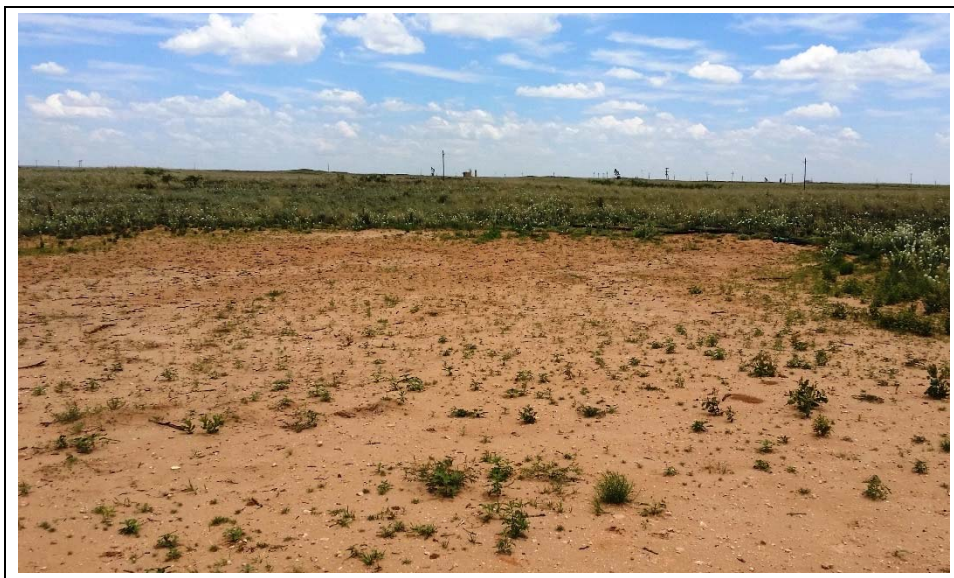
Post liner installation, looking east.

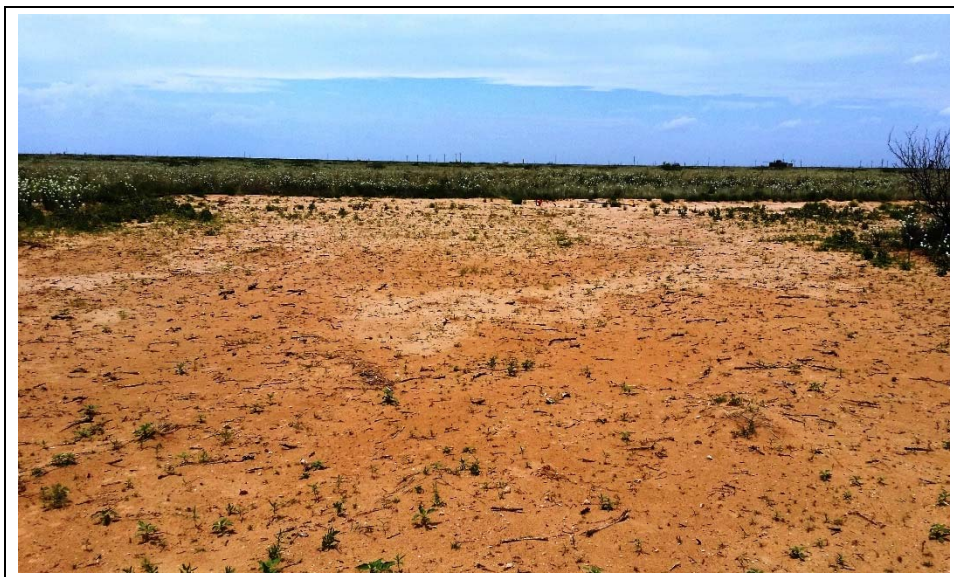
Post liner installation, looking west.
