HOBBSOCD State of New Mexico Energy Minerals and Natural Resources 30 200

Form C-141 Revised August 8, 2011

Morning Glory #1 Accidental discharge April 18, 2015

Morning Glory #1 Final May 28, 2015

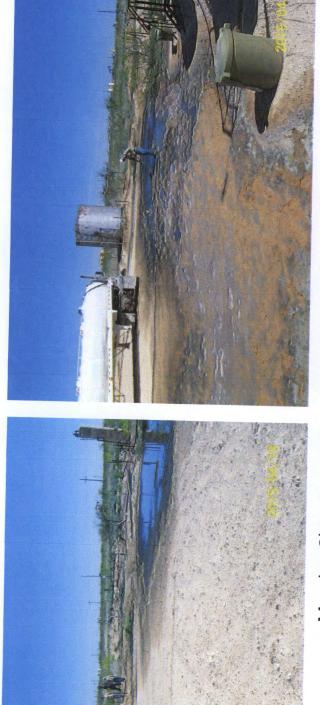
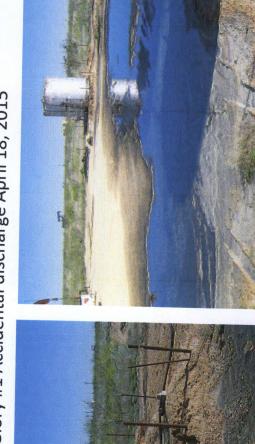
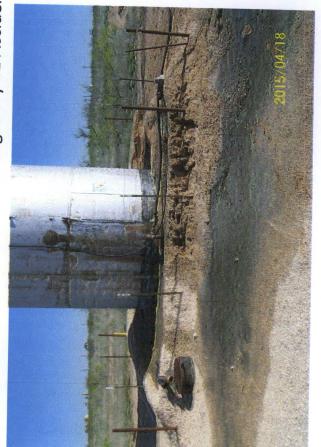
Source of Release water tank failure						Date and Hour of Occurrence			Date and Hour of Discovery		
Was Immediate Notice Given?						04/18/15			04/18/15 9:30 am		
As soon as info was gathered Yes No Not Required						If YES, To Whom?					
By Whom? Carolyn Doran Havnes						who who will be a series of C-141 to 1 omas Oberding					
Was a Watercourse Reached?						Date and Hour 04/18/15 10:15 am If YES, Volume Impacting the Watercourse.					
☐ Yes ⊠ No						, counte impacting the watercourse.					
If a Watercou	rse was Imp	pacted, Descri	be Fully.*		-	D	ECEIVEL				
Describe Cau Steel Tank sea and roadway.	am failure, 1	releasing prod	nced fluid	Taken.* Is into the facility and disposed at Su	berm.	Some water flo	owed from a brea	ık in the	berm onto	the surround	ling caliche pad
Describe Area						•	will will	ос теріа	iccu.		
Area affected main facility to 16 yds ³ was o meter. Attach	was inside to berm. Soils lisposed at seed photos d	the water tank at the old wat Sundance. Ar escribe discha	berm, factor tank site a around arge and co	RP sility caliche pad a e were excavated the gas meter run lean-up.	was sc	roadway. Wolaced. Affect raped and rep	laced with caliche	rroundin e turn-arc	g the facili ound for ea	ty was scrap sy reader ac	ed-up; a total of cess to the gas

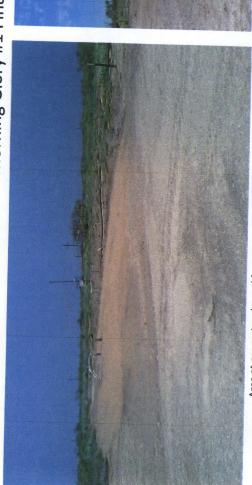
Area at gas meter cleaned for easy reader access

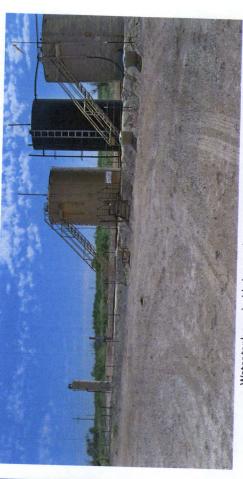
Water tank now inside battery berm with gun barrel and oil tank

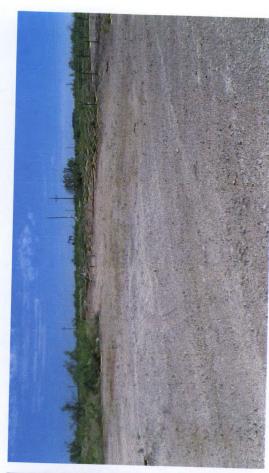
Old water tank removed, area cleaned and resurfaced
