Investigation Summary
Endurance 25 Fed. #2 SWD Produced Water Spill
November 12, 2015

This investigation summary is prepared on behalf of EOG Resources, Inc. (EOG) for submittal to the New Mexico oil Conservation Division (OCD) and U.S. Bureau of Land Management (BLM) for a produced water spill at the EOG Endurance 25 Fed #2 SWD tank battery (Site). The Site is located in Unit E (NW/4, SE/4), Section 25, Township 26 South, Range 33 East, in Lea County, New Mexico. The approximate geodetic position is north 32° 00' 53.75" and west 103° 31' 53.07". The spill occurred on October 4, 2015, due a valve being left open at the load line prior to pulling the transport truck away. The estimated volume of the spill was 100 barrels (bbl) with about 40 bbl recovered. The spill flowed north into a pasture and covered an area measuring about 54,450 square feet or 1.2 acres. The initial C-141 was submitted to OCD District 1 on October 15, 2015. The OCD assigned the spill remediation project number 1RP-3921. Figure 1 presents a topographic map. Figure 2 presents an aerial map.

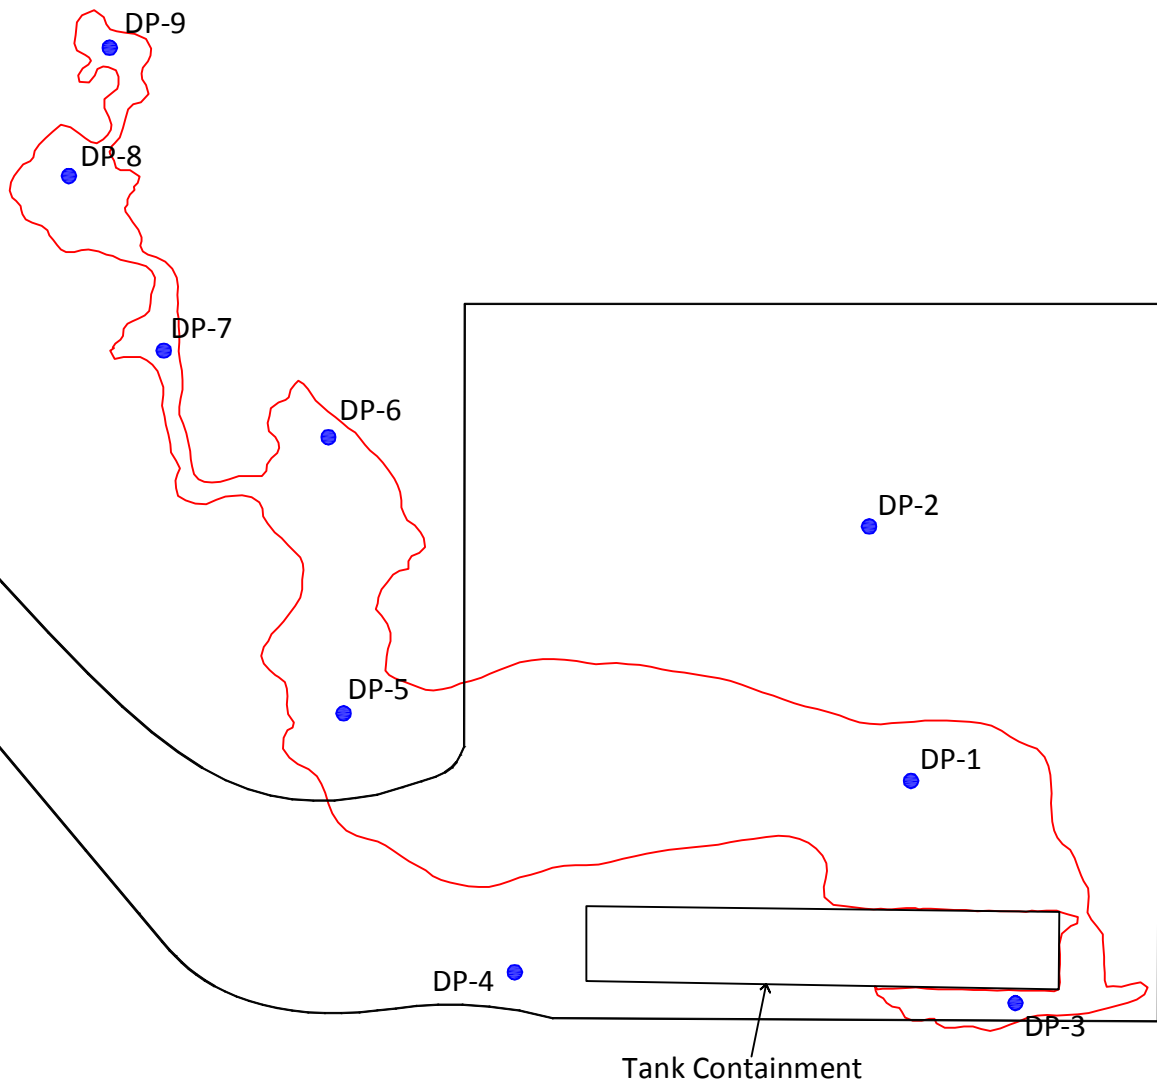
Figure 3 - Site Map

1. Ensure DP-8 is vertically delineated.
2. Provide documentation in regards to the depth to groundwater.
3. For samples DP1, DP5, DP7, DP8, and DP9, we believe going down to 8 feet in these areas will get the majority of the release.
4. Ensure BLM approval/concurrence.

Initial samples were collected on October 16, 2015, October 29, 2015, and November 2, 2015, to delineate the spill. LAI personnel used a direct push (Terraprobe®) rig to collect soil samples at nine (9) locations (DP-1 through DP-9) between approximately 12 and 16 feet bgs. Permian Basin Environmental Lab (PBEL) in Midland, Texas, analyzed the upper sample (0 to 1 foot) for total petroleum hydrocarbons (TPH) by SW-846 method 8015 modified. All samples were analyzed for chloride by method 300. Table 1 presents the analytical data summary. Figure 3 presents the sample locations. Attachment A presents the laboratory report.

Referring to Table 1, TPH was below the RRAL in all samples. TPH was also below the Reporting Limit (RL) in all samples except DP-1 (27.2 mg/Kg). Chloride was delineated vertically to 250 milligrams per kilogram (mg/Kg) in all borings except DP-6 and DP-8. Chloride decreased below 250 mg/Kg between about 0 feet (DP-4) and 14 feet (DP-9). Chloride was 451 mg/Kg and 3,270 mg/Kg in the deepest samples from DP-6, 10 to 12 feet and DP-8, 14 to 16 feet, respectively.
