Gandy Corporation Nuckols 24 #1 Site Investigation Section 24, Township 7S, Range 31E Chaves County, New Mexico

April 12, 2016

SESI was contracted to perform a site investigation to determine the vertical extent of contamination at the Nuckols 24 #1 location. The subject area is located in Section 24, Township 7S, Range 31E in Chaves County, New Mexico.

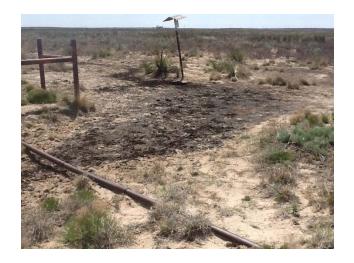
Release Point Area

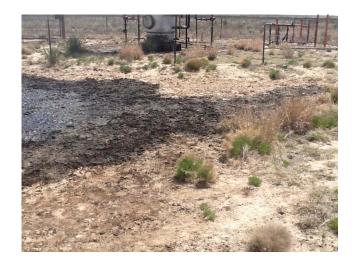
Release Point

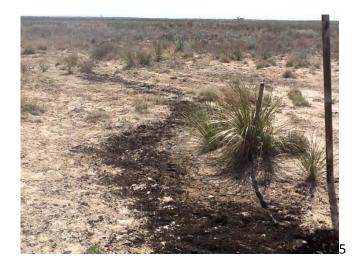
Impacted area West side of location

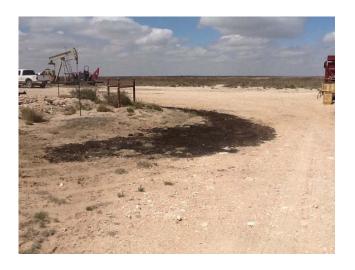
Spill run looking south

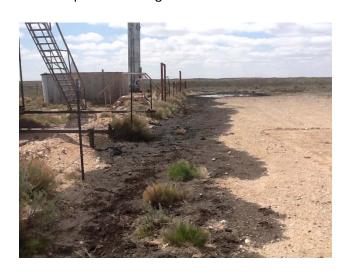
Spill traverse west onto lease road

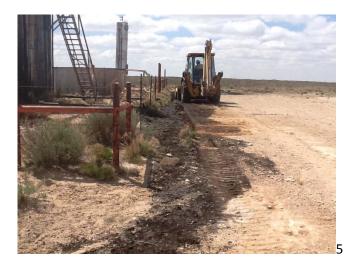
Spill Run North side

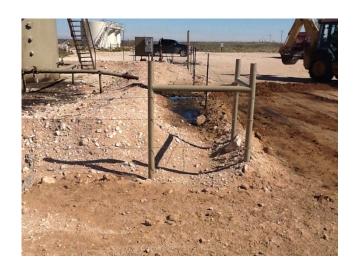
Impact inside bermed area

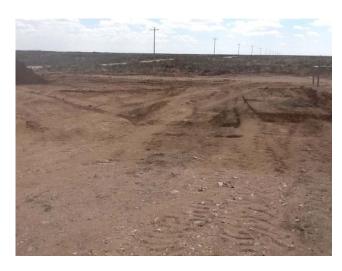
Test Trench

Date	ID	Depth	CI ⁻	TPH			
4-11-16	TT-1	6"	156	.06			
4-11-16	TT-1	1.5'	108	No test			
4-11-16	TT-2	6"	<108	.06			
4-11-16	TT-2	1.5'	<108	No test
