**Re: Release Characterization Work Plan  
Chalupa #4 SWD Pipeline Release Site  
Lea County, New Mexico  
NMOCD Case No. 1R-4633**

**FOUNDATION  
 CHALUPA #4 SWD  
 NORTH AREA**

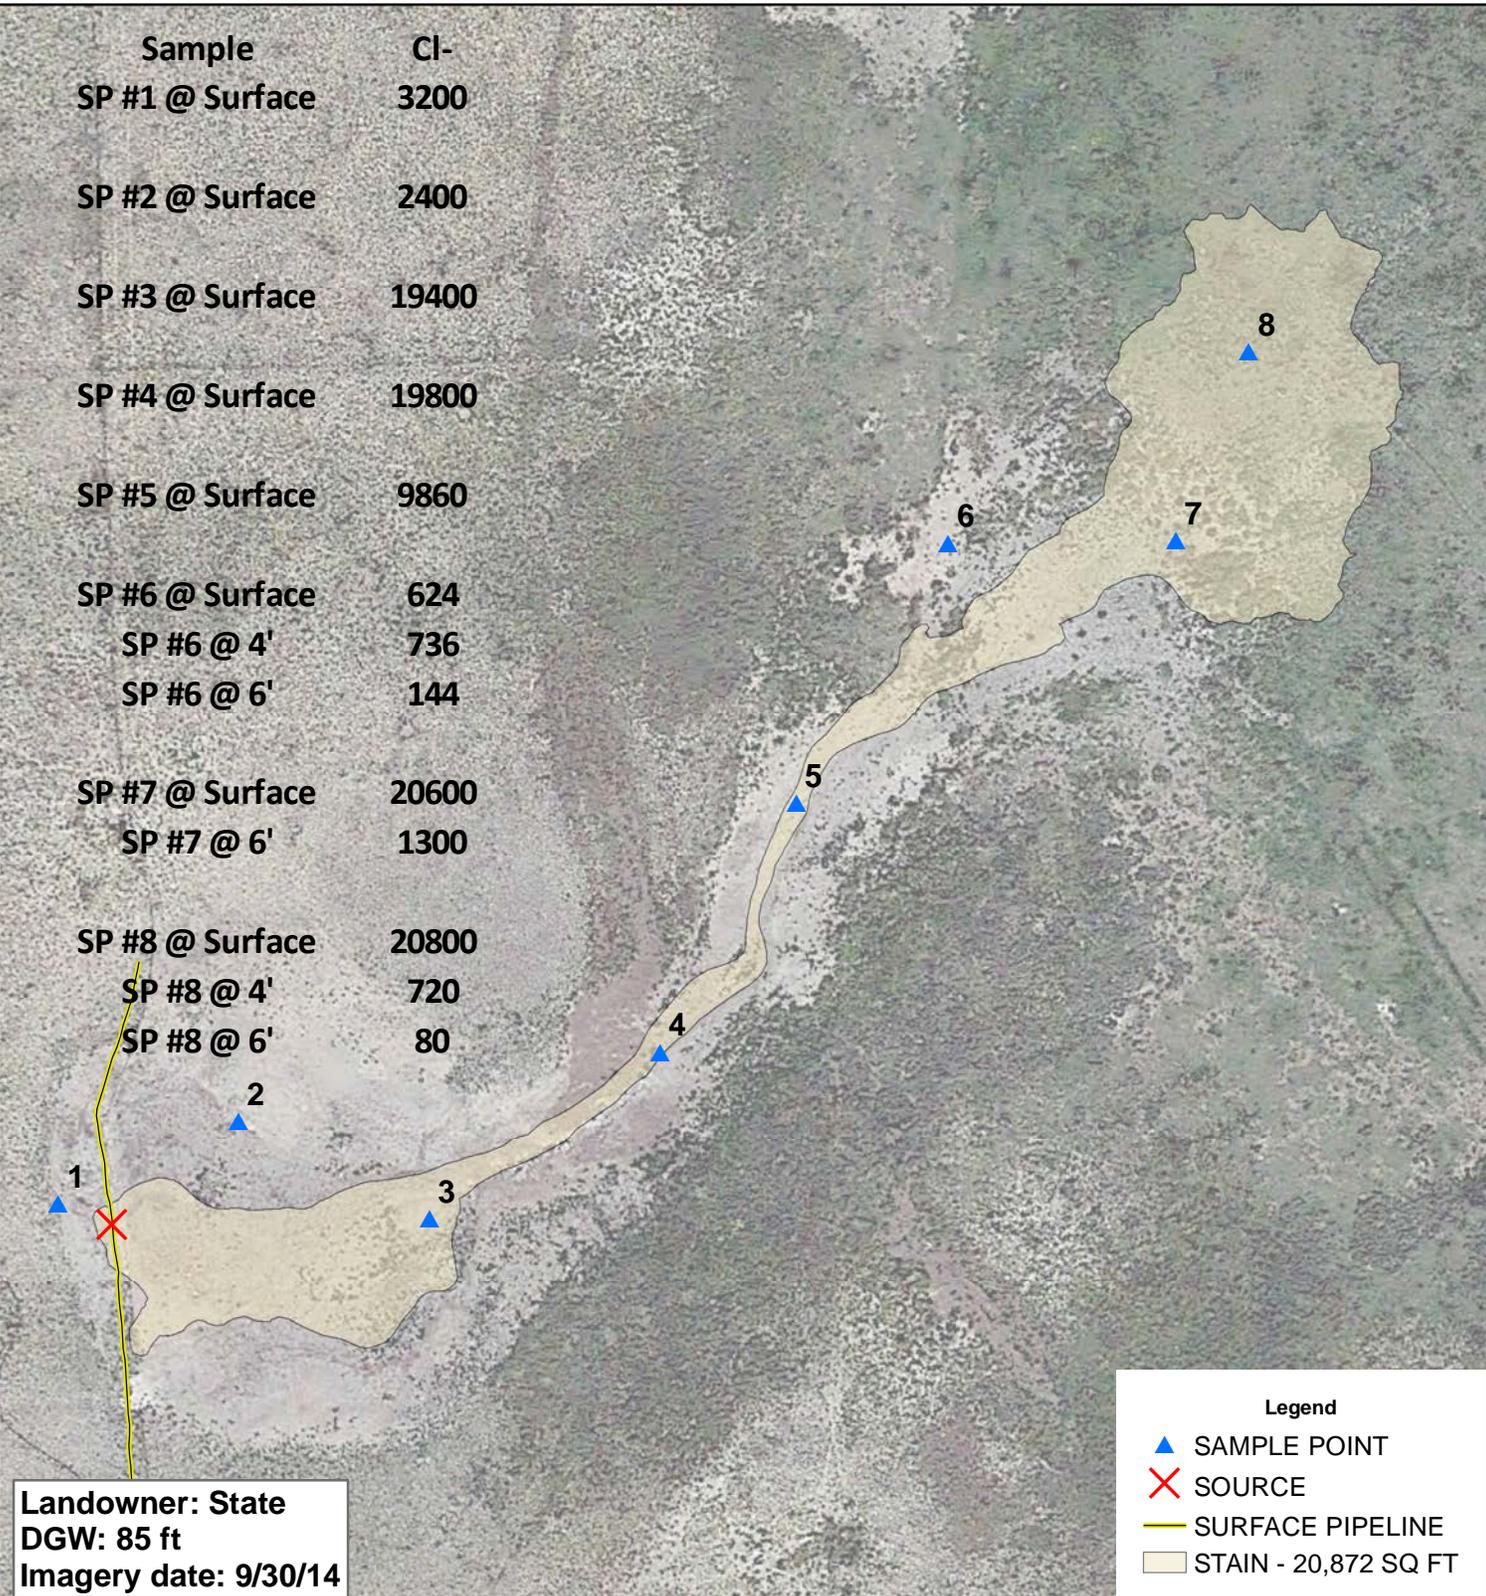
**FIGURE 2**

The released fluids appear to have flowed approximately 550 feet towards the northeast. There appear to be two areas where the produced water accumulated along this flowpath. The first area of accumulation extends from 100 to 200 feet, and the second extends from 400 to 500 feet relative to the point of release. The total affected surface area appears to be approximately 0.48 acres. The New Mexico Office of the State Engineer's (OSE's) online water well database indicates the depth-to-groundwater levels of wells within 2,000-meter radius of the site range between 80 and 120 feet, and average 108 feet below ground surface. The ChevronTexaco Lea

FEM retained Basin Environmental Service Technologies, LLC (Basin) to conduct an initial release characterization at the Site. During this investigation, Basin collected surface soil samples at locations 1 through 8 as shown on Basin's **Figure 2** which is attached. Subsurface soil samples were also collected at locations 6, 7 and 8. These soil samples were submitted to Cardinal Laboratories in Midland, Texas for chloride analyses (Method SM4500-CI B). Basin delineated the lateral limits of impact by mapping the visually apparent surface soil staining. This work was performed on May 16, 2017. The results of Basin's characterization work are presented graphically on **Figure 2**. As can be seen from these results, all but two soil samples contained chloride levels that exceed the NMOCD's cleanup level of for this Site of 600 mg/kg. The horizontal and vertical limits of impact have not been fully defined through these initial assessment activities.

Sample	Cl-
SP #1 @ Surface	3200
SP #2 @ Surface	2400
SP #3 @ Surface	19400
SP #4 @ Surface	19800
SP #5 @ Surface	9860
SP #6 @ Surface	624
SP #6 @ 4'	736
SP #6 @ 6'	144
SP #7 @ Surface	20600
SP #7 @ 6'	1300
SP #8 @ Surface	20800
SP #8 @ 4'	720
SP #8 @ 6'	80
