# 1RP-3178 DELINEATION PLAN Waka Tanka Battery #1 & #2 Produced Water Spill Chaves County, New Mexico

LAI Project No. 17-0175-07

February 20, 2018

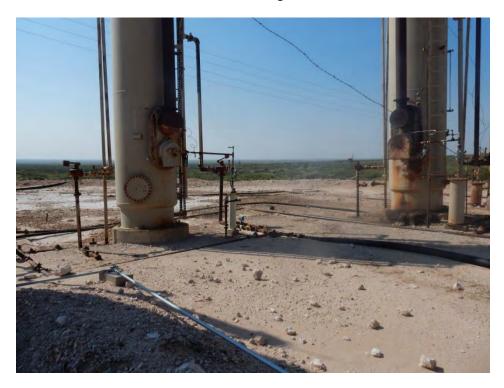
Site Prior to Remediation Viewing Northwest, September 11, 2017

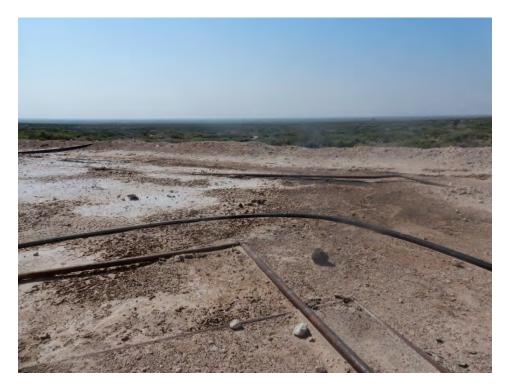
Site Prior to Remediation Viewing North, September 11, 2017

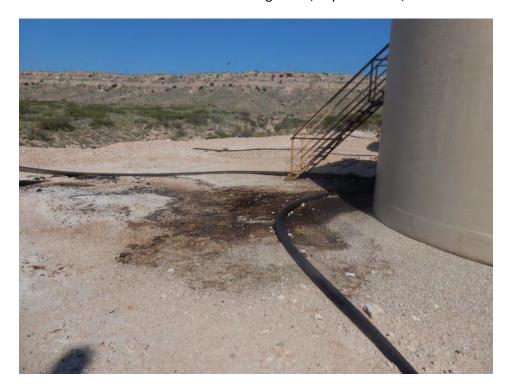
Site Prior to Remediation Viewing East, September 11, 2017

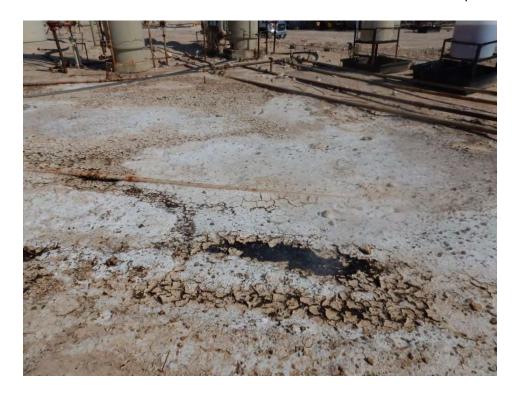
Site Prior to Remediation Viewing South, September 11, 2017

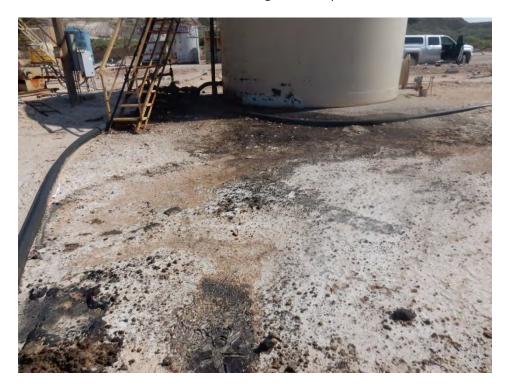
Site Prior to Remediation Viewing South, September 11, 2017
