**Release Notification and Corrective Action**

| Facility Name: EMSU #214 | Facility Type: Flowline near EMSU #214 Wellsite (Oil Well) |

Subject: Site Information, EMSU #214 – OCD #1R-4168, Chevron USA 214 Leak Site,  
Request for Closure.

## **Remediation/Cleanup Work Plan**

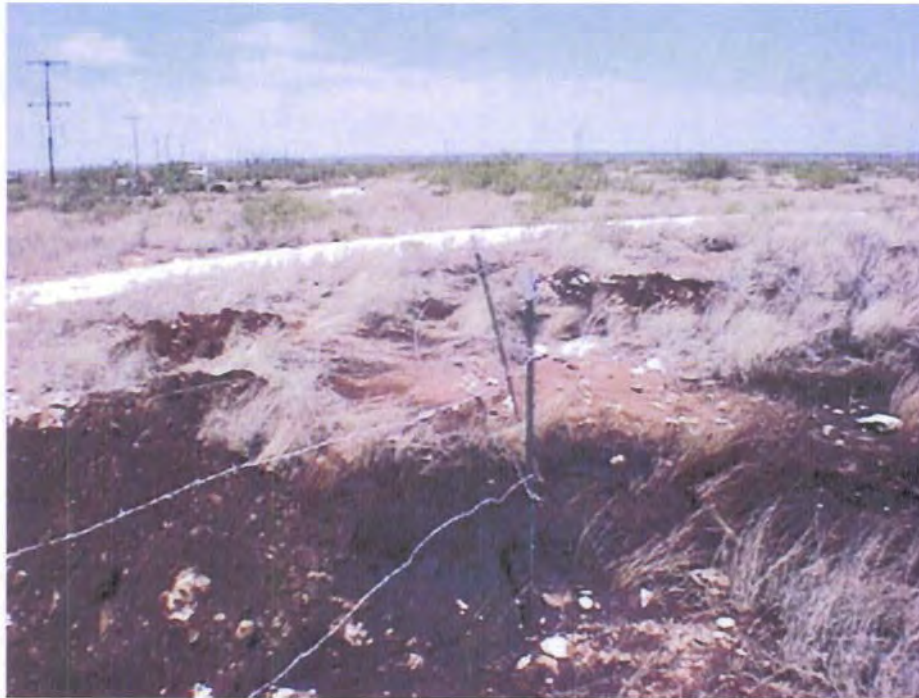
Chevron #214 Leak Site – Facing West\*, July 1998

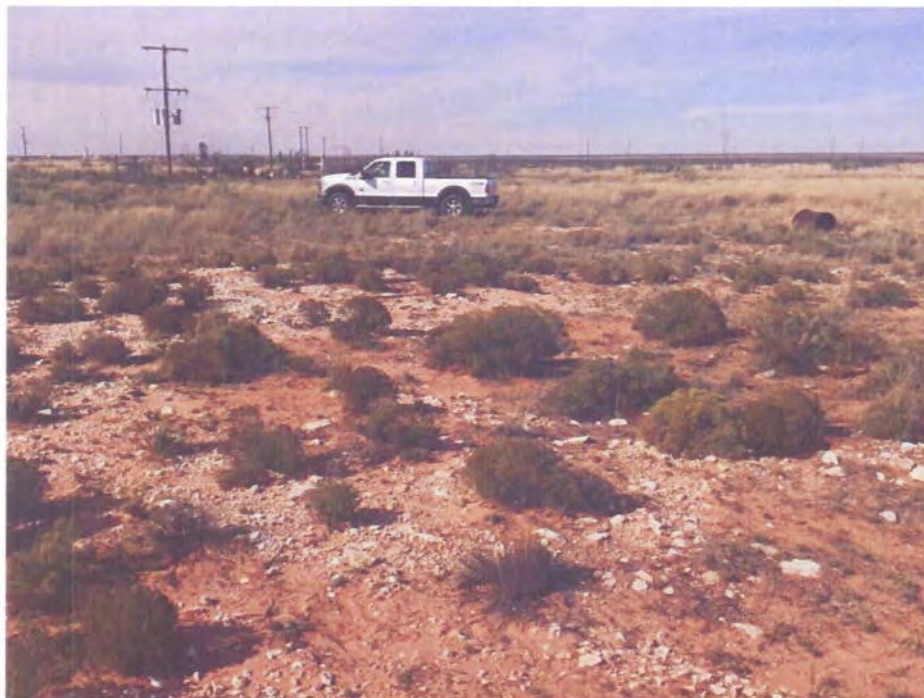
Site photographs taken on November 17 show no current evidence of a release. Depth to water information in excess of 100 feet indicates that any residual impact from the release to groundwater was very unlikely. Though there are no sampling results available, a review of the invoice to Chevron shows that the blending and backfilling according to the work plan was performed.

Chevron #214 Leak Site – Facing West, November 2017

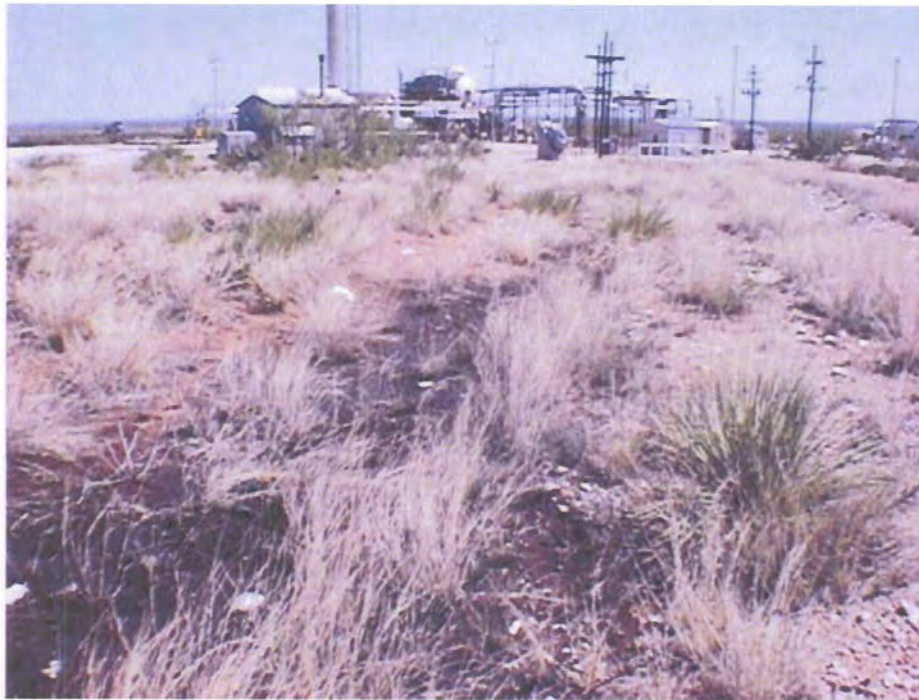
Chevron #214 Leak Site – Facing Northeast, July 1998

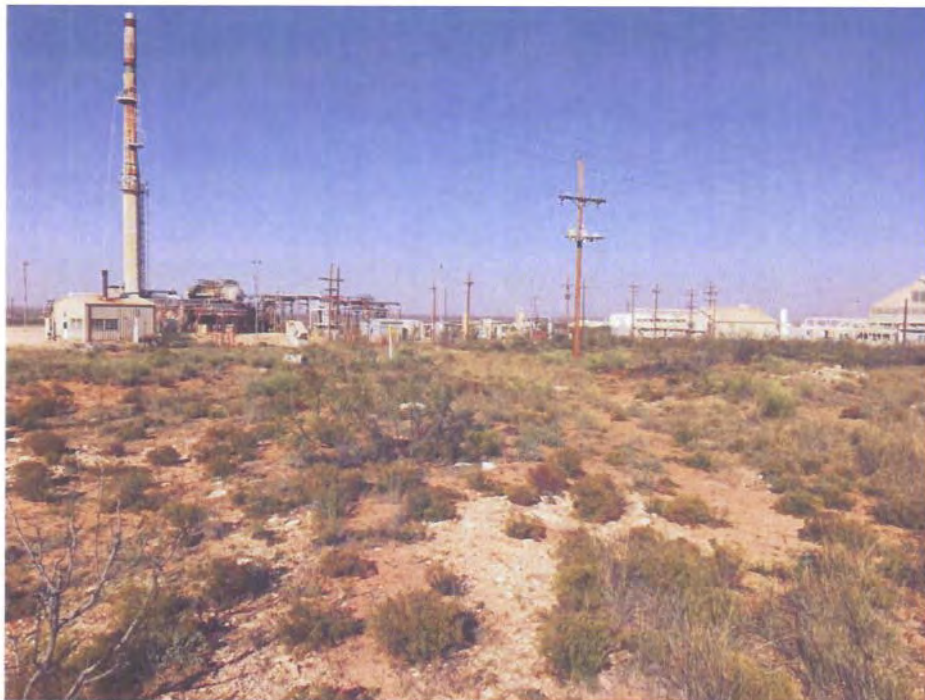
Chevron #214 Leak Site – Facing Northeast, November 2017

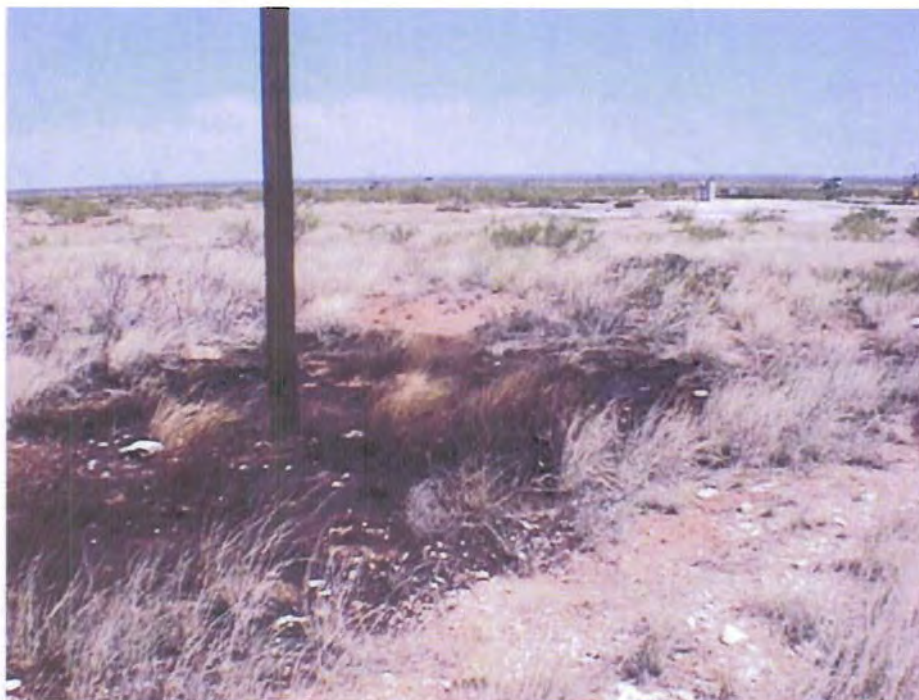
Chevron #214 Leak Site – Facing Northwest, July 1998

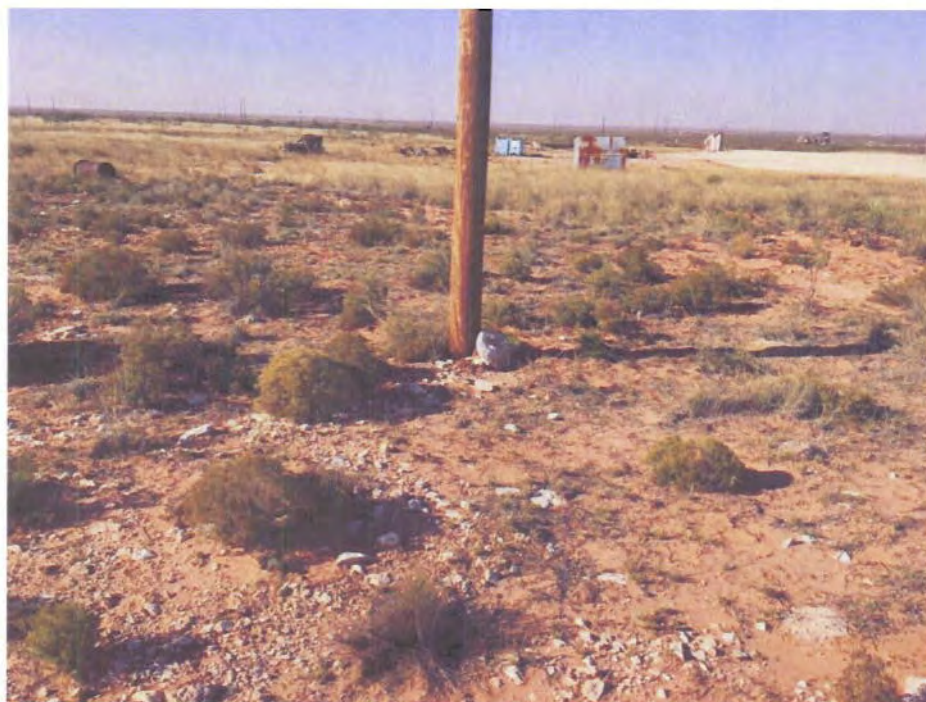
Chevron #214 Leak Site – Facing Northwest, November 2017

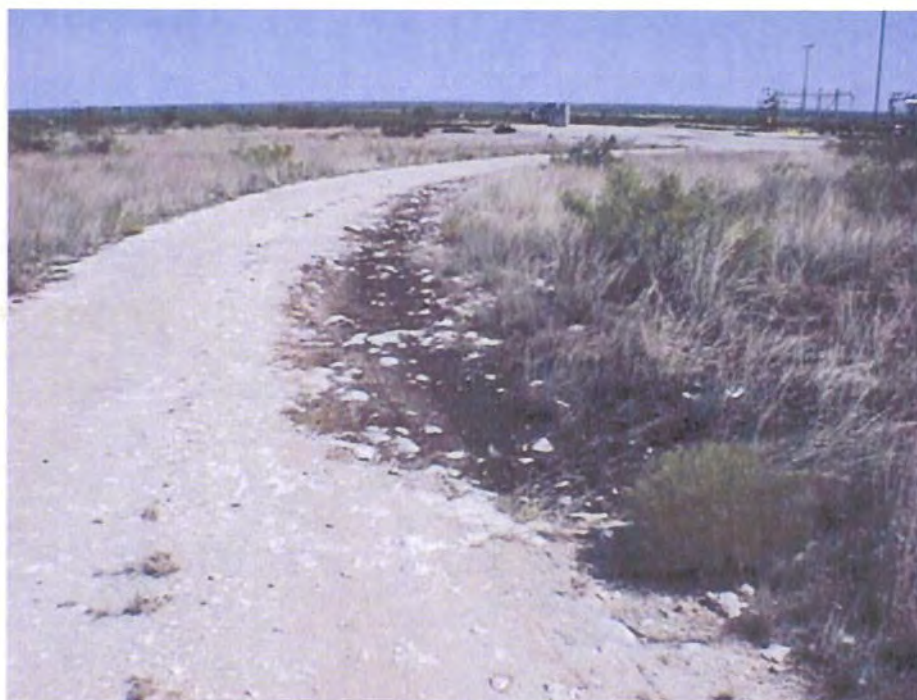
Chevron #214 Leak Site – Facing North, July 1998

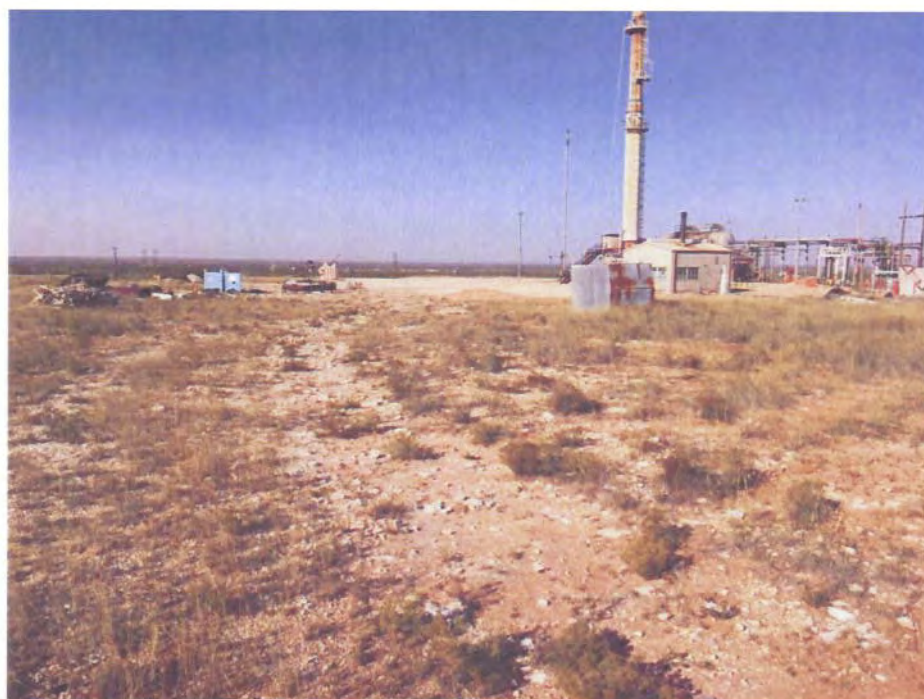
Chevron #214 Leak Site – Facing North, November 2017

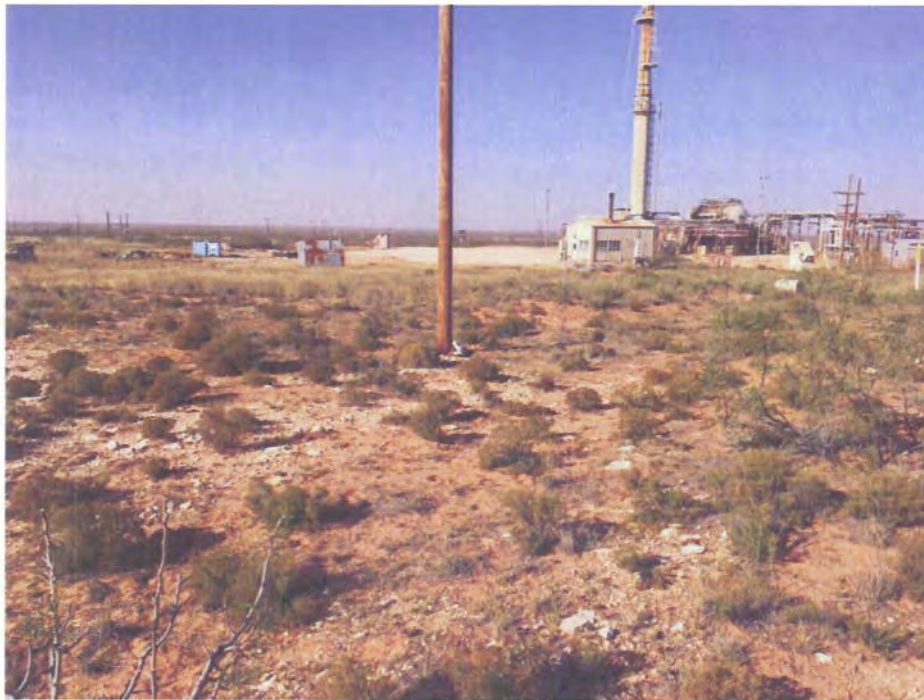
Chevron #214 Leak Site – Facing North, November 2017

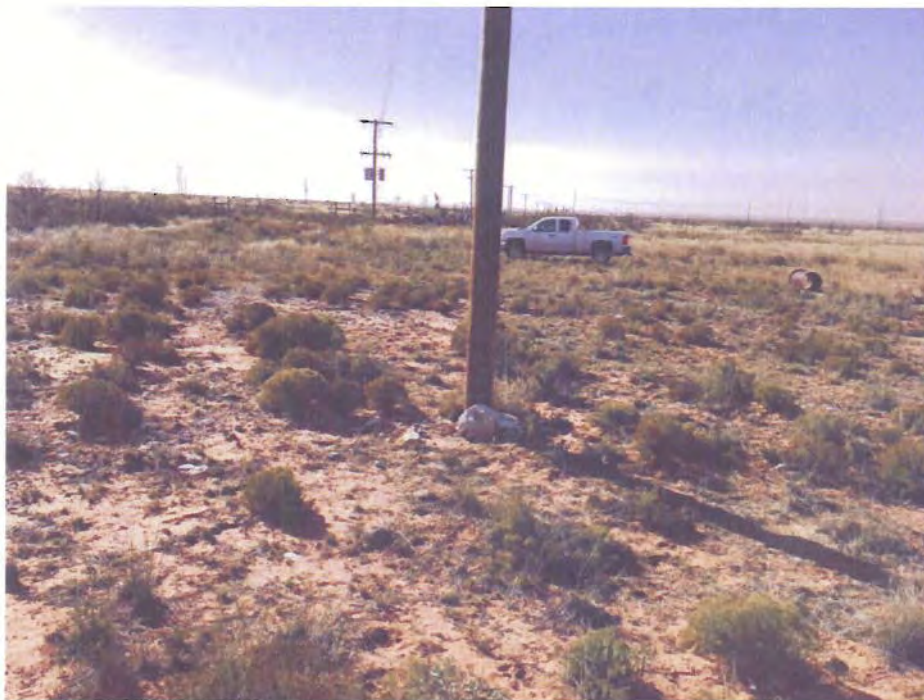
Chevron #214 Leak Site – Facing west, November 2017

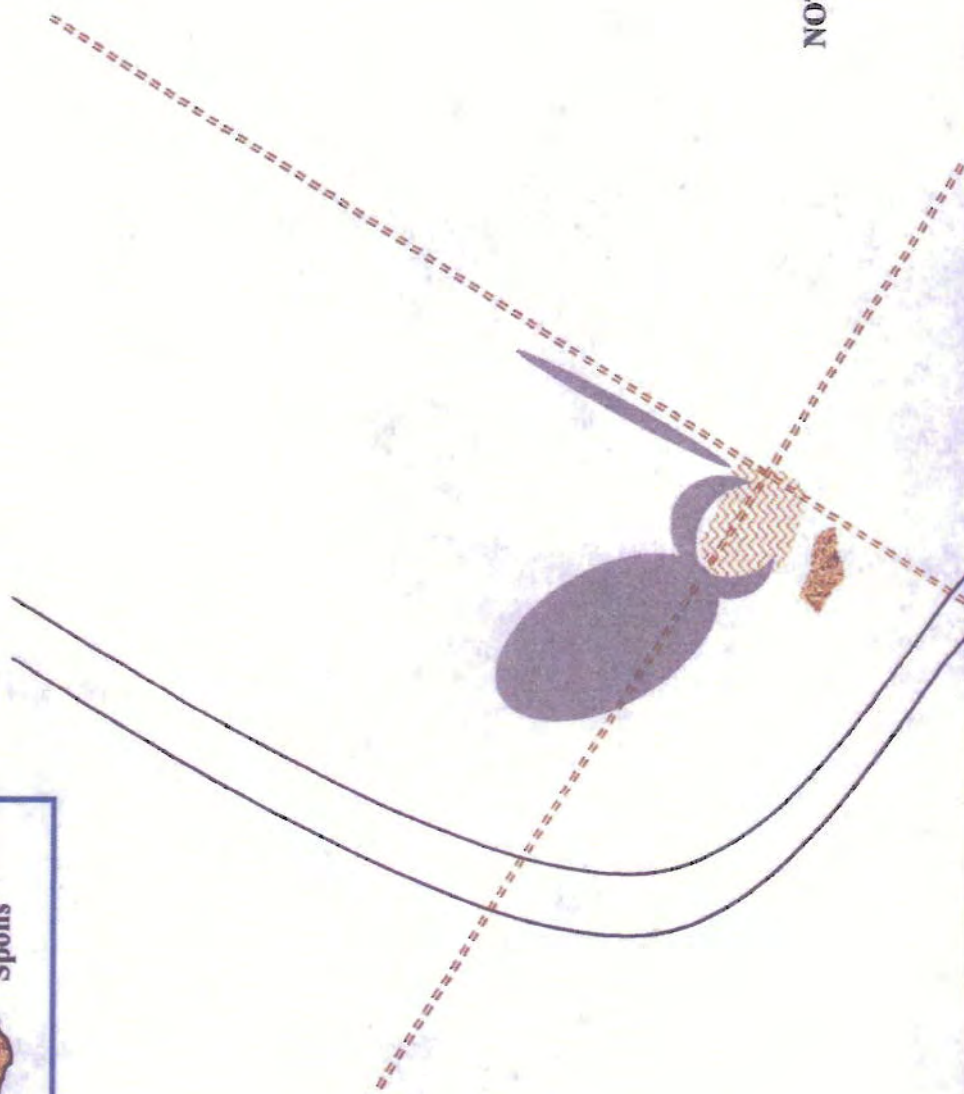
## #214 Leak Site Plan

The leak in the pipeline resulted in crude oil being discharged up to six feet underground and spreading over a surface area approximately 75 feet in length and 4 feet wide in the stream pooling into an area 70 feet by 20 feet. (Site Plan) Chevron USA has received notification from the Oil Conservation Division that the crude oil in this pipeline does not have to be subjected to the Toxic Leaching Characteristic Procedure (TCLP) for toxicity. No evidence of other contaminants was observed.

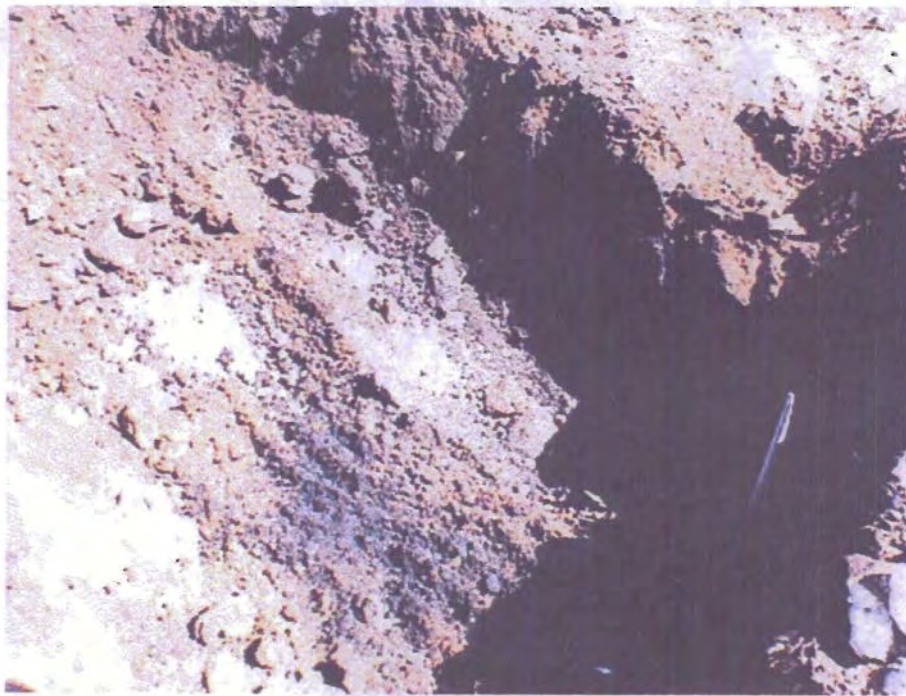
Chevron #214 Leak Site - Excavated Leak Area

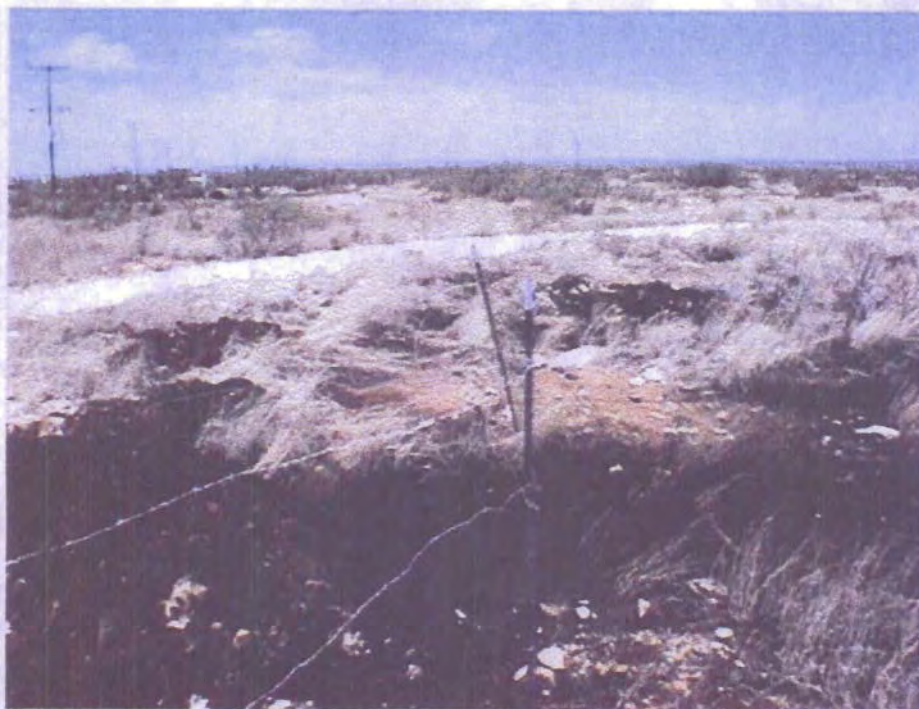
Chevron #214 Leak Site - Facing Northwest

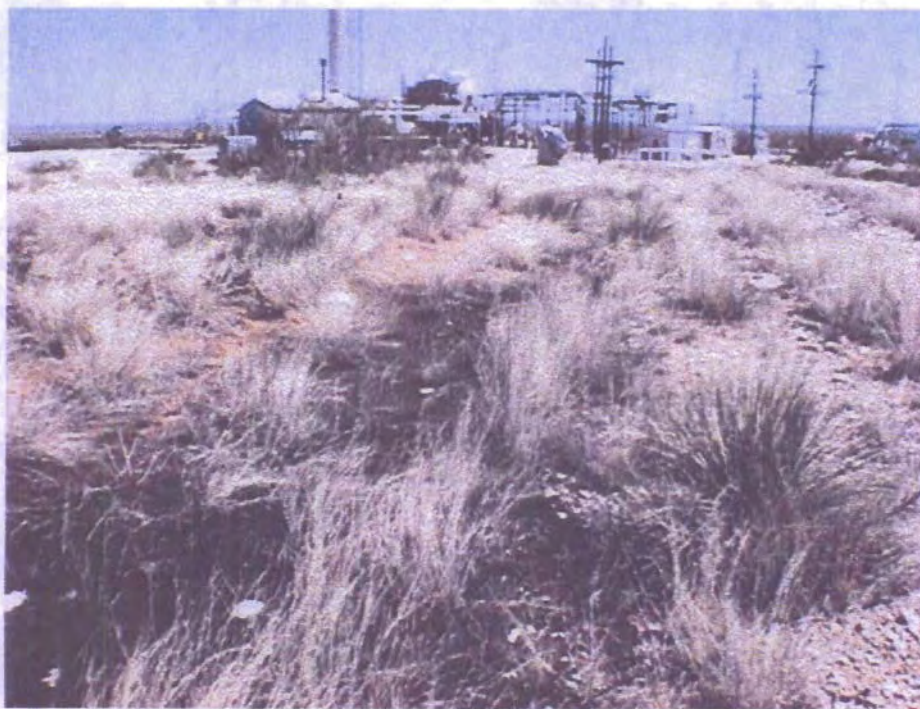
Chevron #214 Leak Site - Facing South

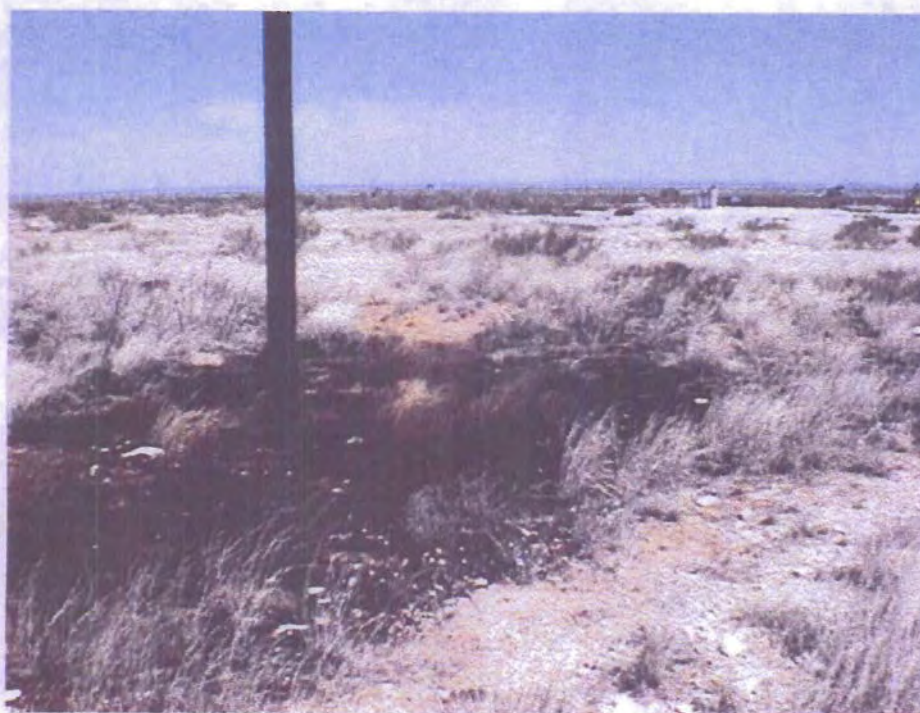
Chevron #214 Leak Site - Facing Southwest

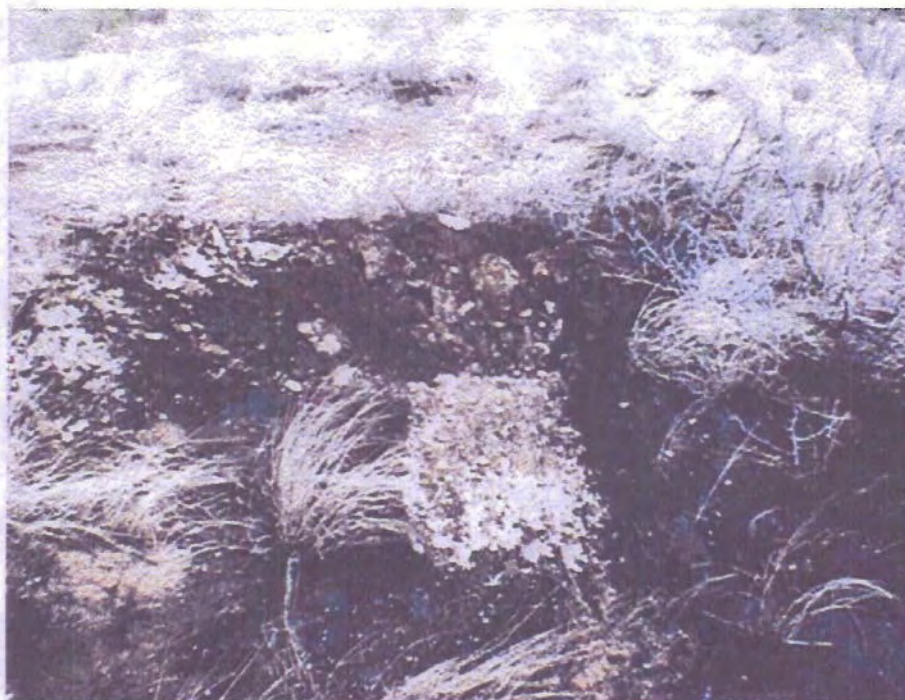
Chevron #214 Leak Site - Spill Area

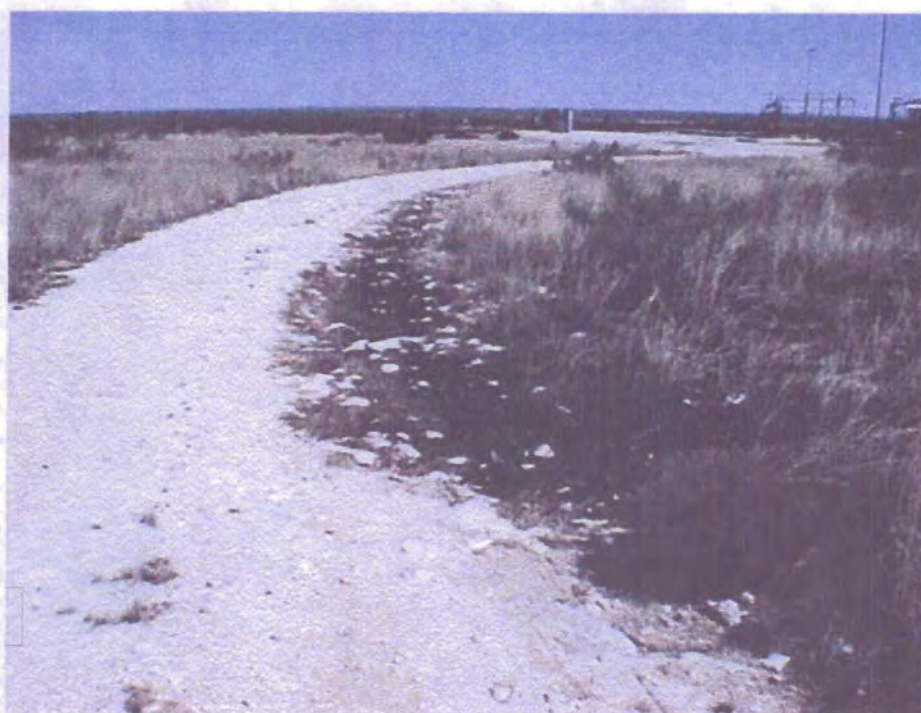
Chevron #214 Leak Site - Facing Southwest
