1RP-4831
DELINEATION PLAN
EMSU Well #101 Flow Line Leak
Lea County, New Mexico

LAI Project No. 17-0192-01

October 15, 2017

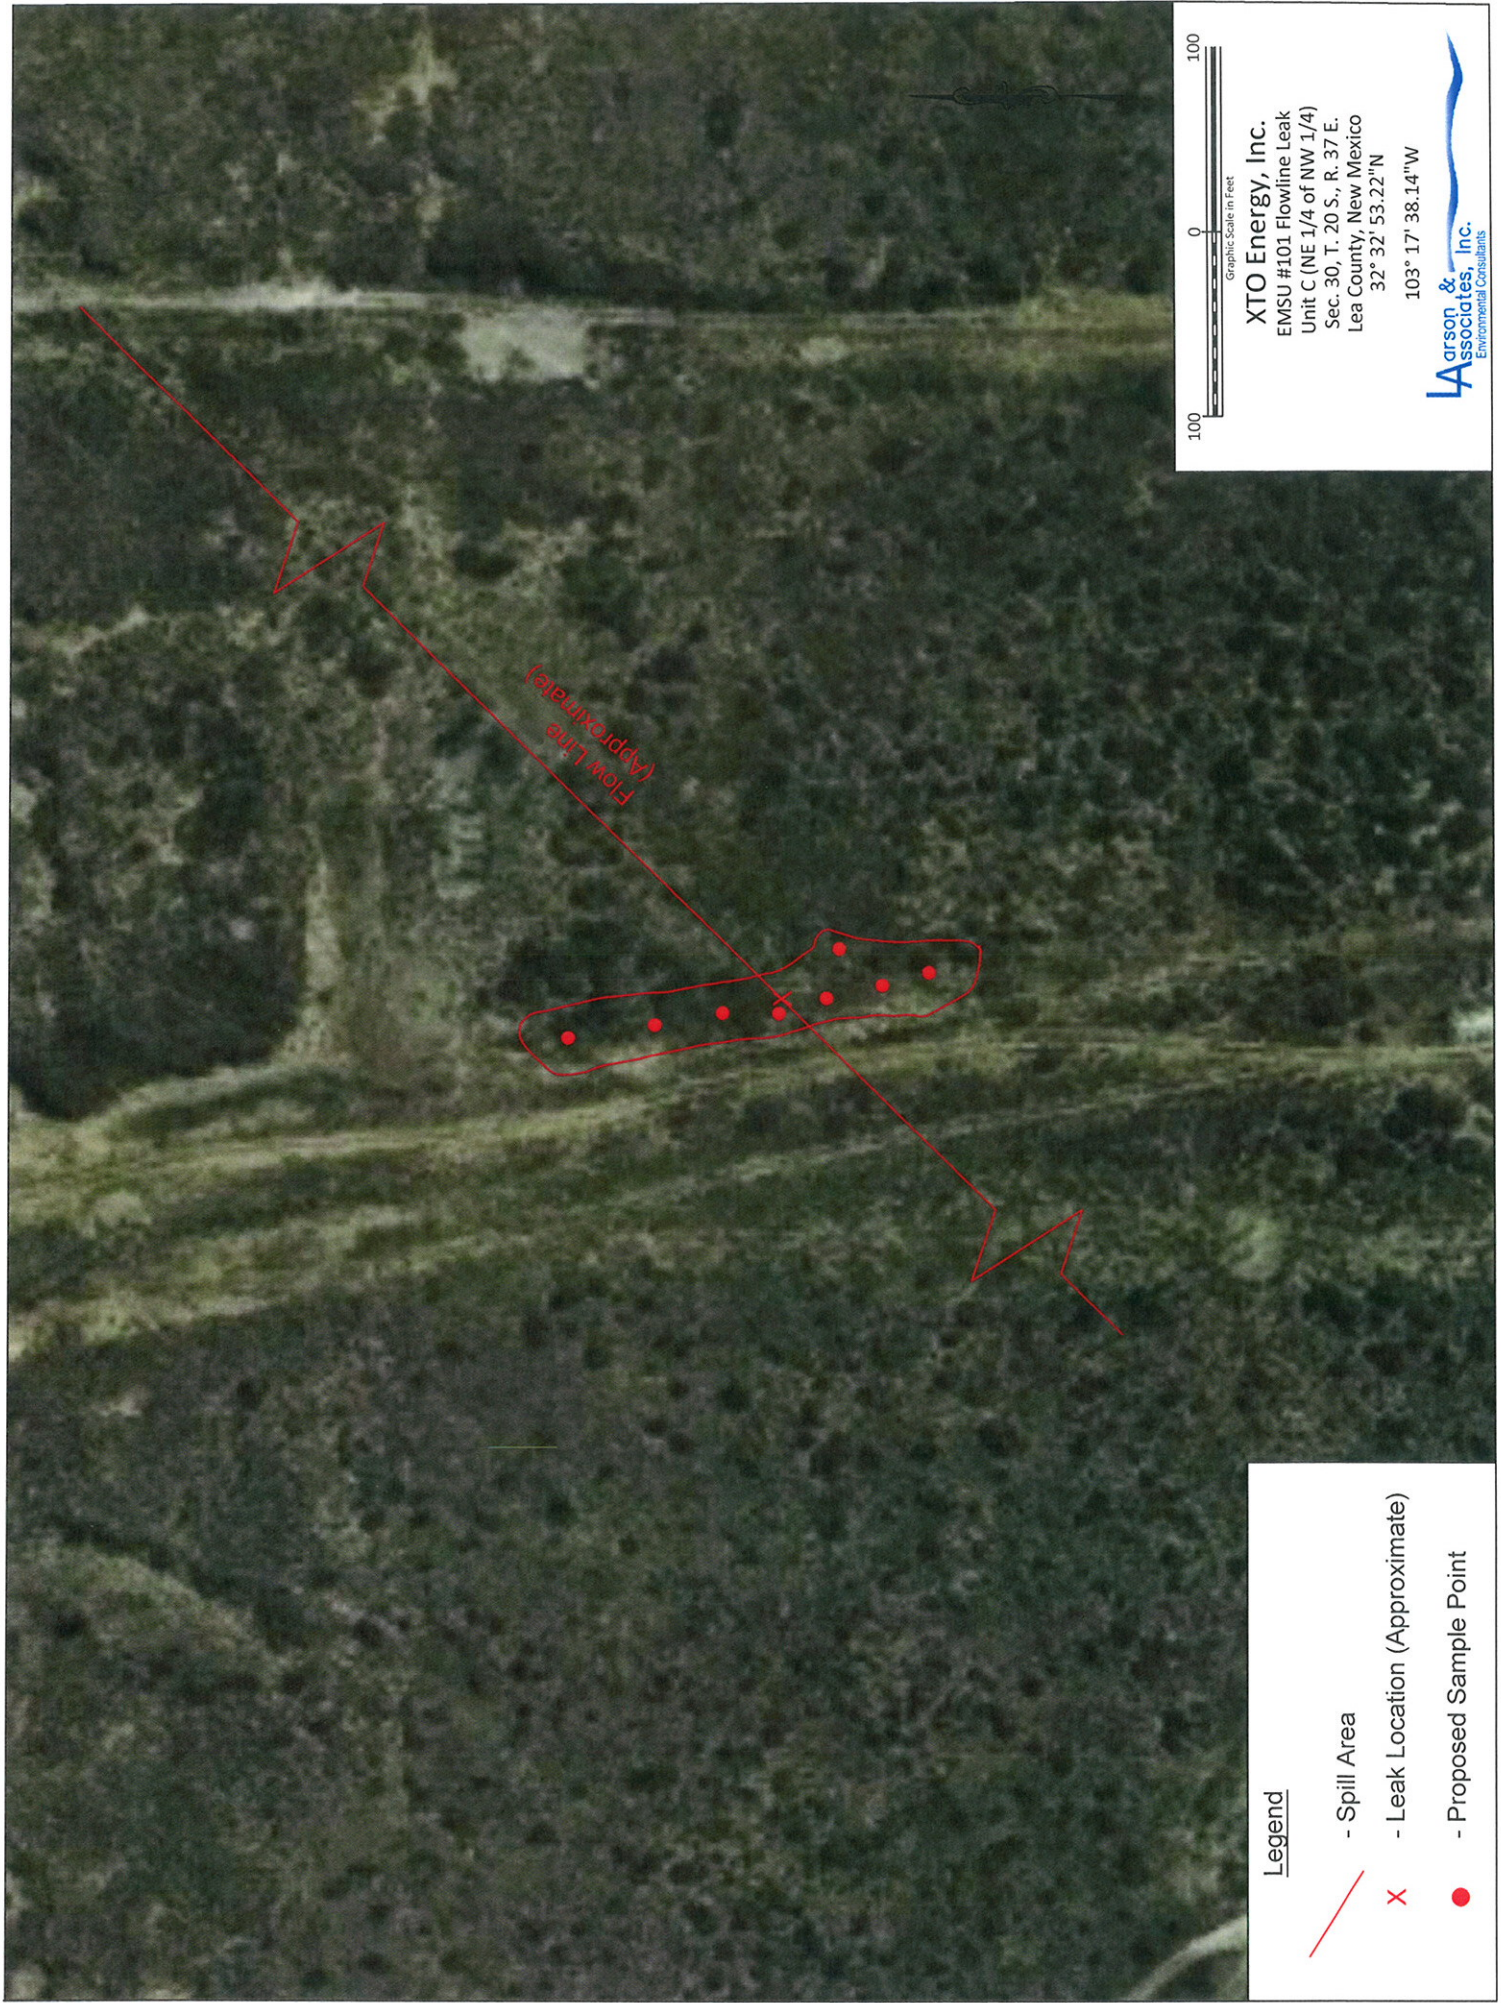
Figure 3 - Aerial Map Showing Spill Area and Proposed Soil Sample Location

LAI proposes to direct push technology (DPT) to collect soil samples at eight (8) locations in the spill area outside of the trench excavated to repair the fiberglass flow line plus a sample in each cardinal direction (north, south, east and west) for horizontal delineation. LAI will collect soil samples from inside the bottom of the trench at approximately 4 feet bgs plus 6 and 8 feet bgs for vertical delineation. Soil samples will be collected from the sidewalls (north, south, east and west) at approximately 3 feet bgs. The soil samples from inside the trench will be collected with a stainless steel trowel and hand auger. The soil samples outside the trench will be collected with direct push technology (DPT) at 1 foot increments to about 4 feet bgs and 2 foot increments to approximately 12 feet bgs depending on subsurface conditions. The samples will be tested in the field for chloride using QuanTab® chloride test strips (300 - 6,000 mg/L). Additional samples may be collected if chloride is not delineated vertically to 600 mg/Kg with an additional five (5) vertical feet below the deepest sample from each location as allowed by subsurface conditions. The samples will be delivered to Permian Environmental lab (PBEL) in Midland, Texas, under preservation and chain of custody. The laboratory will analyze the bottom sample at approximately 4 feet bgs from the trench, trench sidewalls and the upper samples (0 to 1 foot) for total petroleum hydrocarbons (TPH), including gasoline range organics (GRO), diesel range organics (DRO) and oil range organics (ORO) by EPA SW-846 Methods 8015M. All samples will be analyzed for chloride by EPA Method 300. Figure 3 presents the approximate boring locations.

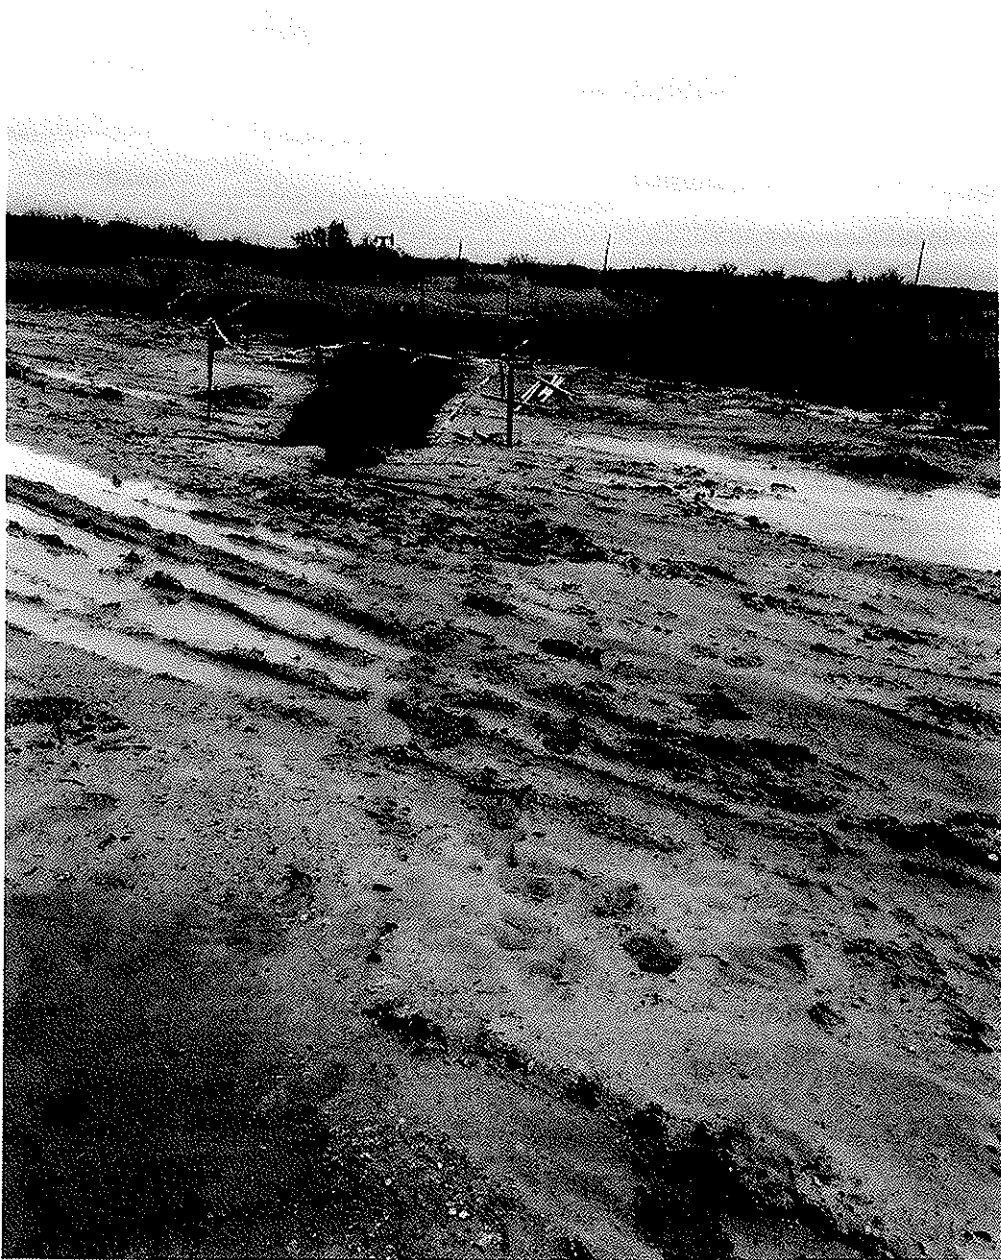
Site Viewing Southeast, October 6, 2017

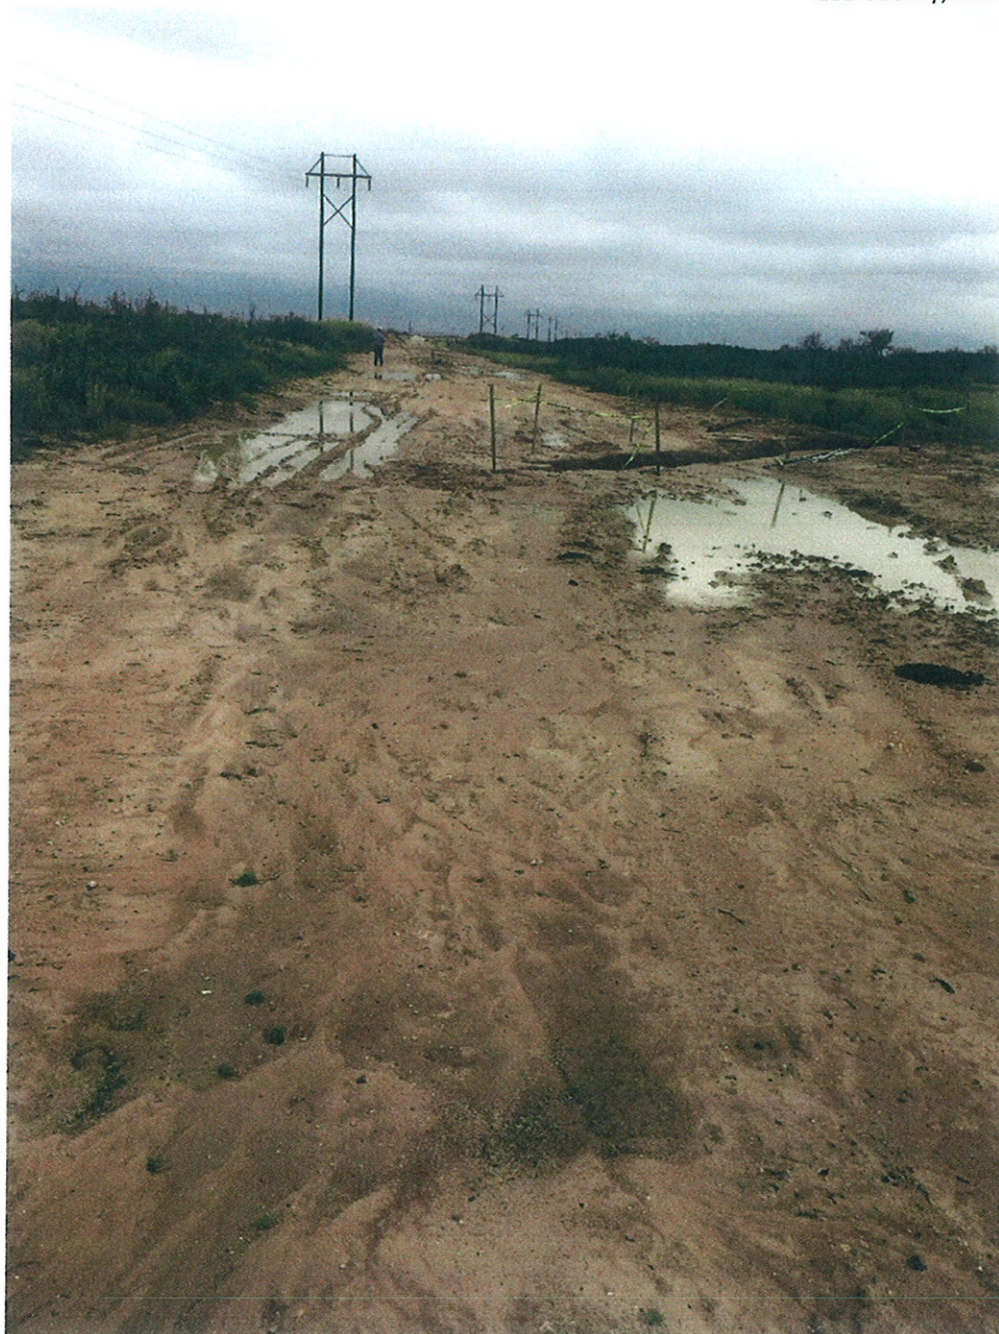
Site Viewing East, October 6, 2017
