Release Notification and Corrective Action

Name of Company EOG Y Resources, Inc.	OGRID Number 25575	Contact Robert Asher
Address 104 S. 4 th Street	Telephone No. 575-748-1471	
Facility Name Waylon BMD State #8	Facility Type Battery

MAYLON State Unit #8

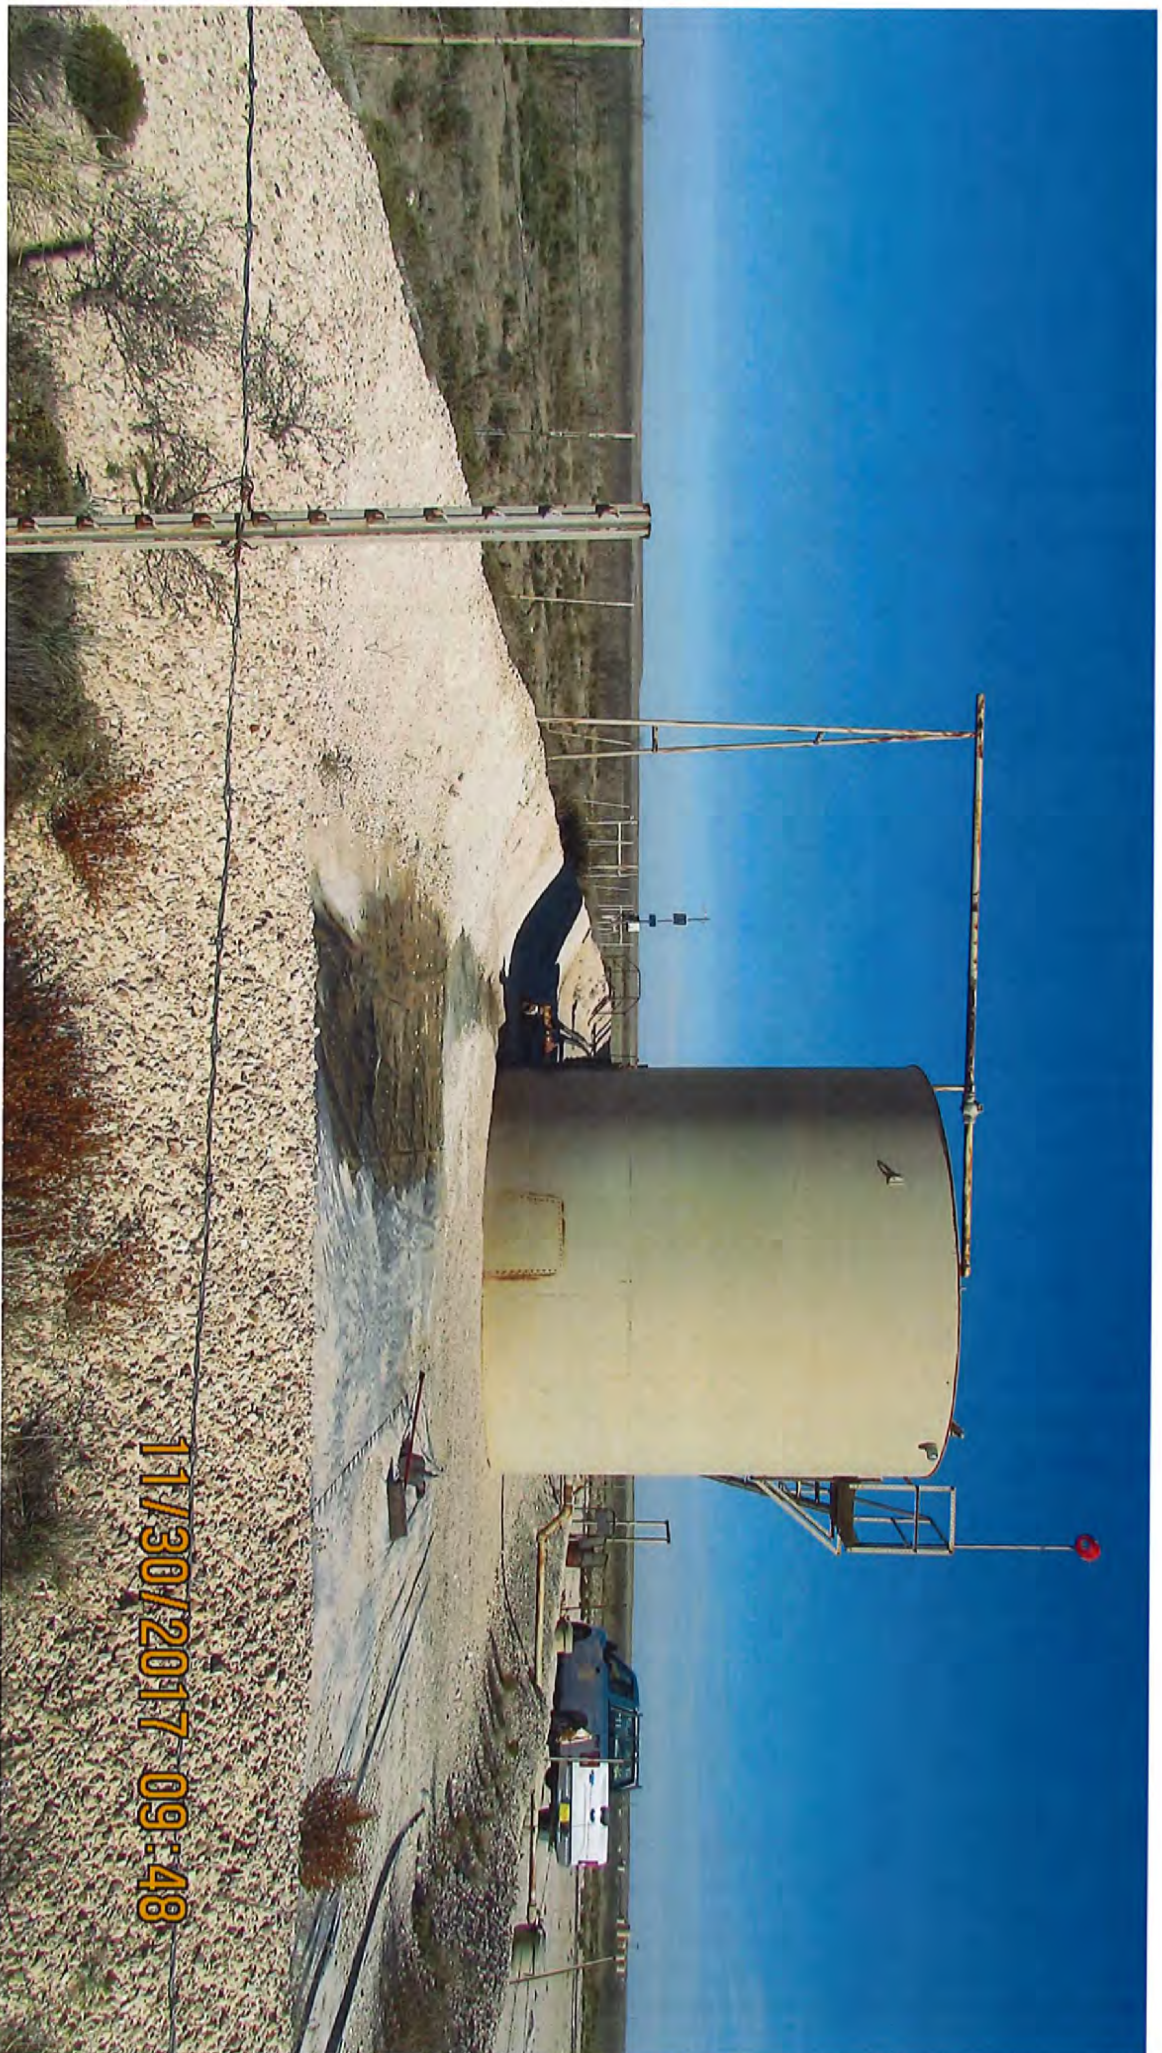
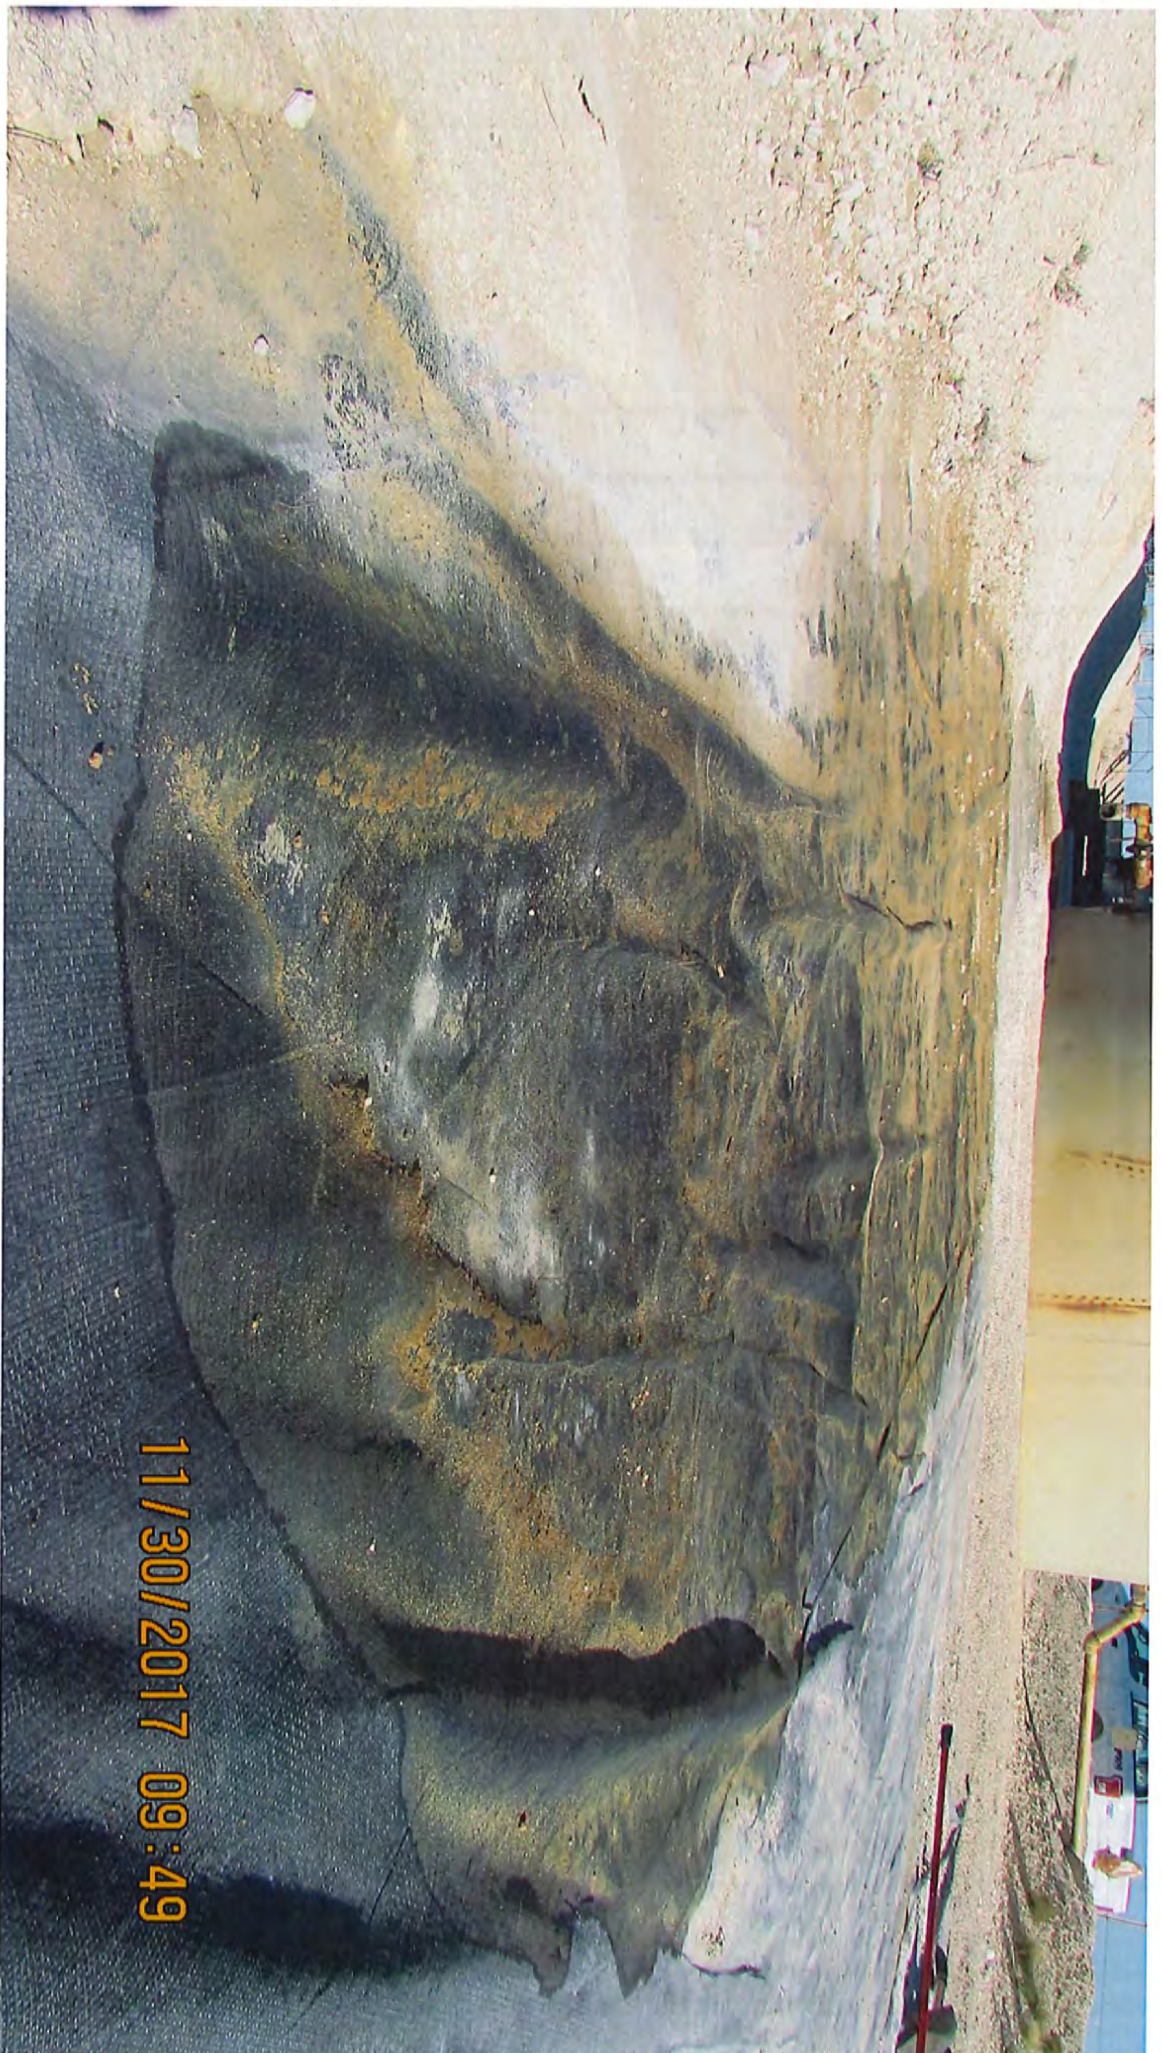
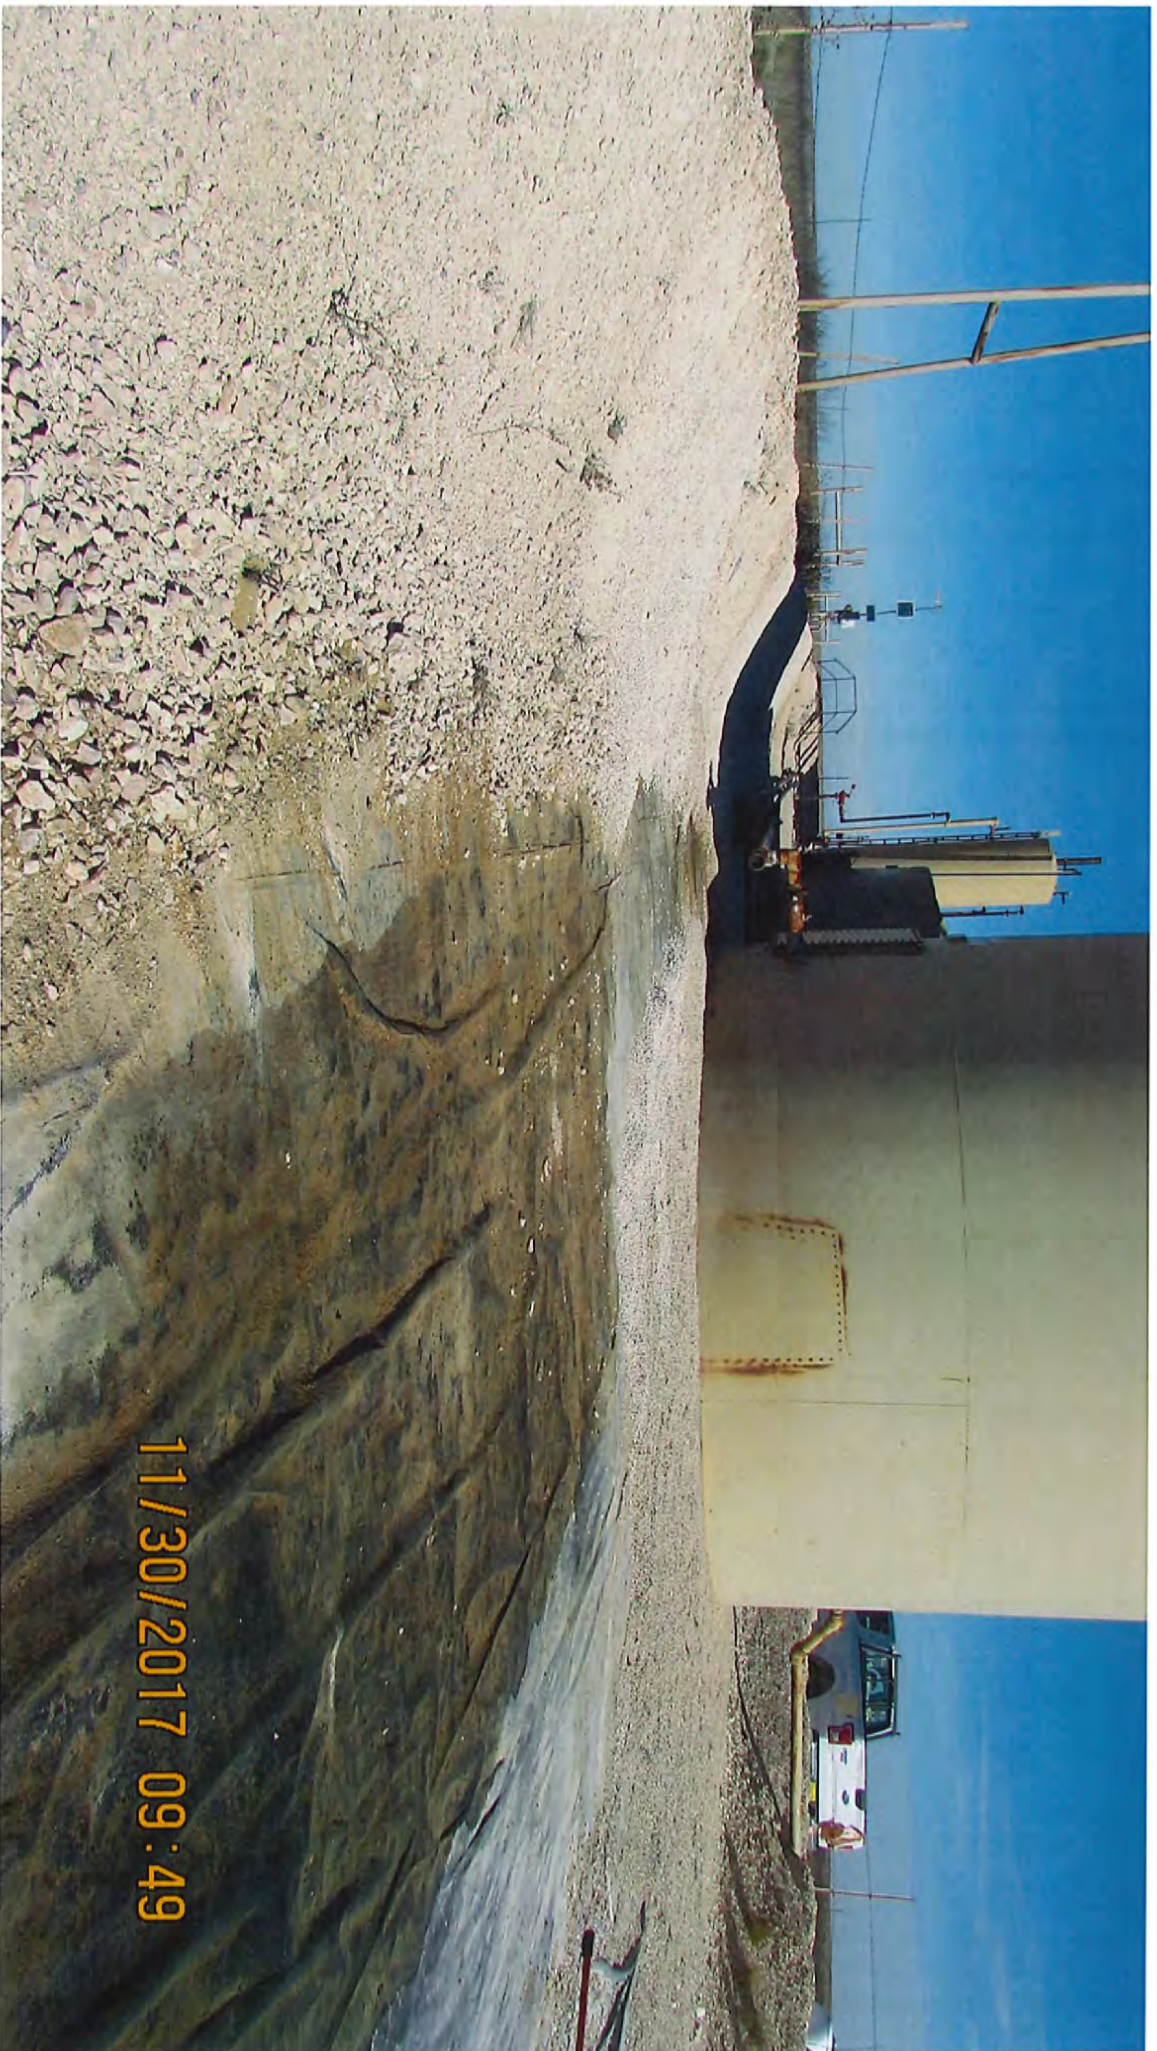
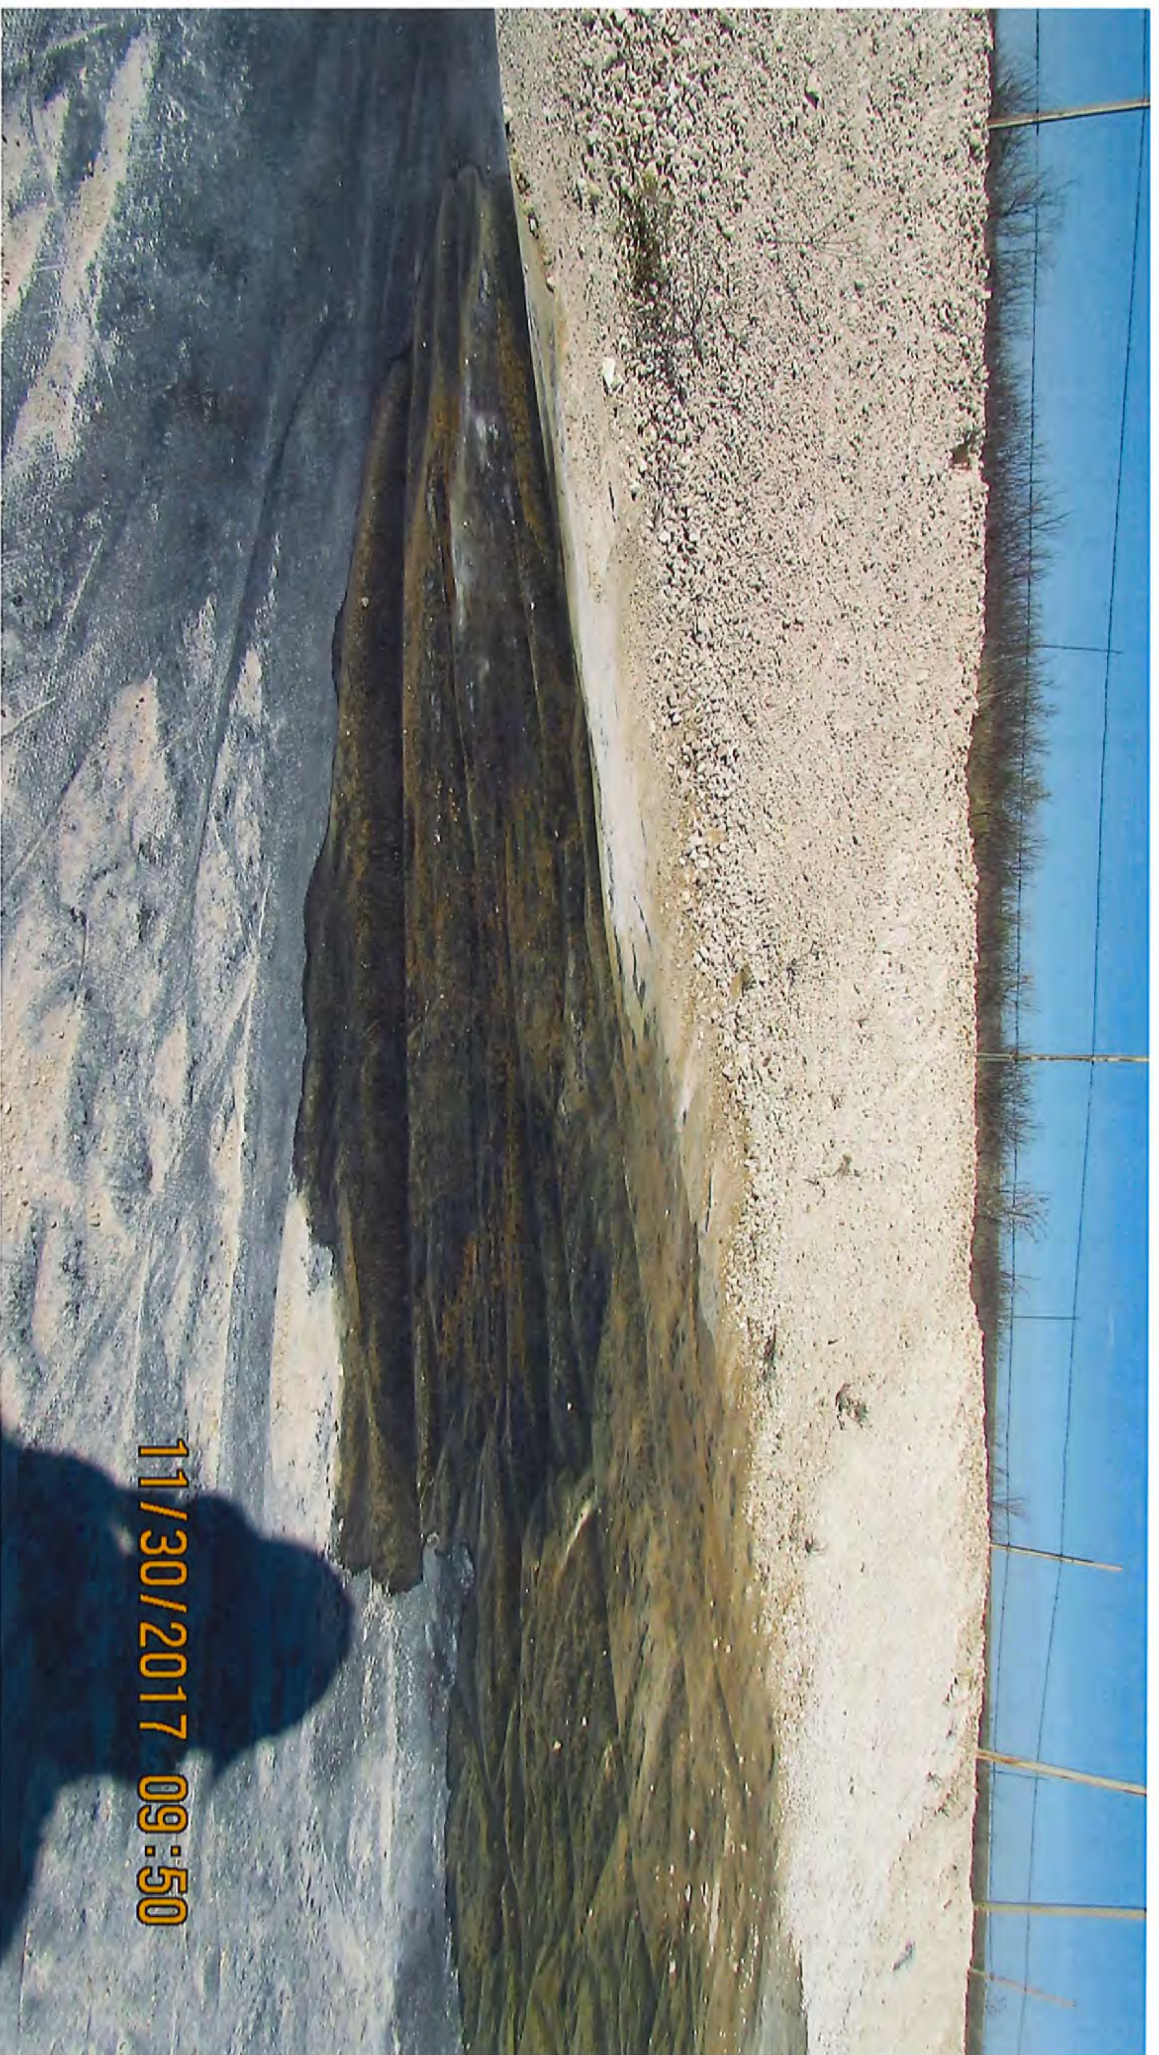
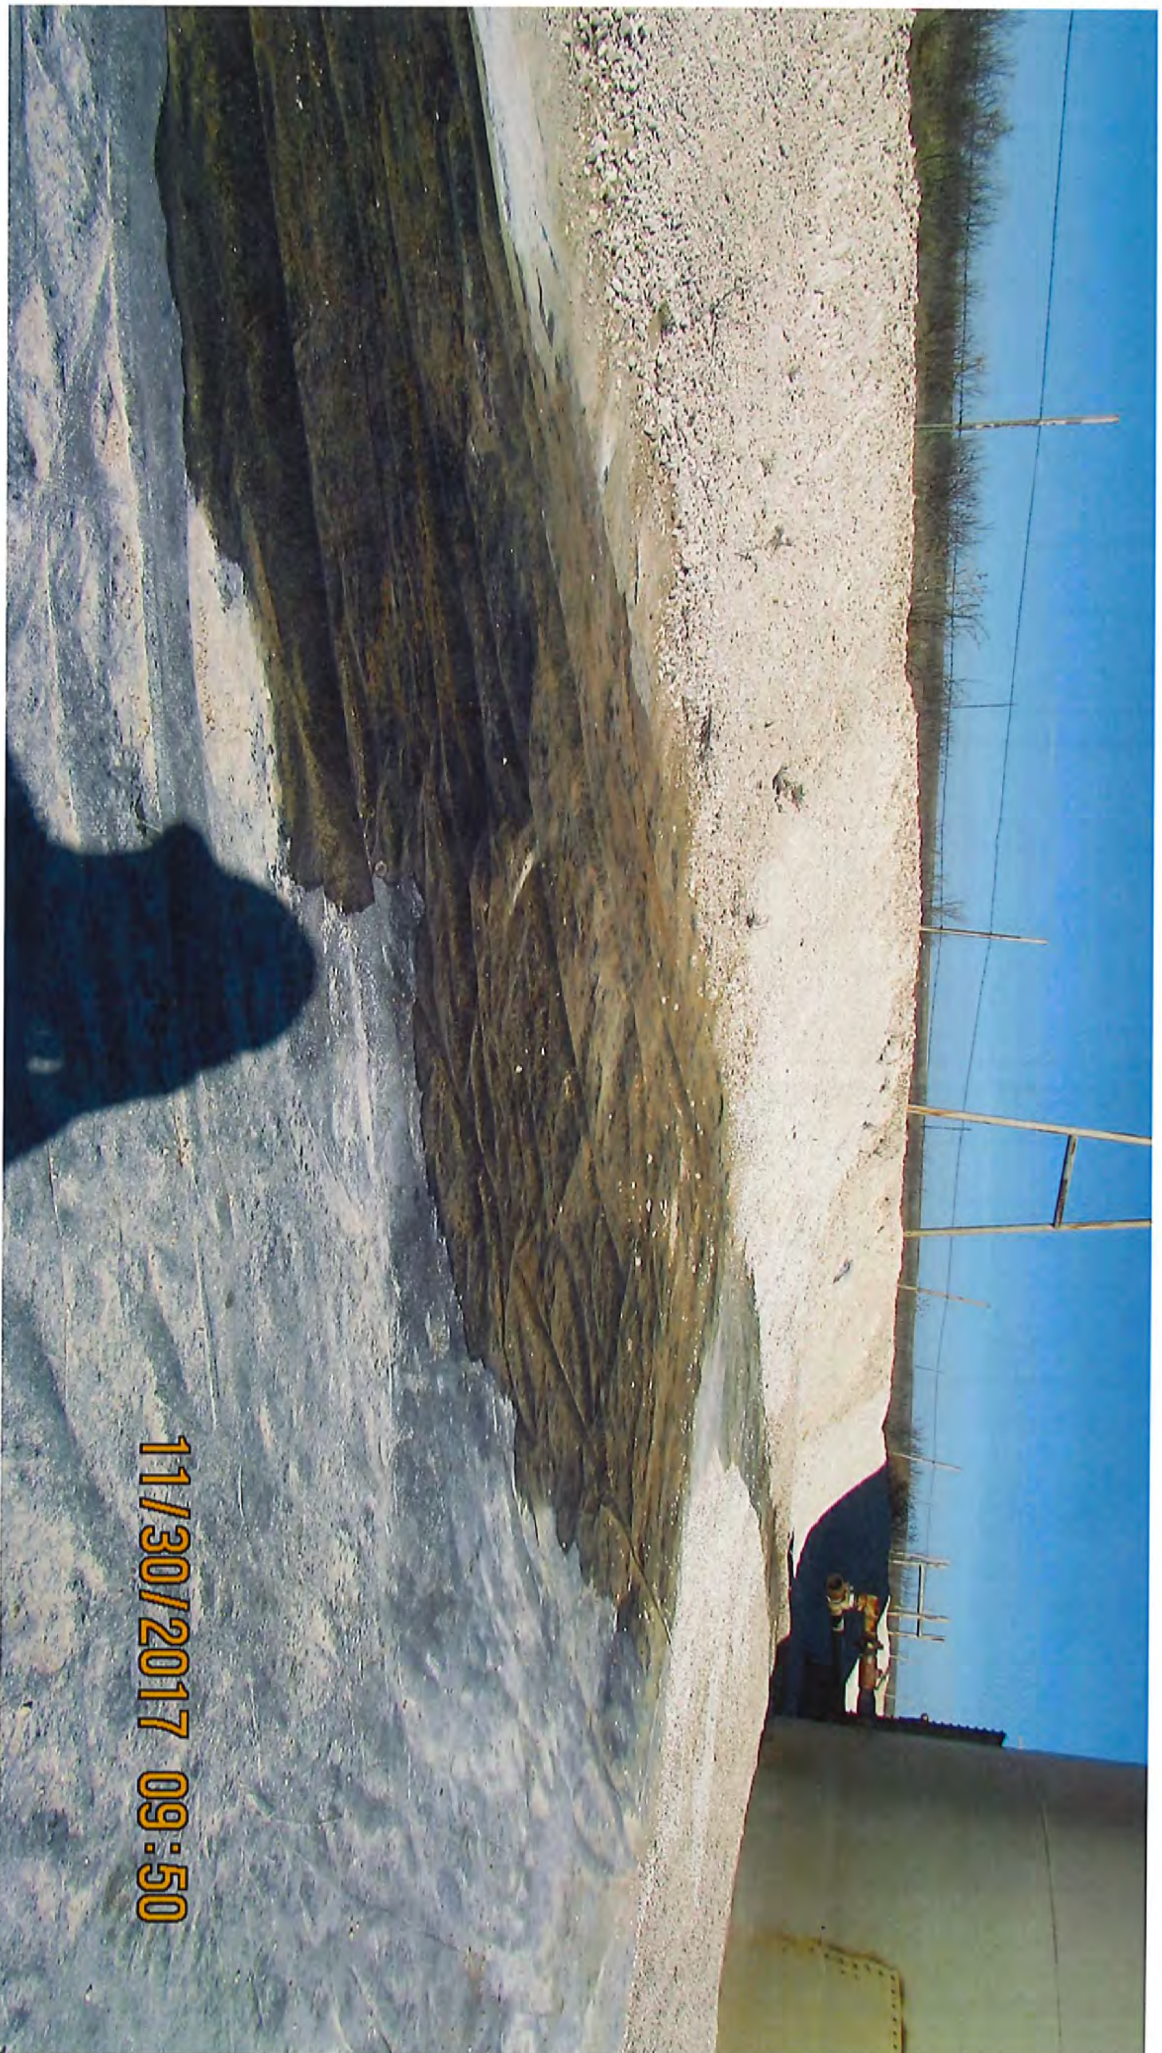
Pumper drained water from oil tank to water tank. Left valve open to long causing too much fluid to equalize over. Causing water tank to run over. Vacuum truck(s) and roustabout/backhoe crews were called.

An approximate area of 10'X 30', this battery is bermed and has a synthetic liner. Vacuum truck recovered 4.5 B/O, remaining 0.5 B/O entrained within gravel material on top of liner. Roustabout crews removed impacted gravel, that gravel was disposed at an NMOCD approved facility. EOG Y will inspect liner and attest to liner integrity. **Depth to Ground Water: <50' (approximately 33.85', per NMOSE & USGS Groundwater Levels), Wellhead Protection Area: No, Distance to Surface Water Body: >1000', SITE RANKING IS 20. Based off of the liner inspection/enclosed photos, EOG Y requests closure.**
