Re: Moped BQP State #1
30-005-20645
Section 26, T15S-R31E
Chaves County, New Mexico
1RP-

EOG Y Resources, Inc. is submitting the enclosed CLOSURE REPORT and C-141 Final Report for the above captioned location. The report is being submitted in response to the C-141 Initial Report dated 12/18/2017.

Figure 1

Moped BPQ State #1

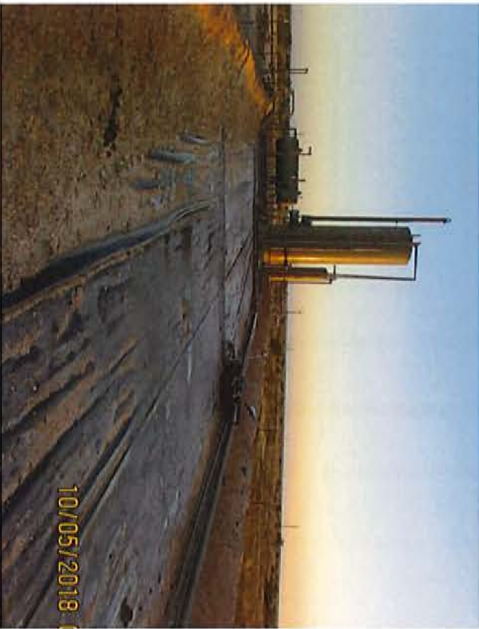
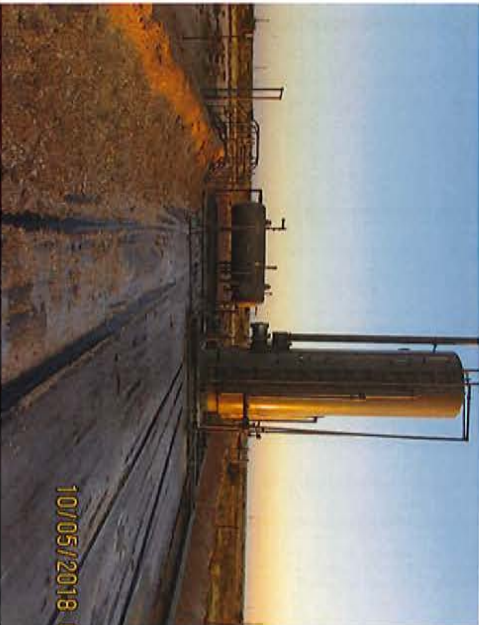
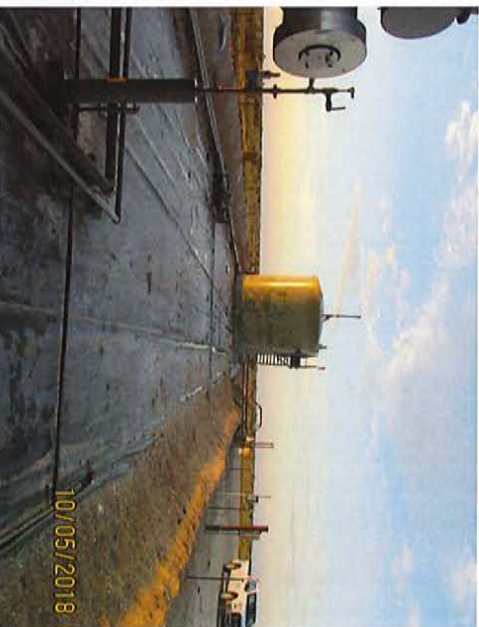
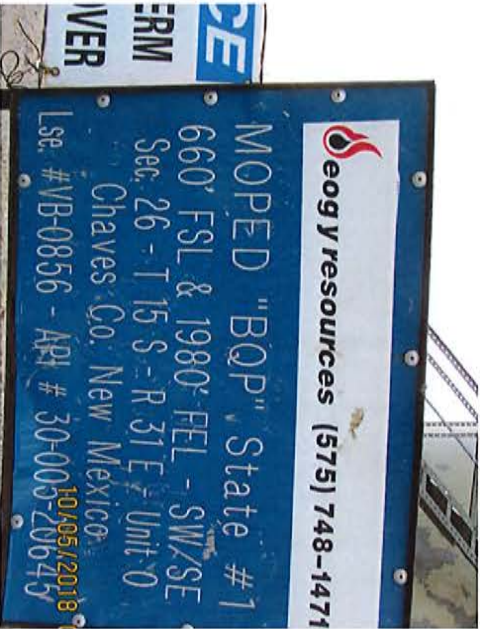
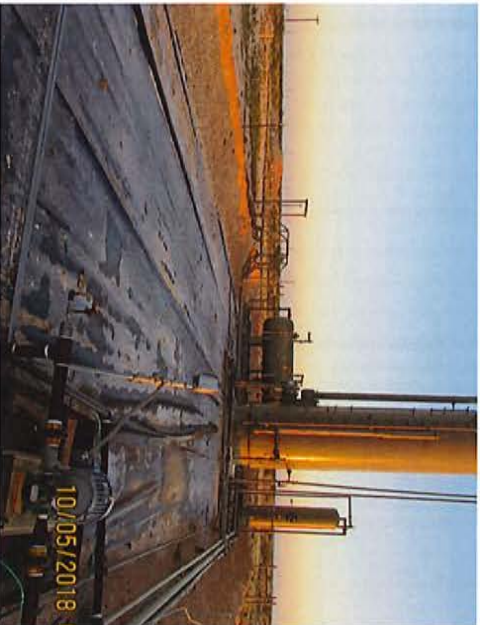
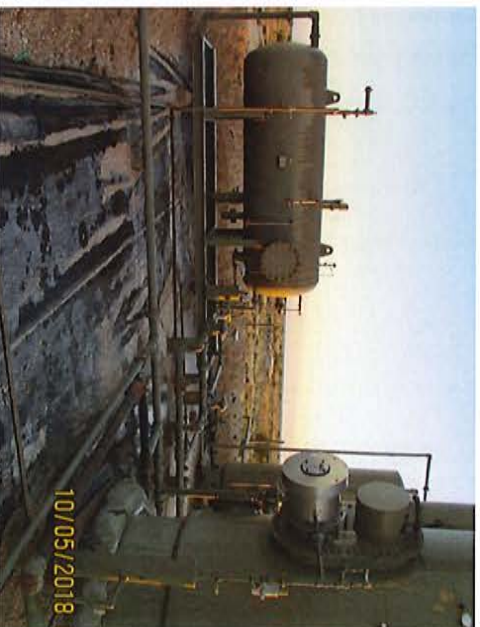
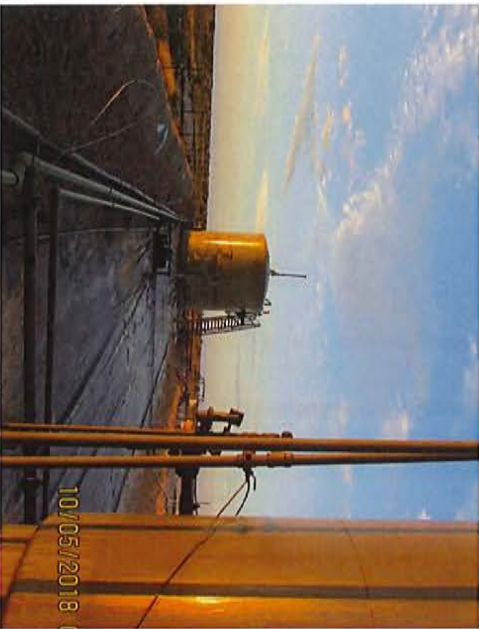
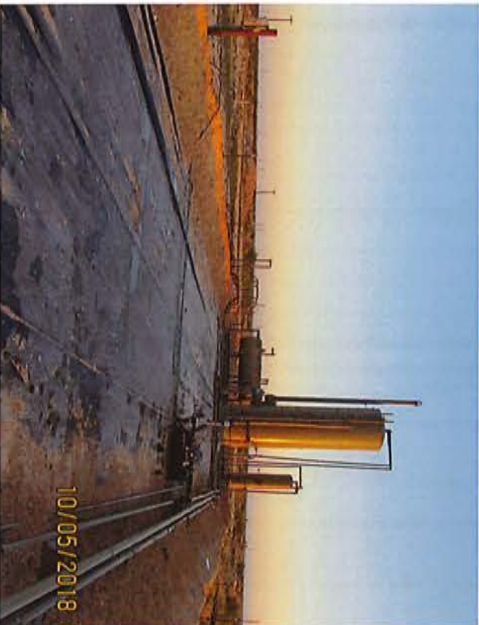
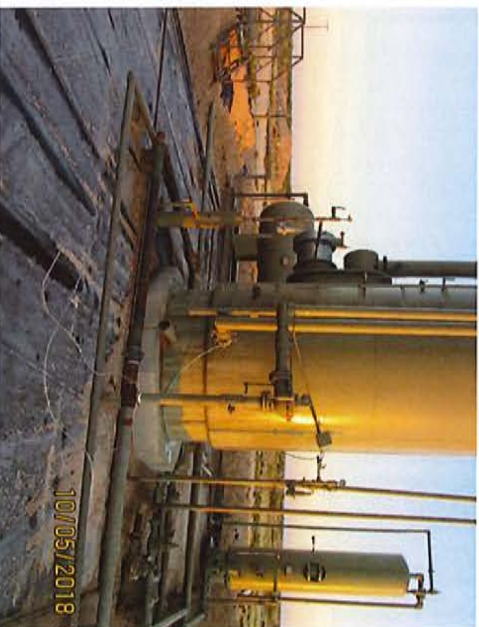
Figure 2

On December 14, 2017, EOG Y Resources, Inc. submitted to the NMOCD District I office a Form C-141 for the release of 60 B/PW with 57 B/PW recovered (the remaining 3 B/PW entrained within the gravel). The affected area is approximately 186' X 32' within the secondary containment of the production facility and was contained within the bermed and lined battery. The release was caused by a 500 BBL steel water tank bottom that corroded, causing the release. A vacuum truck was dispatched and recovered 95% of the released produced water. A roustabout crew was dispatched and excavated the visibly impacted gravel. The impacted gravel excavated was hauled to an NMOCD approved disposal facility.

With the battery being bermed and lined with a 20 millimeter liner, Per the Conditions of Approval on the C-141 Initial Report, the NMOCD requested the liner to be inspected and provide a concise report of the inspection with affirmation the liner has and will continue to contain liquids.
