SUNDRY NOTICES AND REPORTS ON WELLS (DO NOT USE THIS FORM FOR PROPOSALS TO DRILL OR TO DEEPEN OR PLUG BACK TO A DIFFERENT RESERVOIR. USE "APPLICATION FOR PERMIT" (FORM C-101) FOR SUCH PROPOSALS.)		WELL API NO. 30-025-38576

2. Name of Operator DCP Midstream LP		6. State Oil & Gas Lease No. V07530-0001
3. Address of Operator 370 17 th Street, Suite 2500, Denver, CO 80202		7. Lease Name or Unit Agreement Name Linam AGI

Purpose of this workover is to describe the proposed procedure for the repair of the Linam AGI#1 to address tubing leak and compromised casing. Please see attached detailed description and revised well bore diagram.

DCP LINAM AGI #1 WELLBORE SCHEMATIC

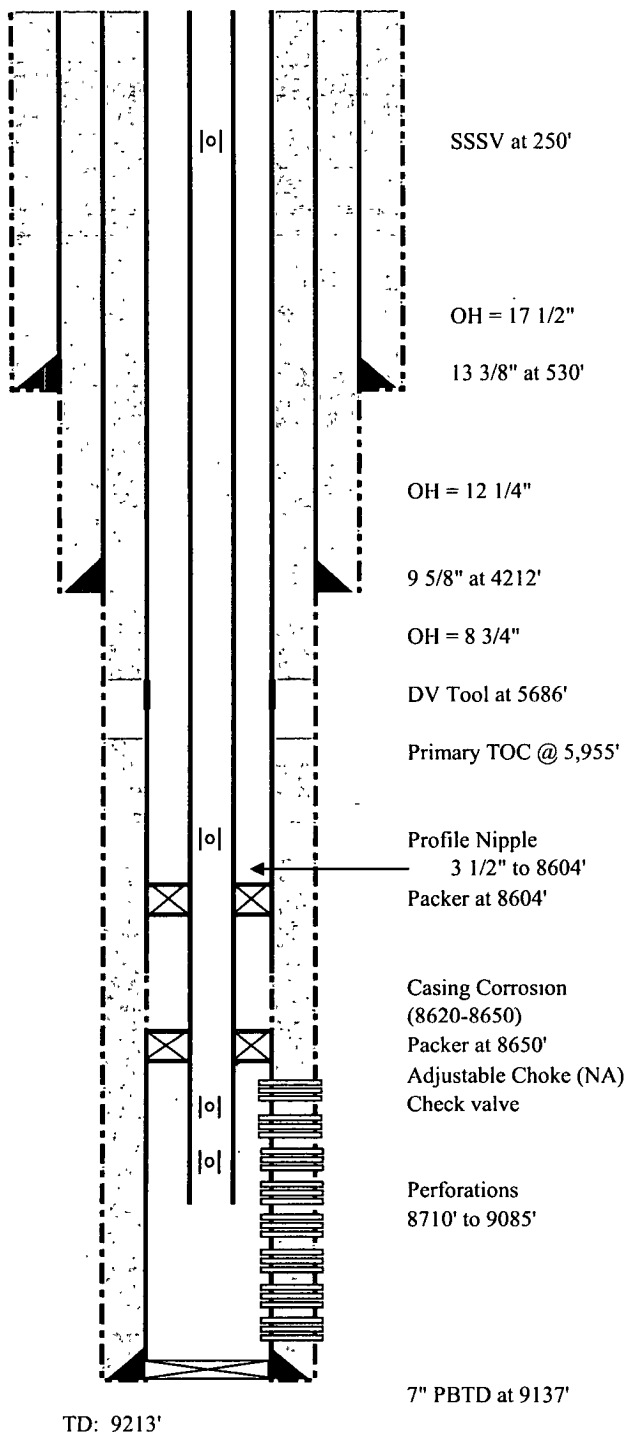
SURFACE CASING:
 13 3/8", 48.00#/ft, H40, STC at 530'

INTERMEDIATE CASING:
 9 5/8", 40.00#/ft, J55, LTC at 4212'

PRODUCTION CASING:
 7", 26.00#/ft, L80, STC at 9200'
 PBTD = 9137'

TUBING:
 Subsurface Safety Valve at 250 ft
 3 1/2", 9.2#/ft, L80, Hunting SLF at 8604'

PACKER:
 Permanent Production Packer (2)
 Adjustable Choke
 Check valve

Primary Target	Secondary Target
Lower Bone Springs	Brushy Canyon
8710' - 8730'	5000' to 5300'
8755' - 8765'	(Not perforated)
8780' - 8795'	
8780' - 8890'	
8925' - 8930'	
8945' - 8975'	
8985' - 9000'	
9045' - 9085'

TD: 9213'

1. Run in hole with new Inconel packer and set packer at 8604' within caprock section
2. Run in hole with a new string of tubing and SSSV.
3. Clean out annulus, treat and load annulus with inhibited diesel packer fluid
4. Install new injection tree.
5. Remove blanking plugs
6. Notify OCD of MIT test. Pressure test casing/tubing annulus to 500 psi. Chart for 30 minutes.
7. Bleed pressure 200# SICP at end of job.
8. File a C-103 subsequent report with the MIT.
