# Mogi 9 1H Rathole Data

February 28, 2013

Revised November 1, 2013

## **Murchison Oil and Gas, Mogi 9 State Com 1H Rat Hole Evaluation and Brinninstool 4 State 3H Observations**

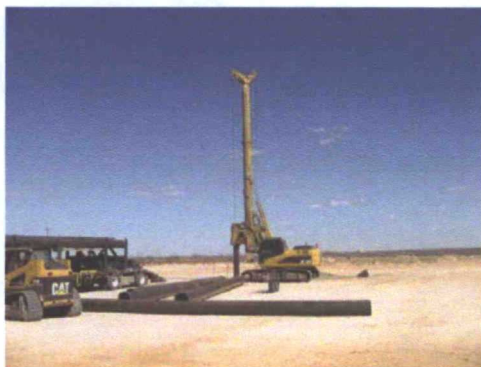
On February 27, 2013 Dale Littlejohn witnessed the drilling of the rat hole at the Mogi 9 #1H site. Ready Drill LLC of Monahans, Texas performed the work using a track-mounted 30-inch auger drilling rig as shown in the adjacent photograph.

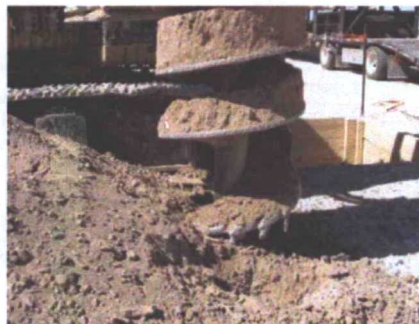
At 11:25 am the rig had been re-fueled and the bottom 1 foot was cut, removed, and inspected for possible moisture. The photograph from the 70 to 71-foot depth interval (shown to the right) demonstrates that the soil cuttings were completely dry. Also, a mirror was used to reflect sunlight in to the boring in order to inspect the walls and bottom. There were no indications of water seeps in the walls or an accumulation of water at the total depth.

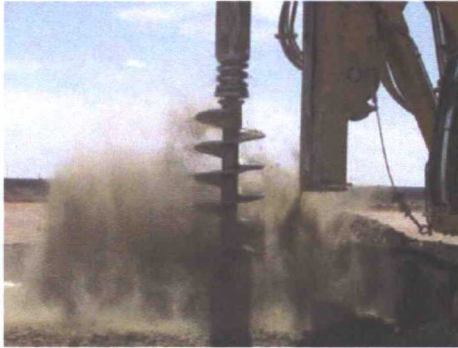
The photograph to the left was taken from the soil recovered at a depth of 98 feet as it is being spun from the auger. This photograph demonstrates the lack of moisture in the cuttings. It is believed that any potential moisture from the bottom or walls of the boring would have been easily identified during the drilling process as each trip into the hole should contact wet soil if it is present at any depth.
