Internal Incident Report – Spill/Release

Location: NEDU #247 Injection Line

One Line Summary: Injection line leak

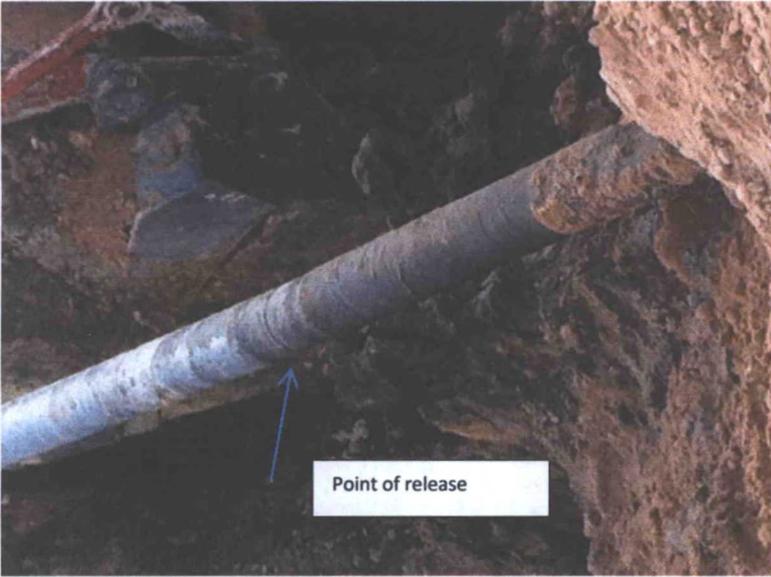
- Line ruptured in old welded section.

Point of release

- Line will be replaced to the valve box, caliche will be placed up to 6" of the line, fill sand will be placed around the line for protection.

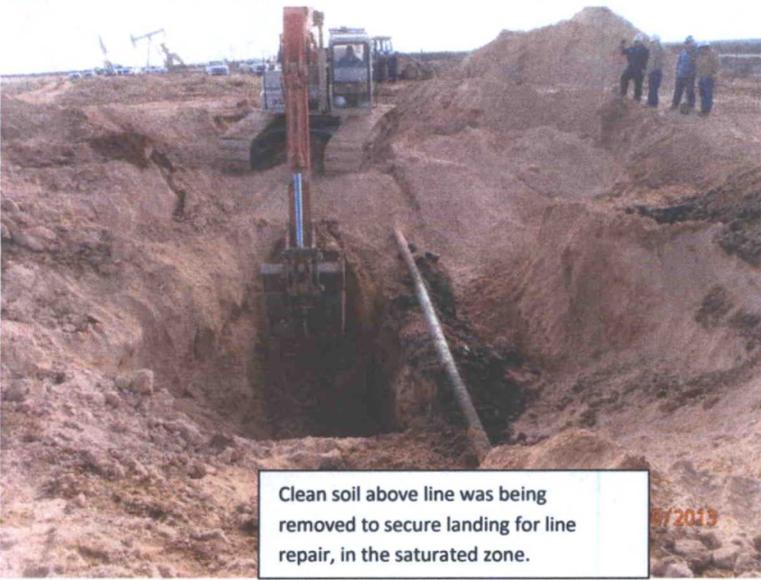
Clean soil above line was being removed to secure landing for line repair, in the saturated zone.
