Pit or Below-Grade Tank Registration or Closure

Re: Final C-144
Chevron USA (O-Grid #4323)
Harry Leonard E #8 (Ref. #200106)
API#30-025-37834
UL-G, Section 16, Township 21 South, Range 37 East

Figure 1
 Area Map
 Chevron Corporation
 Harry Leonard E #8

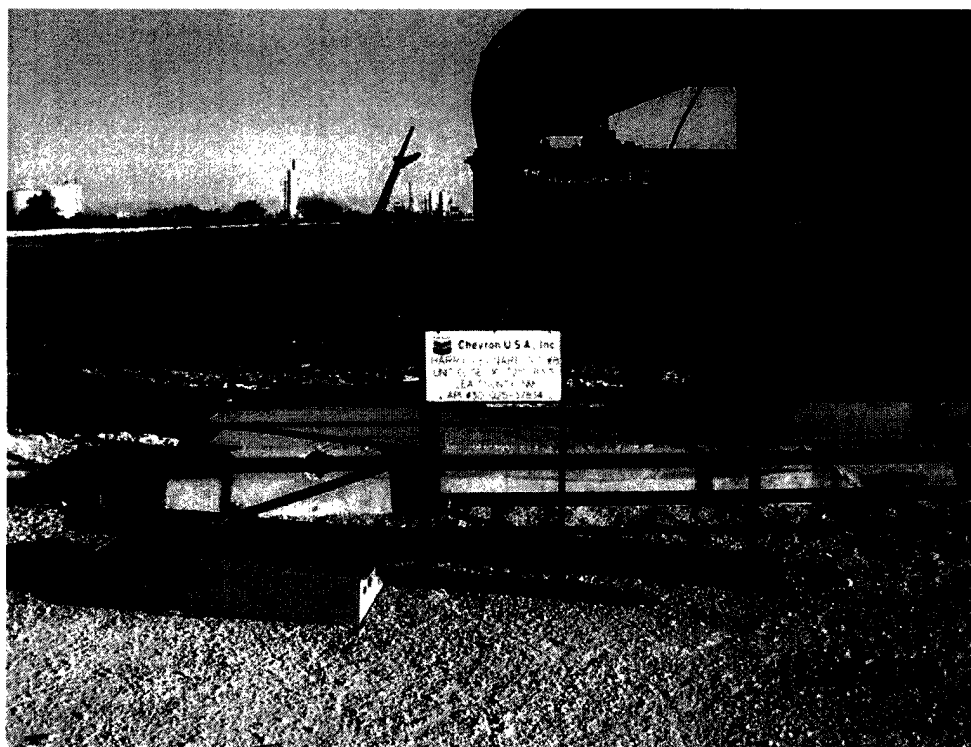
Photograph #7 – Closed pit.
