Pit or Below-Grade Tank Registration or Closure

Operator Chevron USA (O-Grid #4323)		Telephone: 505-394-1237		e-mail address: billyanderson@chevron.com	
Address: PO Box 1949 2401 Avenue O Eunice, New Mexico 88231					
Facility or well name: Eunice King #32 API #: 30-025-38336 Unit Letter (UL): A Qtr/Qtr NE¼ NE¼ Section: 28, T21S, R37E					
County: Lea Latitude: N 32° 27' 22.5" Longitude: W 103° 09' 49.1" NAD: 1927 <input type="checkbox"/> 1983 <input type="checkbox"/> WGS 84 <input checked="" type="checkbox"/>					
Surface Owner: Federal <input type="checkbox"/> State <input type="checkbox"/> Private <input checked="" type="checkbox"/> (Kennann Estate) Indian <input type="checkbox"/>					
Pit			Below-grade tank		
Type: Drilling <input checked="" type="checkbox"/> Production <input type="checkbox"/> Disposal <input type="checkbox"/> Workover <input type="checkbox"/> Emergency <input type="checkbox"/>			Volume: bbl Type of fluid		
Lined <input checked="" type="checkbox"/> Unlined <input type="checkbox"/>			Construction material:

Figure 3
Site Map
Chevron Corporation
Eunice King #32

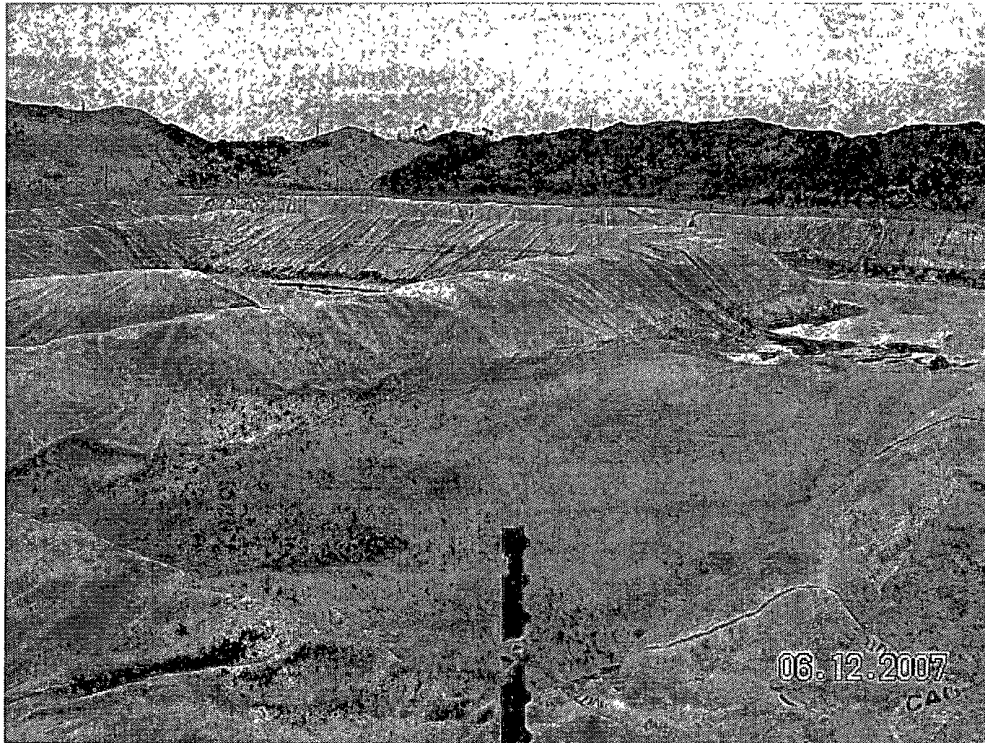
Photograph #3 – Pit with berms, looking northwesterly.

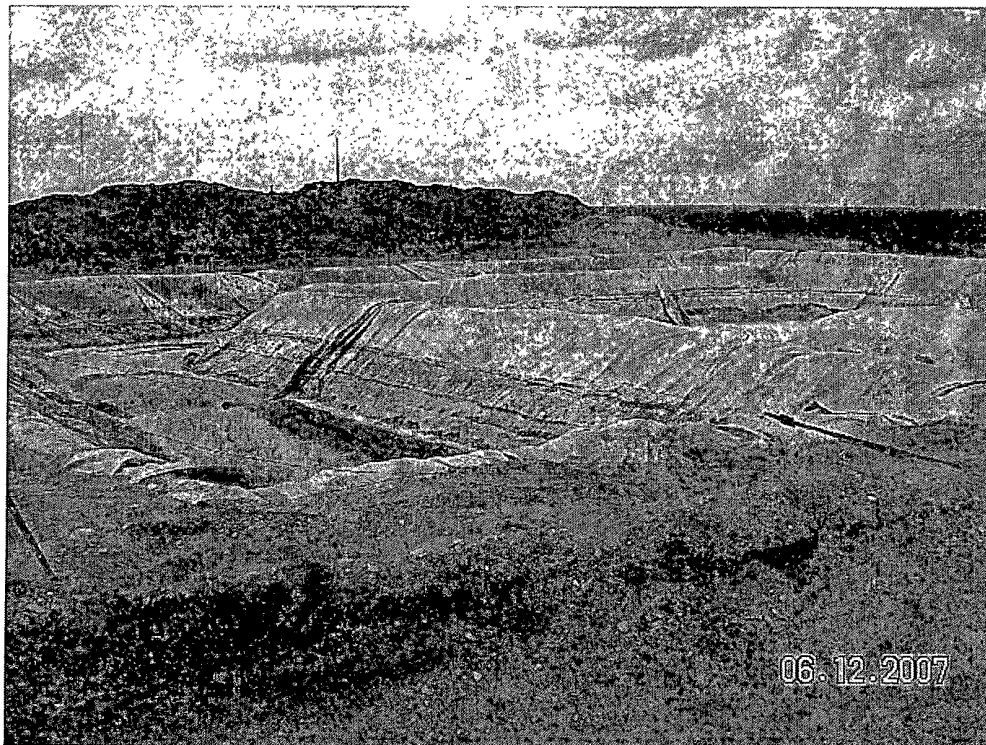
Photograph #4 – Pit with berms, looking northeasterly.

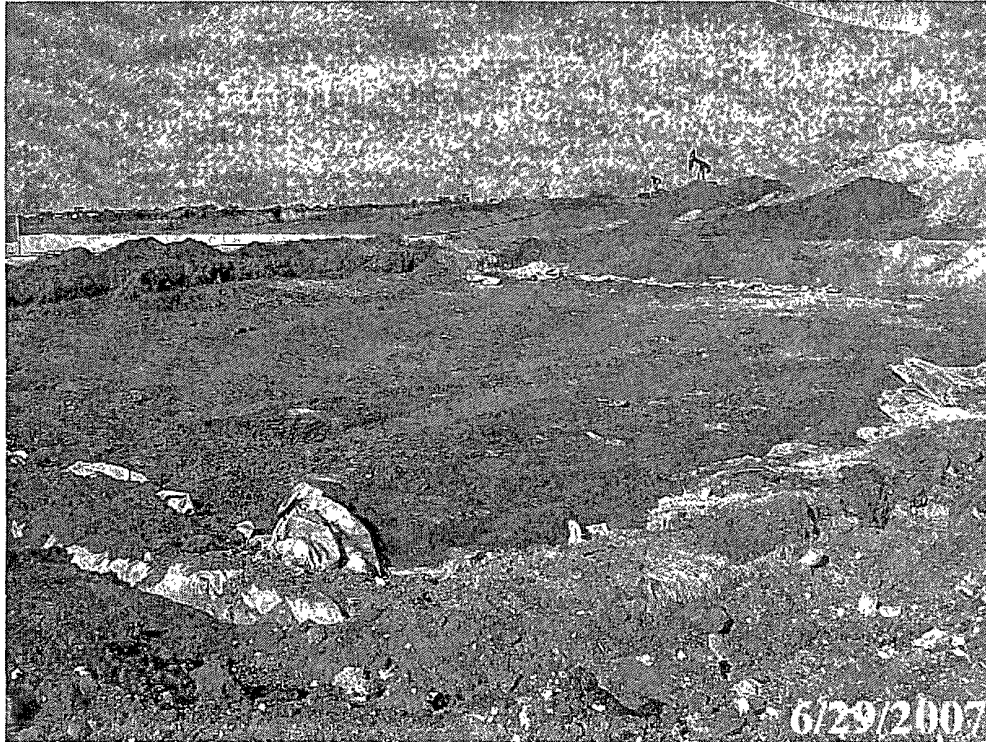
Photograph #5 – Stiffening of pit contents

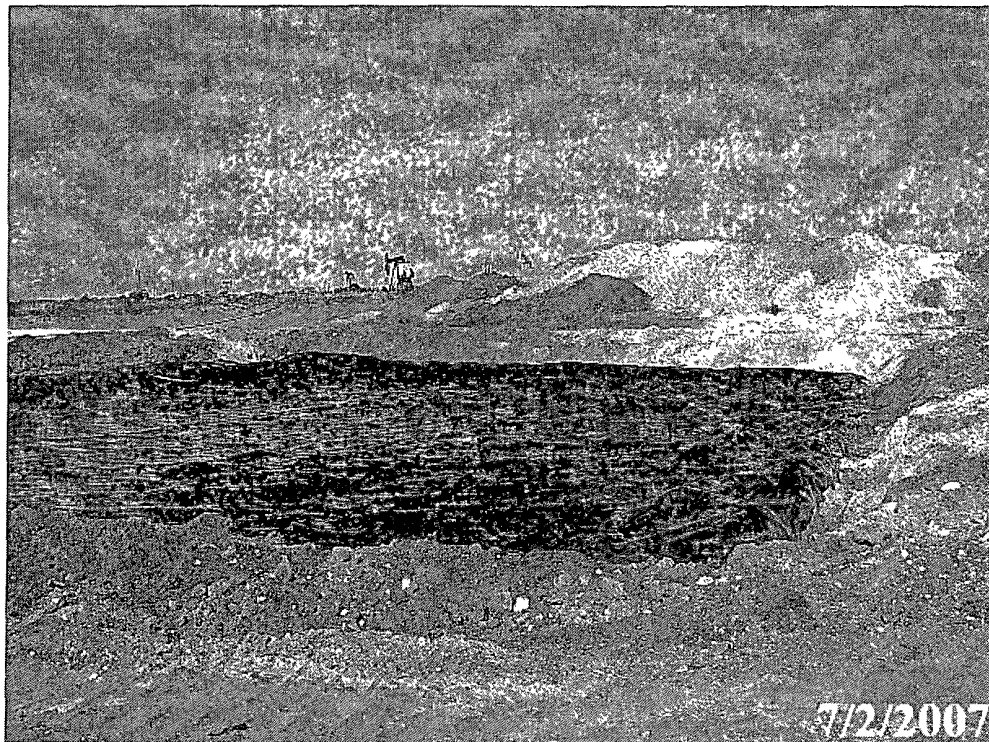
Photograph #6 – Installation of pit liner

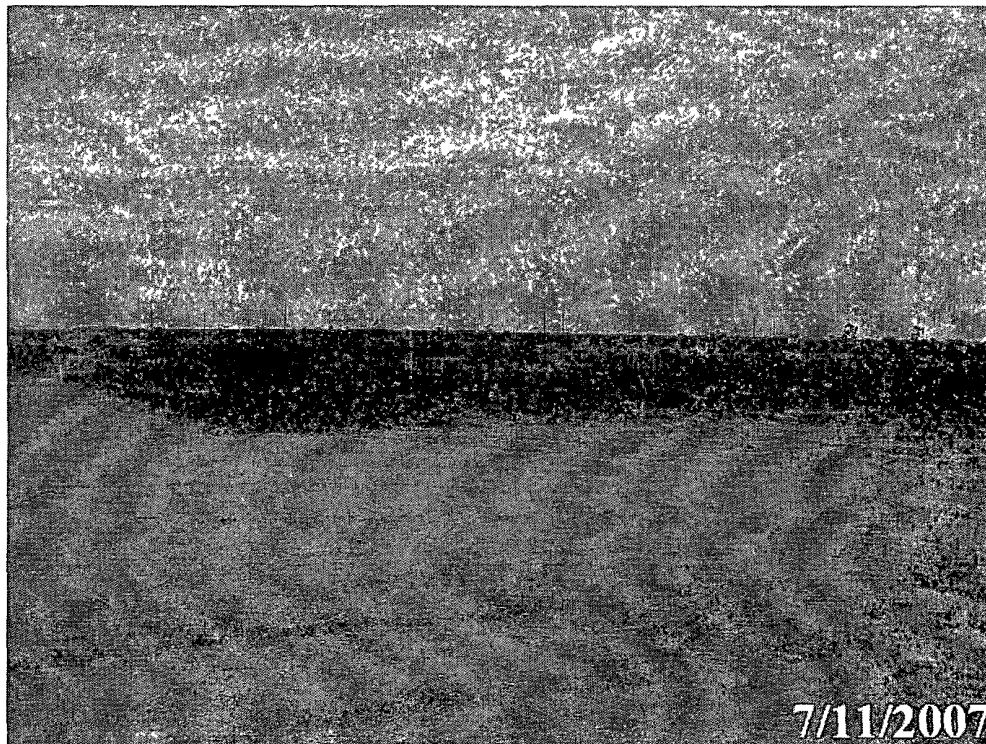
Photograph #7 – Remediated, reseeded site

Additional Comments: The pit has been closed consistent with the "ChevronTexaco Drilling and Reserve Pit Closure General Plan, December 2004" and the NMOCD Pit and Below-Grade Tank Guidelines, November 1, 2004 as promulgated under NMOCD Rule 50 (19.15.2.50 NMAC).	
Pit Status: Liner intact <input checked="" type="checkbox"/> Liner punctured or torn <input type="checkbox"/>	
Method of Closure: The pit has been closed via in situ encapsulation which consisted of mixing earthen materials to stiffen pit contents sufficiently to provide physical stability and support a pit cover. Upon stiffening pit contents as required, the edges of the pit liner were folded over the edges of the stiffened mud and cuttings. The pit was covered with a 20-mil thick impervious, reinforced synthetic polyethylene liner meeting ASTM Standards designed to be resistant to encapsulated material. The liner was covered with a minimum of three (3) feet of clean soil or like material capable of supporting native plant growth. The disturbed area was contoured for natural drainage, disked and seeded.

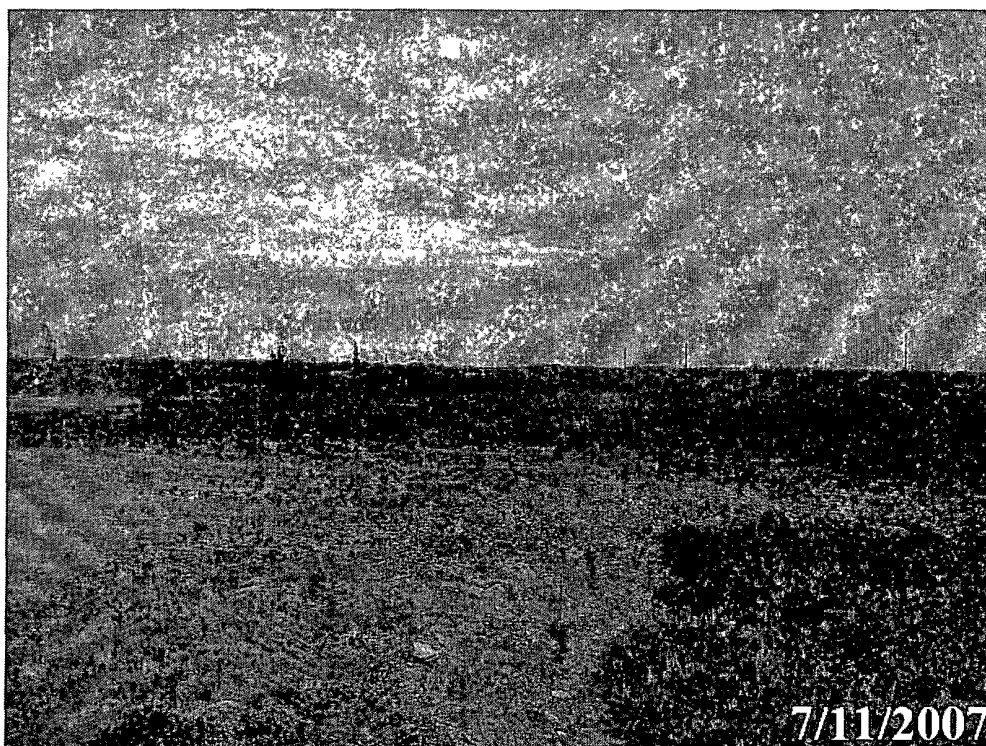
Photograph #8 – Remediated, reseeded site
