Release Notification and Corrective Action

Name of Company Occidental Permian Limited Partnership	Contact Steven M. Bishop	
Address 1017 West Stanolind Road, Hobbs, N.M. 88240	Telephone No. (575) 397-8251	
Facility Name South Hobbs Unit #209	Facility Type Production	
Surface Owner Mr. Dee A. Cochran	Mineral Owner	Lease No. API 30-025-29522

08/25/2008 SHU #209 INJ LINE LEAK 3" FIBERGLASS

RE: Remediation Plan  
South Hobbs Unit #209 3" Fiberglass Injection Line  
UL 'C', Sec. 8, T-19-S, R-38-E

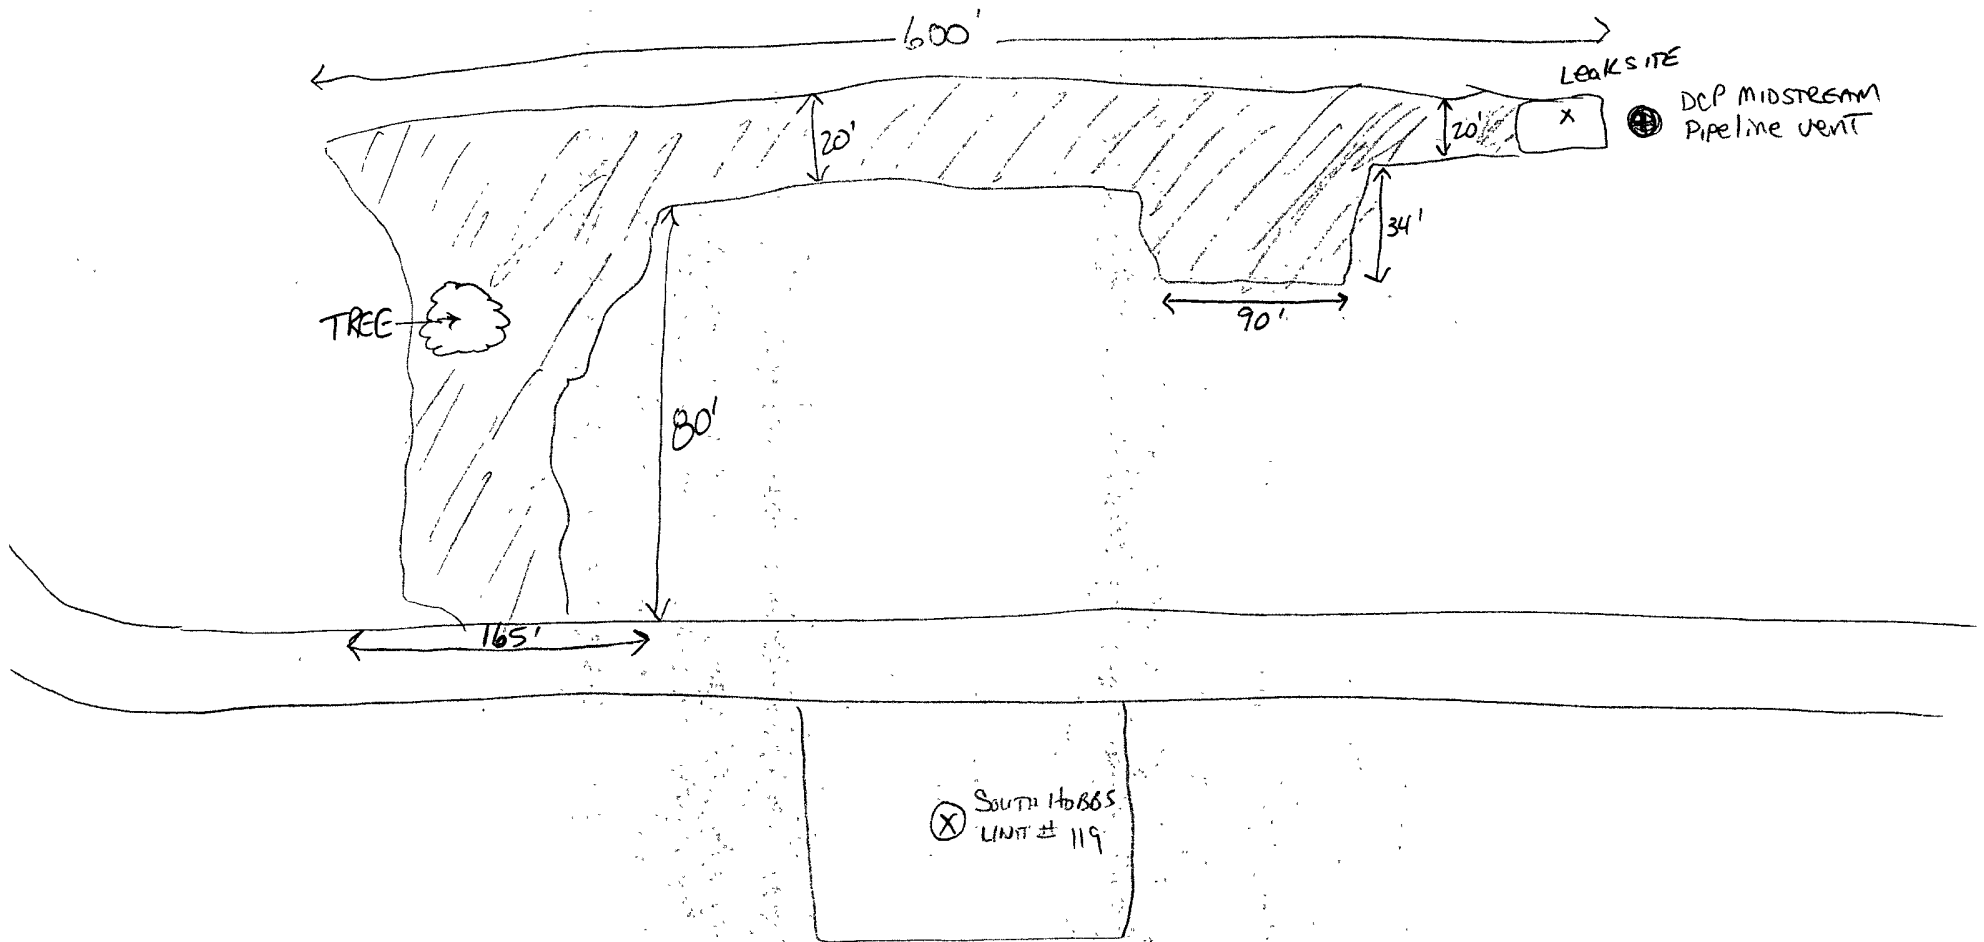
# SPILL MAP

Describe Cause of Problem and Remedial Action Taken.\* ☐ Landowner discovered a leak just north east of South Hobbs Unit Well #119. Landowner originally called DCP Midstream since it was by a DCP blow down. Oxy operators were called Monday 08/25/2008 evening to see if Oxy had lines close. Operators discovered the line went to South Hobbs Unit Well #209. Operators shut valves on injection header inside building #9 going to South Hobbs Unit Injection Well #209, and wellhead valves to contain leak. The well was not taking water at the time so leak occurred due to an automated valve at the header leaking. Valves were shut before and after the automated valve.

Describe Area Affected and Cleanup Action Taken.\* ☐ Spilled fluid ran approximately 600' to the west of DCP blow down along a pipeline right of way. Fluid ran across grassy pasture and accumulated at the west end 600' away from the leak site. For the most part the area is 20' wide and 600' long but accumulated in a couple of areas. No fluid was recovered. Area will be remediated to NMOCD spill guidelines.

1. Piping will be excavated and repaired.
2. Affected area will be excavated and soil will be disposed of at Sundance Services, Parabo Faciltiy near Eunice, NM.
3. Soil samples will be gathered from affected area.
4. NMOCD guidelines will be used to insure the site is in compliance with guidelines.
5. Any soils removed will be replaced with clean fresh soils, where needed.
