Rele	ease Notific	ation	n and Co	orrective A	ction	1		
					OPERA	TOR X Initial Report Final R			Final Repo		
Name of Company XTO Energy					Contact Gene Hudson						
Address PO Box 700, Eunice, NM 88231					Telephone No. 575-441-1634						
Facility Name Section 27 SWD # 2					Facility Type Injection Well						
Surface Owner Larry Squires STATE Mineral Owner:				wner:	r: State Lease No. 30.025.03142						
				LOCA	TIO	N OF RE	LEASE	•		-0'	
Unit Letter H	Section 27	Township 18S	Range 35E	Feet from the	North	rth/South Line Feet from the East/West Line County Lea					
Latitude_32 43'25.79" Longitude_103 26'19.12"											
				NAT	URE	OF REL	EASE				
Type of Releas						1	Release 600			Recovered 480	
Source of Rele	ease Steel	Valve				Date and H	Iour of Occurrenc	e		Hour of Discove 08:30 am	ry
Was Immediat	e Notice G		-			If YES, To	Whom? Geoff L		MOCD		
		Х	Yes 🗌	No Not Req	juired		Larry S	quires/	Land owner	r

XTO Energy Section 27 SWD #2 Township 18 South, Range 35 East, Section 27 Lea County, New Mexico

Work Plan

December 28, 2009

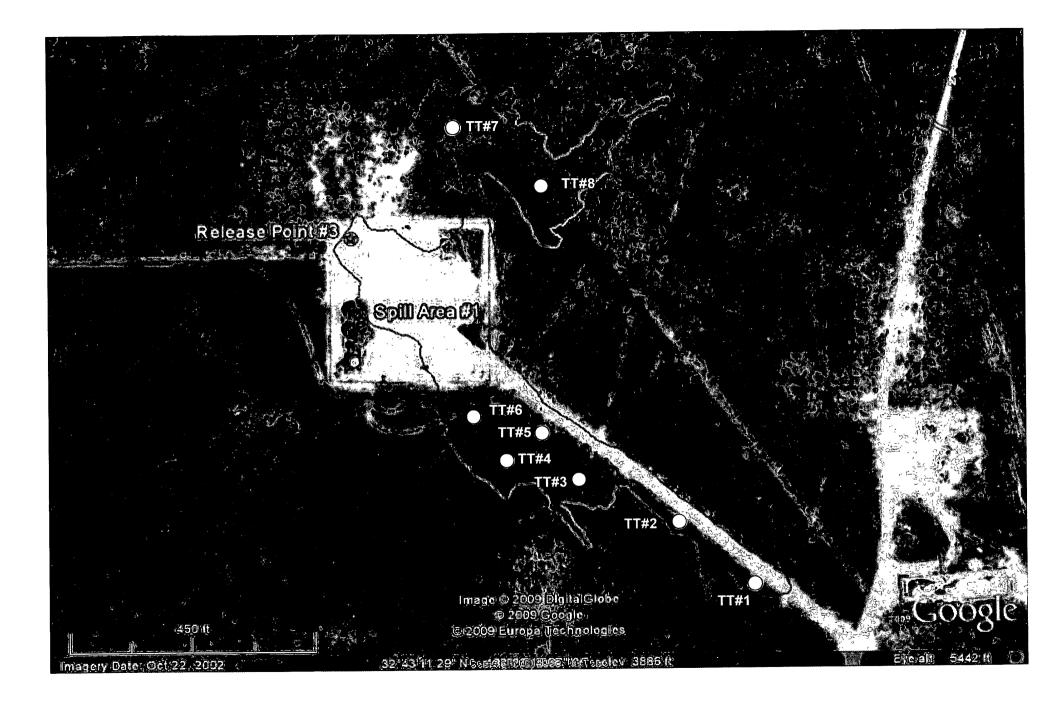
On December 28, 2009, SESI was onsite with Hungry Horse to install a total of eight (8) test trenches (See Figure 2). Samples were retrieved at depths ranging from one (1) to two (2) feet. The samples were properly preserved and transported under Chain-of-Custody to Cardinal Laboratories of Hobbs, New Mexico for analysis. The samples were analyzed for Chlorides (EPA method 4500-Cl⁻B) (See Appendix A).

Sample Point	Chlorides (mg/kg)
TT #1-2'	80
TT #2-2'	832
TT #3-2'	736
TT #4-1'	<16
TT #5-1 1/2'	1,500
TT #6-2'	2,040
TT #7-2'	1,400
TT #8-1'	32

It is requested that the top 1 to 1 $\frac{1}{2}$ of soil be excavated from the spill area and transported to an NMOCD approved facility for disposal. The excavation will be backfilled with clean soils, and then the area will be contoured to natural grade and reseeded in the next growing period.

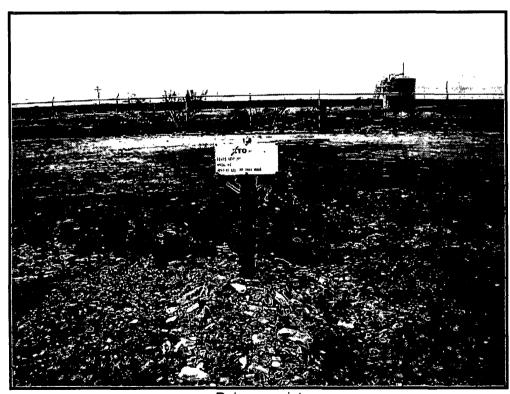
Safety and Environmental Solutions, Inc. (SESI) was engaged by XTO Energy to perform clean-up services at the Section 27 SWD #2 release. Approximately 600 barrels of produced water was released due to internal corrosion of a steel valve on the injection well, and recovered approximately 480 barrels.

Release point

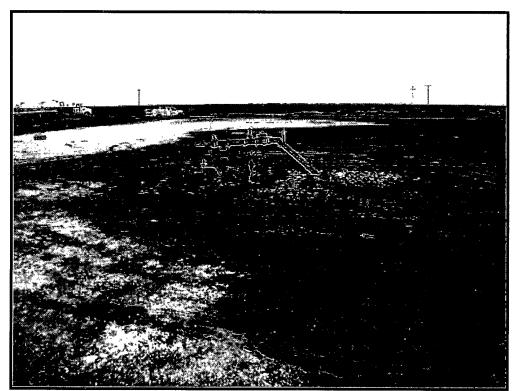
Release area facing east

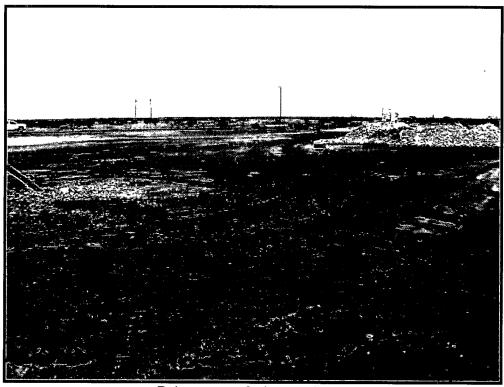
Release area facing southeast

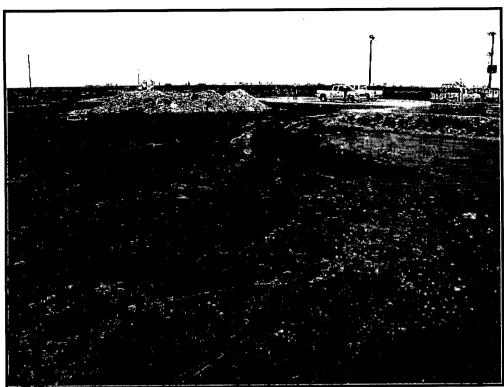
Release area facing southeast

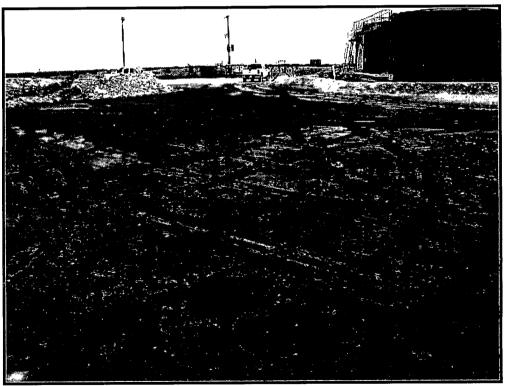
Release area facing south

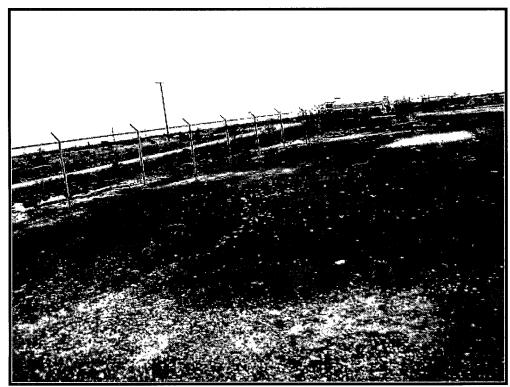
Release area facing west

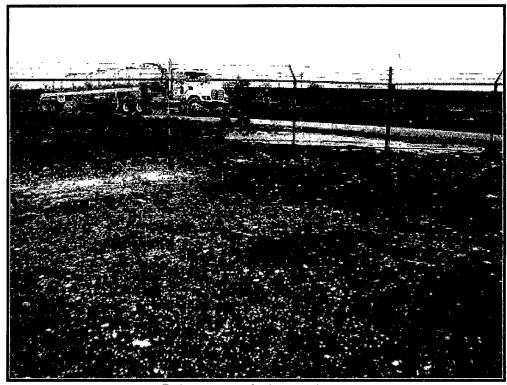
Release area facing northeast

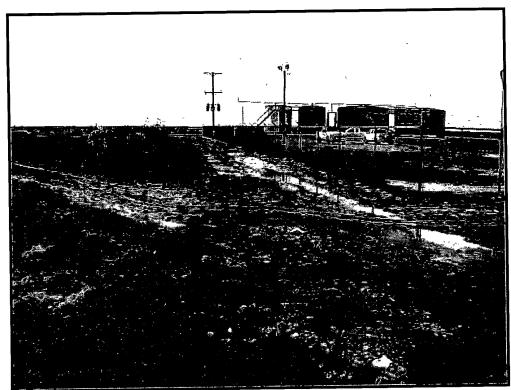
Release area facing west

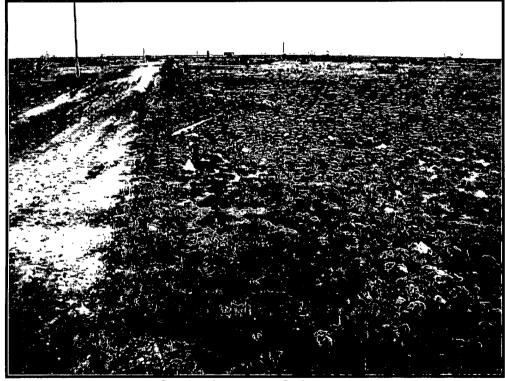
South release area facing east

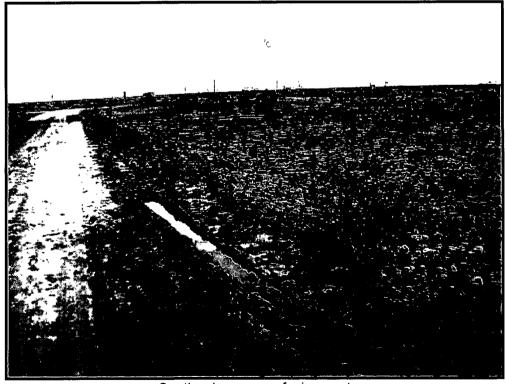
South release area facing east

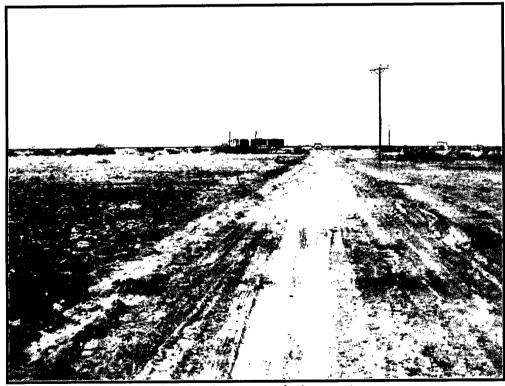
South release area facing west

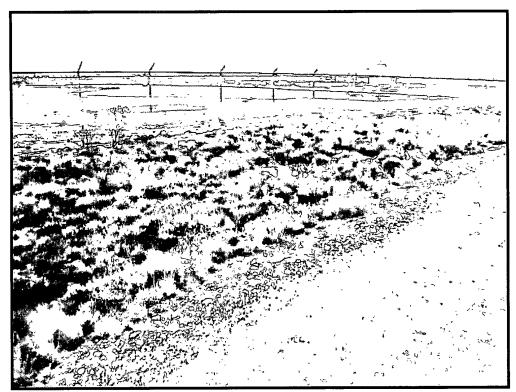
Release area facing northwest

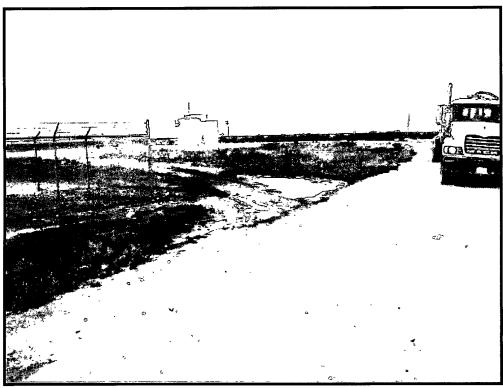
North release area facing north

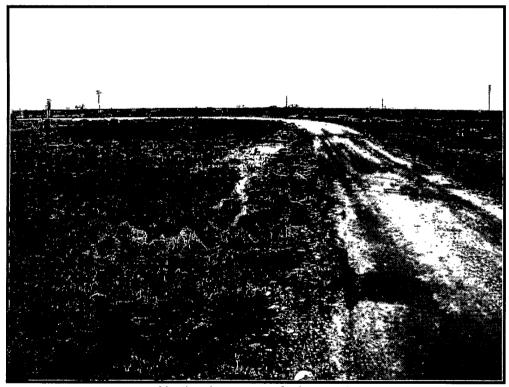
North release area facing north
