**Range Operating New Mexico, Inc.
Greenwood Battery
Section 9, Township 22S, Range 37E
Lea County, New Mexico**

Work Plan

June 26, 2009

IRP # 10.2.2429

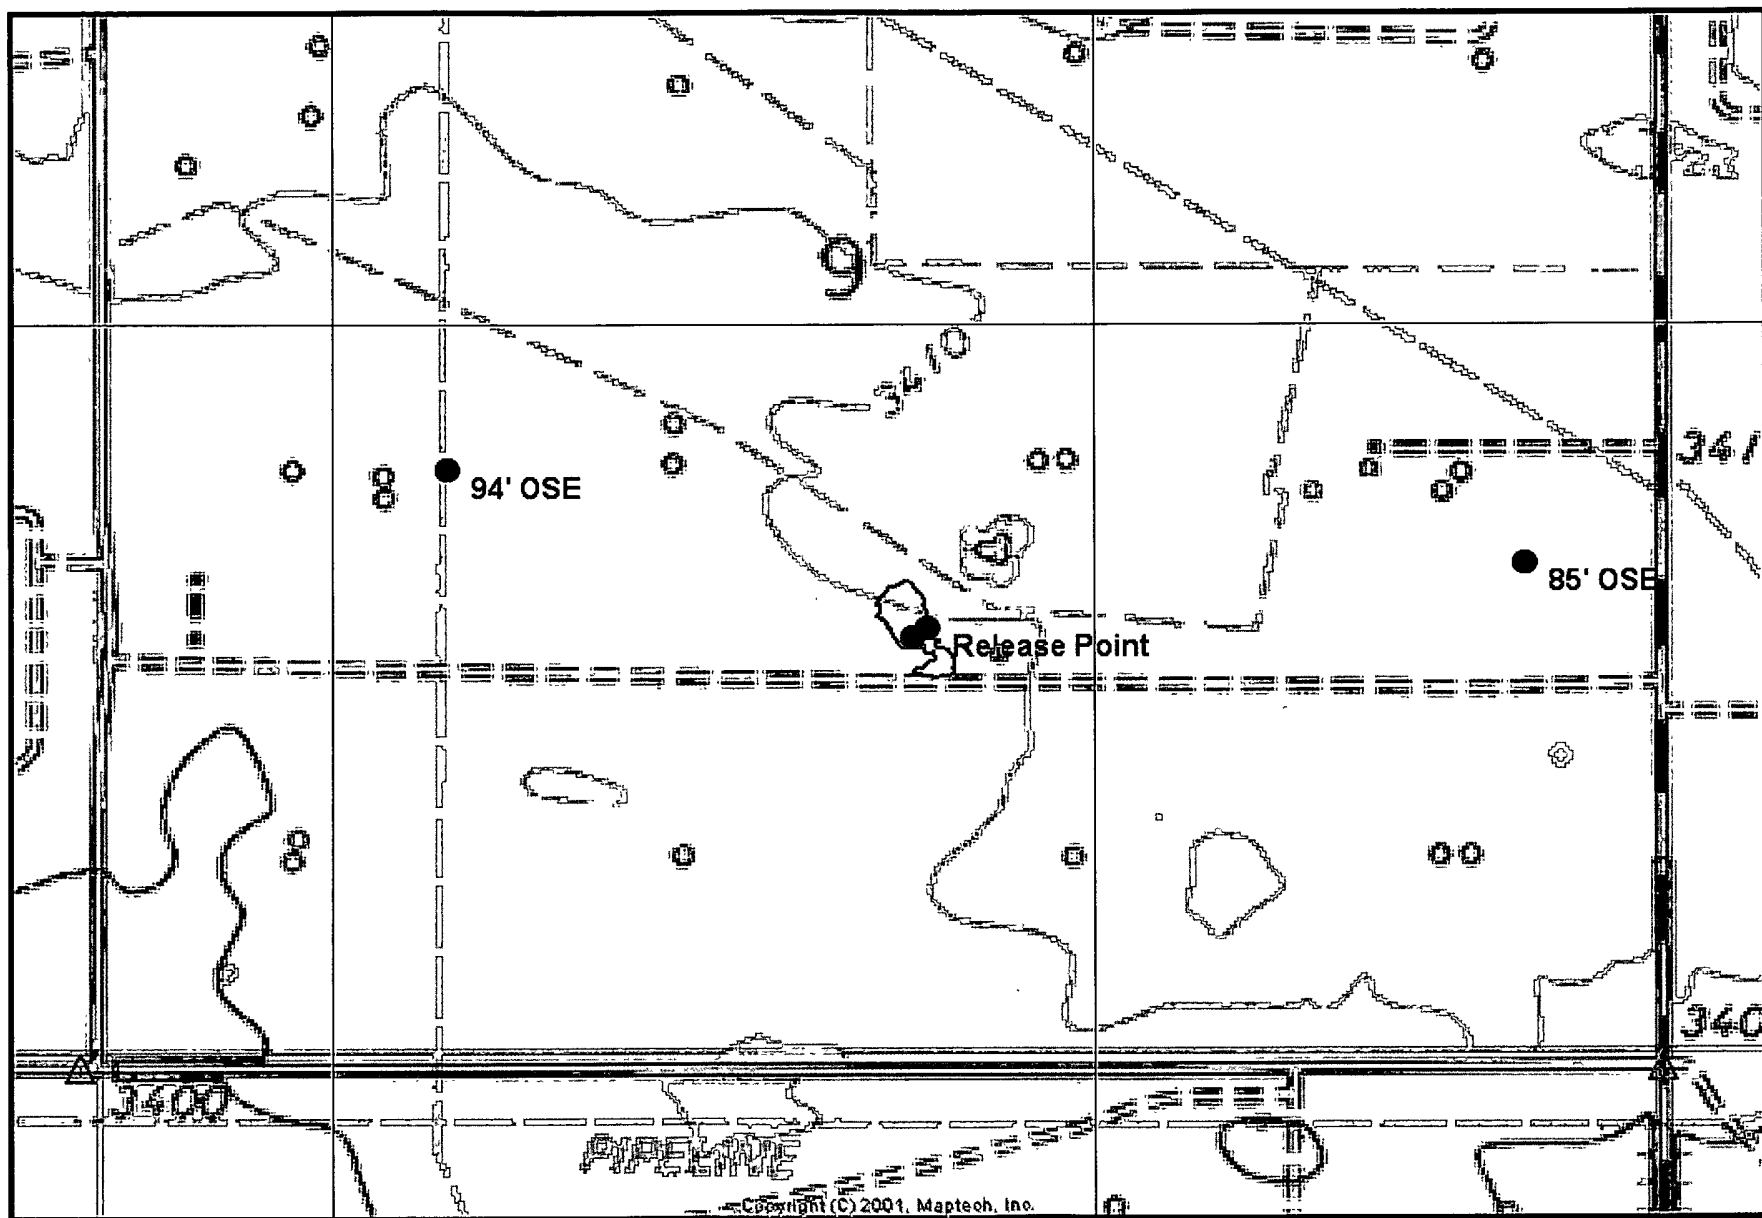
Figure 2
Site Plan

Point of Release

Auger Hole #1

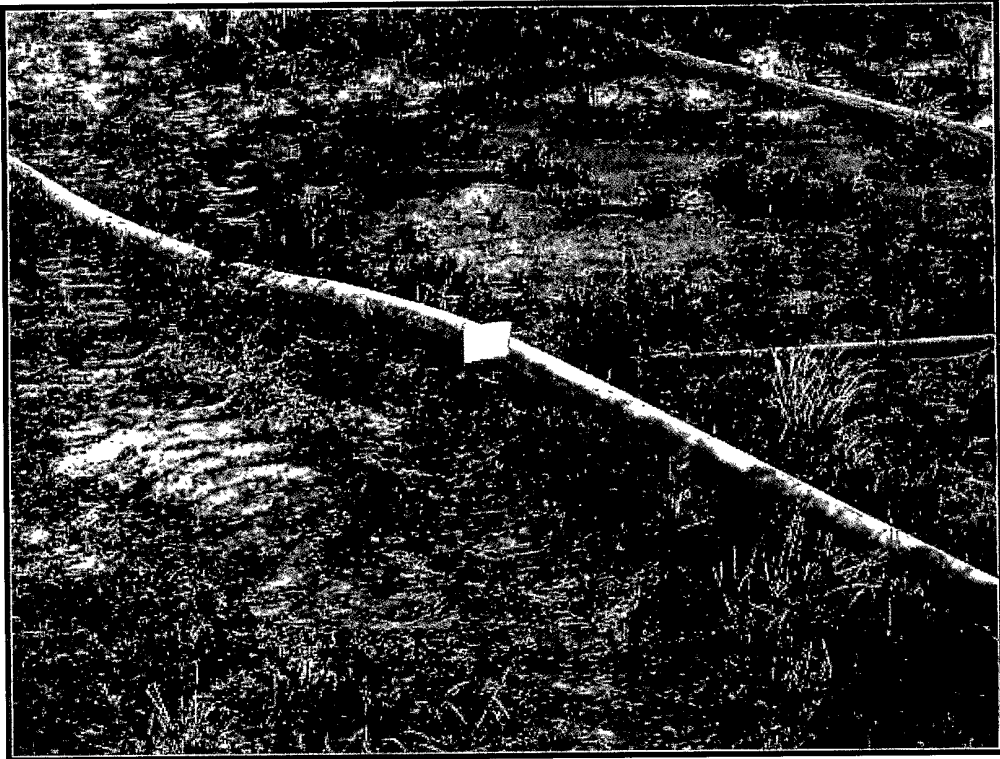
Auger hole # 1 facing west
