State of New Mexico
Energy, Minerals and Natural Resources

Lovington San Andres Unit

38

Pure Resource LSAU No. 38 6-7-02

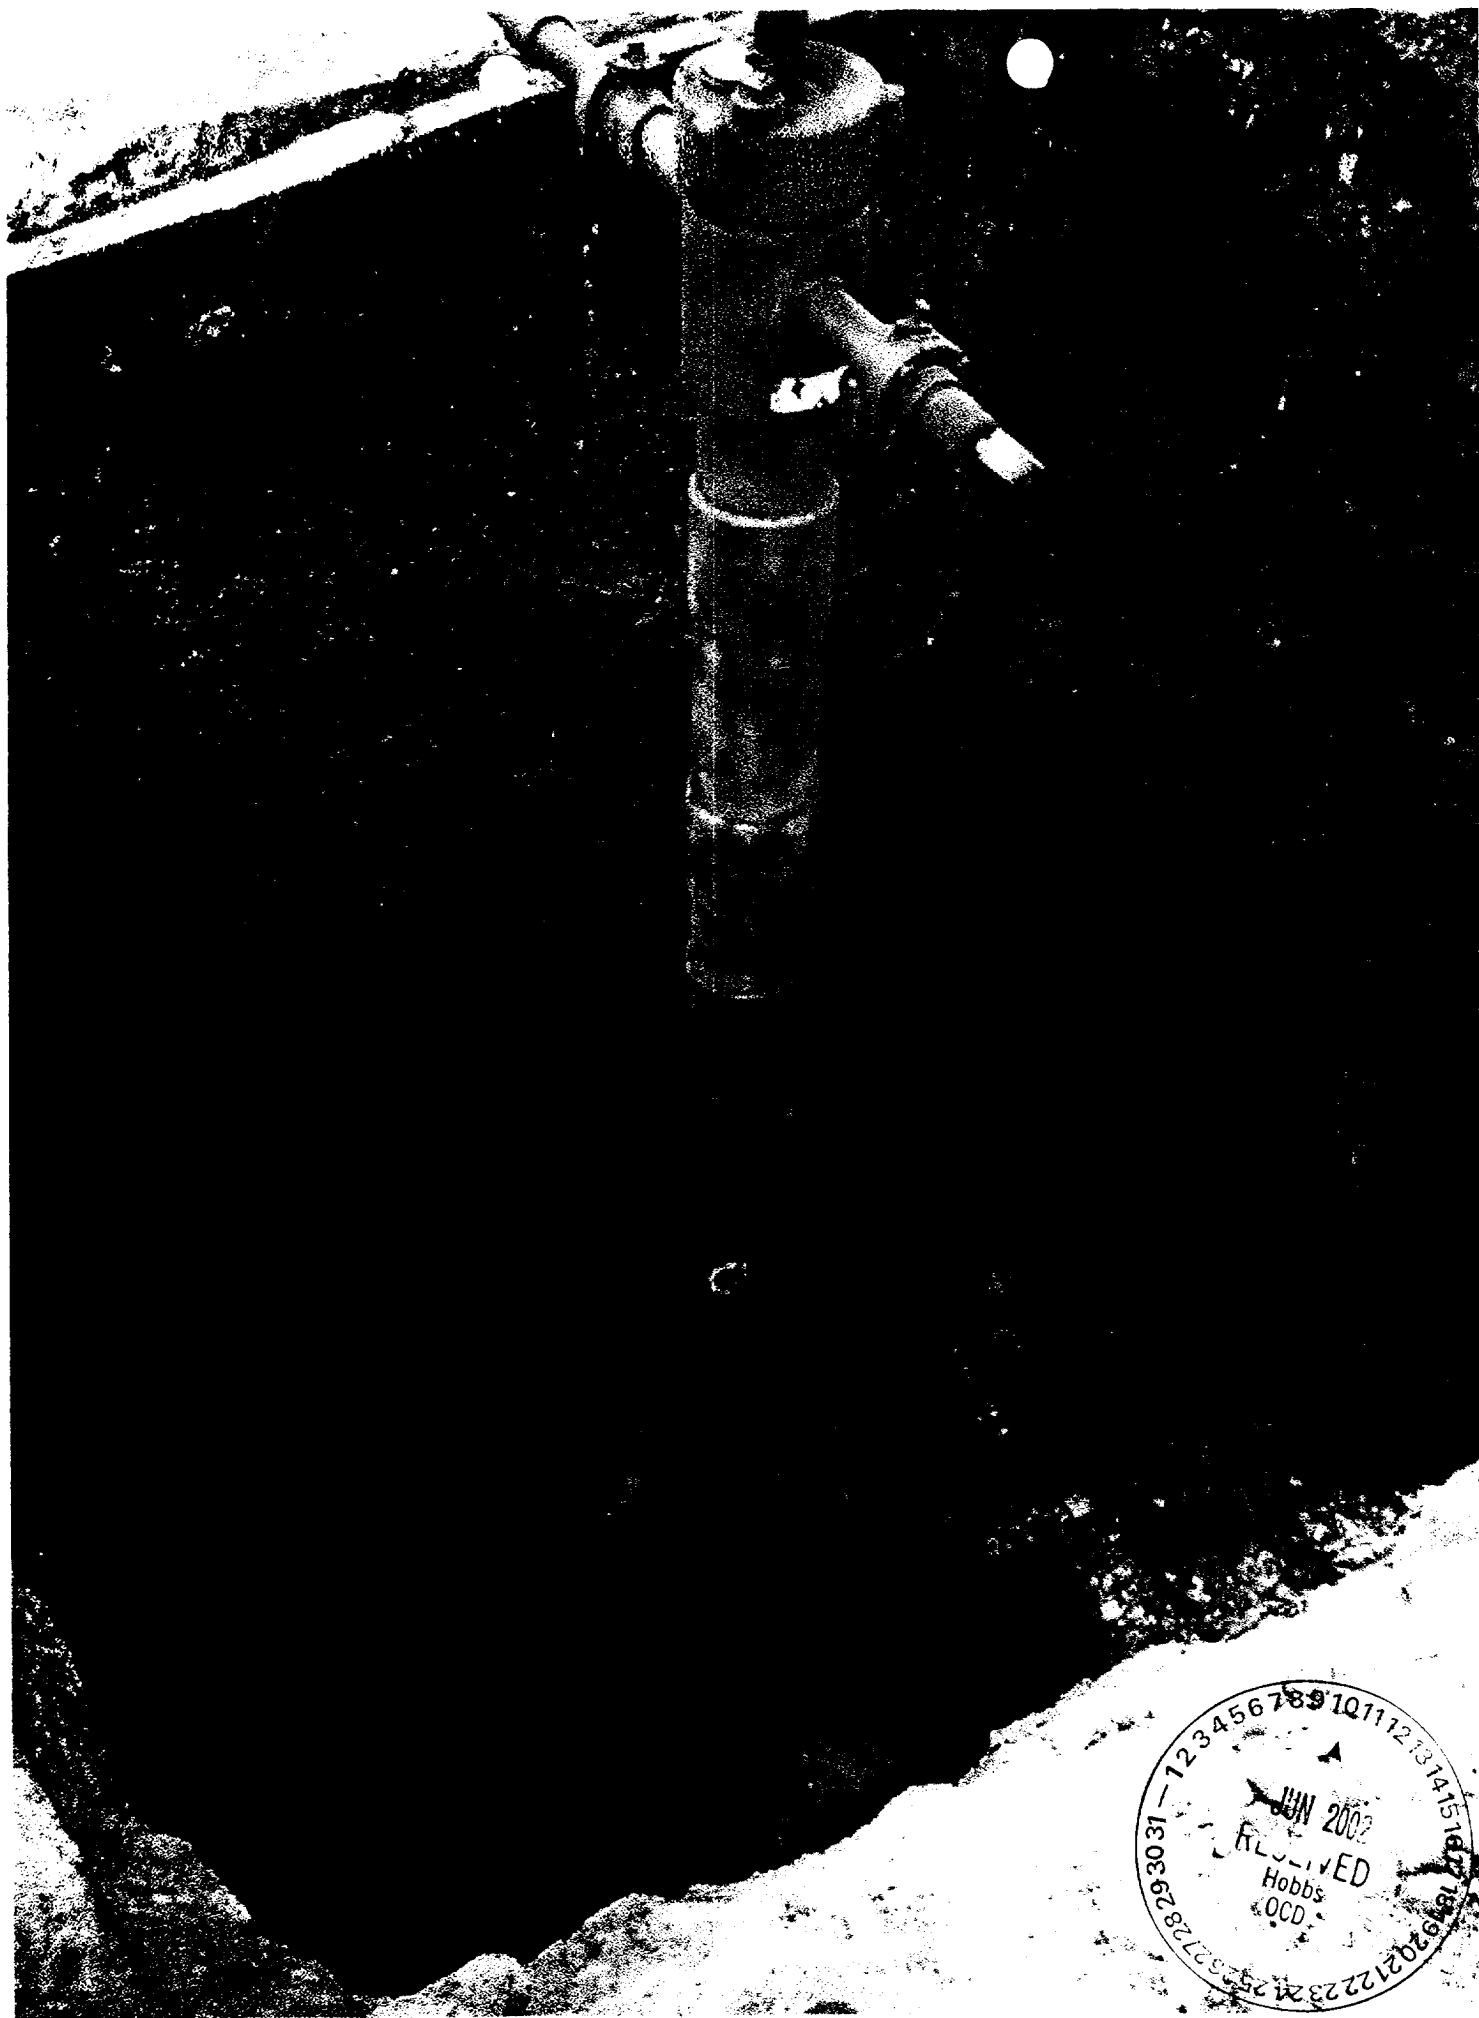
Failed mechanical integrity test due to excessive pressure drop on production casing. Excavated well head to surface casing hanger and found severe exterior corrosion and hole in the top three 7" casing subs (see picture) and severely corroded flange and pack-off bolts. Replaced all flange and pack-off bolts. Moved in pulling unit and replaced defective casing subs with one 79" long 7" 20# sub. Flanged up wellhead and ran mechanical integrity test. Installed new risers from surface and intermediate casing.

DROVE CREW TO LOCATION. RIG UP. BLEED PRESSURE TO GRAVITY PIT. ND 8 5/8" 8 RD LARKIN WELL HEAD. NU BOP. COULD NOT GET PKR TO RELEASE OR SHEAR. STACKED TBG OUT ON PKR, BACKED THE 3 - 7" CSG SUBS OUT. REPLACED W/ 1 NEW 79" 20# SUB. INSTALLED LARKIN WH. PRESSURED UP ON CSG TO 405 PSI. HAD A 5 PSI DROP IN 30 MIN. CAUGHT CHART FOR THE OCD. SDON. WILL RD IN THE AM:
