Sundry Notices and Reports on Wells

8. Well Name & Number
Grambling #8

9. API Well No.
30-045-21564

Grambling #8 Sundry Notice

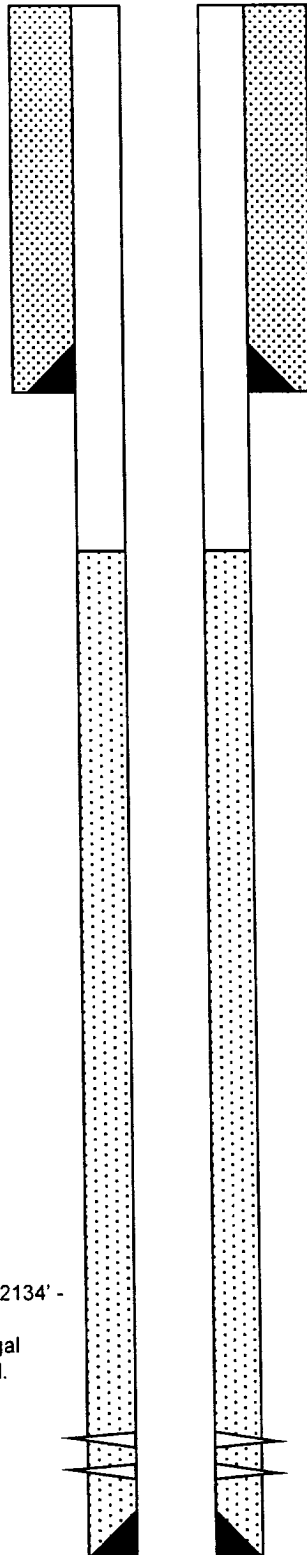
CURRENT

8-5/8" csg set @ 123'
Cmt'd w/112 cu ft
Circ to surface

Top of Ojo @ 1008'

Top of PC @ 2120'

2-7/8", 6.4#, J-55 csg
Set at 2290'
Cmt w/392 cu ft

TOC @ 750' T.S.

Pictured Cliffs perfed at 2134' -
40', 2170' - 74' 6 spz
Water frac'd w/ 26,500 gal
water, 26,000# 20/40 sd.

PBTD @ 2280'

TD @ 2290'
