2. Name of Operator MERIDIAN OIL			San Juan 32-9 Unit
		8.	
3. Address & Phone No. of Operator PO Box 4289, Farmington, NM 87499 (50	9.	San Juan 32-9 U #56 API Well No. 30-045-11497

WORKOVER PROCEDURE - TUBING REPAIR

San Juan 32-9 #56
DPNO 69955
Blanco Mesaverde
SW, Section 12, T32N, R10W
San Juan County, New Mexico
Latitude/Longitude: 36.9960964 - 107.837631

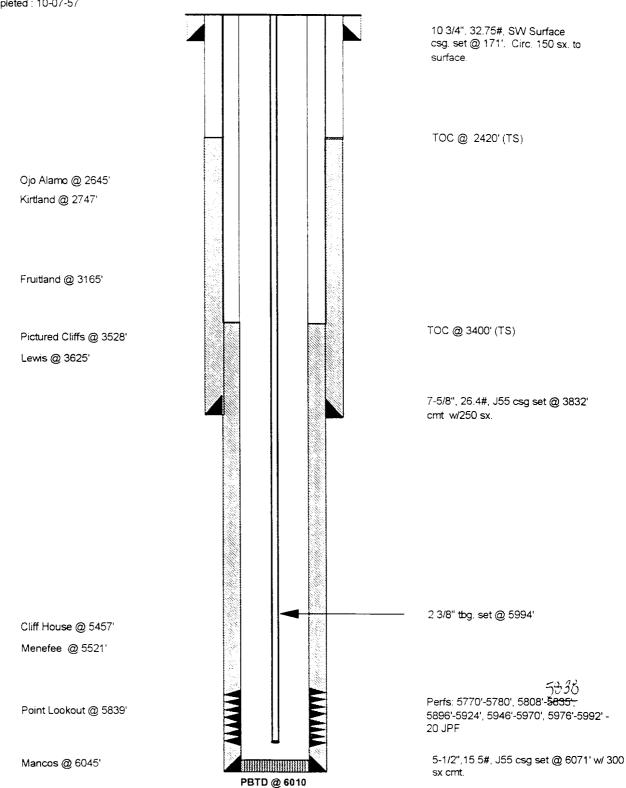
Current -- 7-18-95

San Juan 32-9 Unit #56

DPNO 69955 Blanco Mesaverde

1550' FSL, 1600' FWL Sec. 12, T32N, R10W, San Juan Co., NM Latitude/Longitude: 36.9960964 - 107.837631

TD @ 6078'
