**Pit or Below-Grade Tank Registration or Closure**

Operator: Chevron USA (O-Grid #4323) Telephone: 505.394.3133 e-mail address: lduke@chevrontexaco.com		
Address: PO Box 1949 2401 Avenue O Eunice, New Mexico 88231		
Facility or well name: VM Henderson 20 API #: 30-025-37412 Unit Letter (UL): F Qtr/Qtr: SE1/4 NW1/4 Section: 30, T21S, R37E		
County: Lea Latitude: N 32°27'12.84" Longitude: W 103°12'21.83" NAD: 1927 <input type="checkbox"/> 1983 <input type="checkbox"/> WGS 84 <input checked="" type="checkbox"/>		
Surface Owner: Federal <input type="checkbox"/> State <input type="checkbox"/> Private <input checked="" type="checkbox"/> (Tom Kennann) Indian <input type="checkbox"/>		
<b>Pit</b>	<b>Below-grade tank</b>	
Type: Drilling <input checked="" type="checkbox"/> Production <input type="checkbox"/> Disposal <input type="checkbox"/> Workover <input type="checkbox"/> Emergency <input type="checkbox"/>	Volume:      bbl Type of fluid:	
Lined <input checked="" type="checkbox"/> Unlined <input type="checkbox"/>	Construction material:

Re: Final C-144  
Chevron USA (O-Grid #4323)  
VM Henderson 20 (Ref. #200071)  
UL-F, Section 30, Township 21 South, Range 37 East

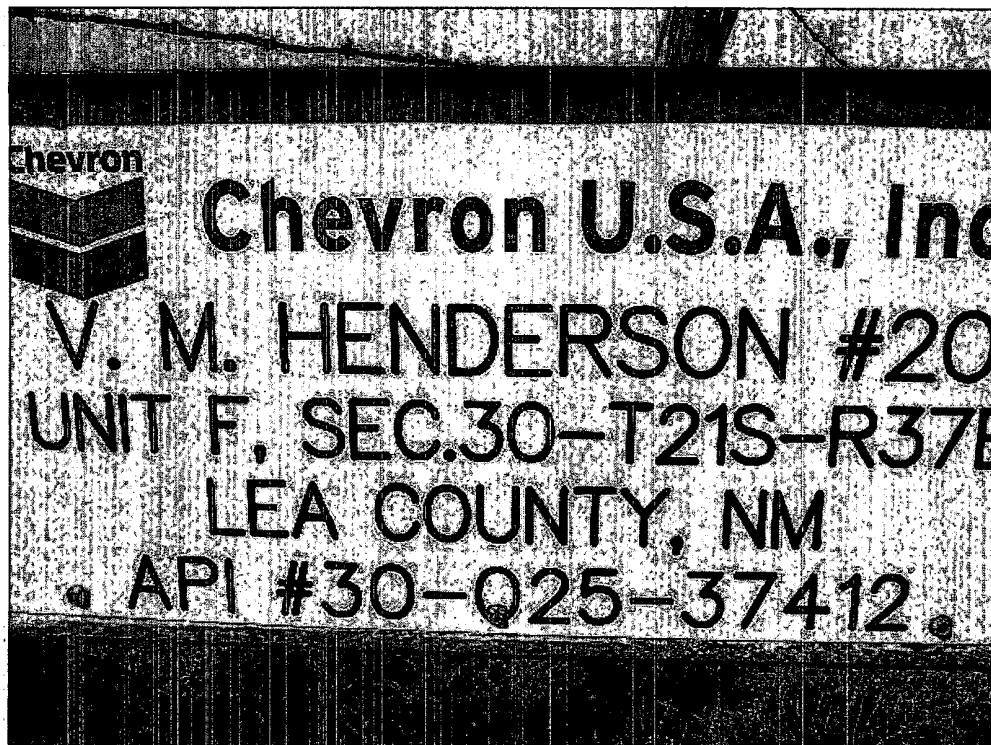
Photograph #1- Lease sign.

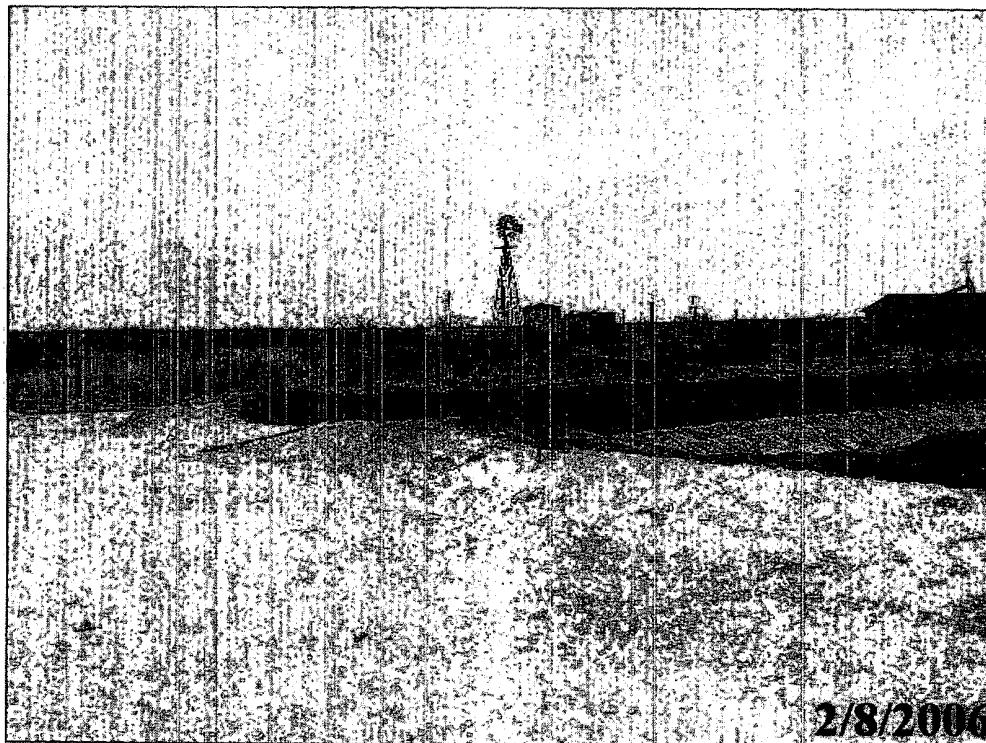
Photograph #2 - Pit and berm looking westerly.

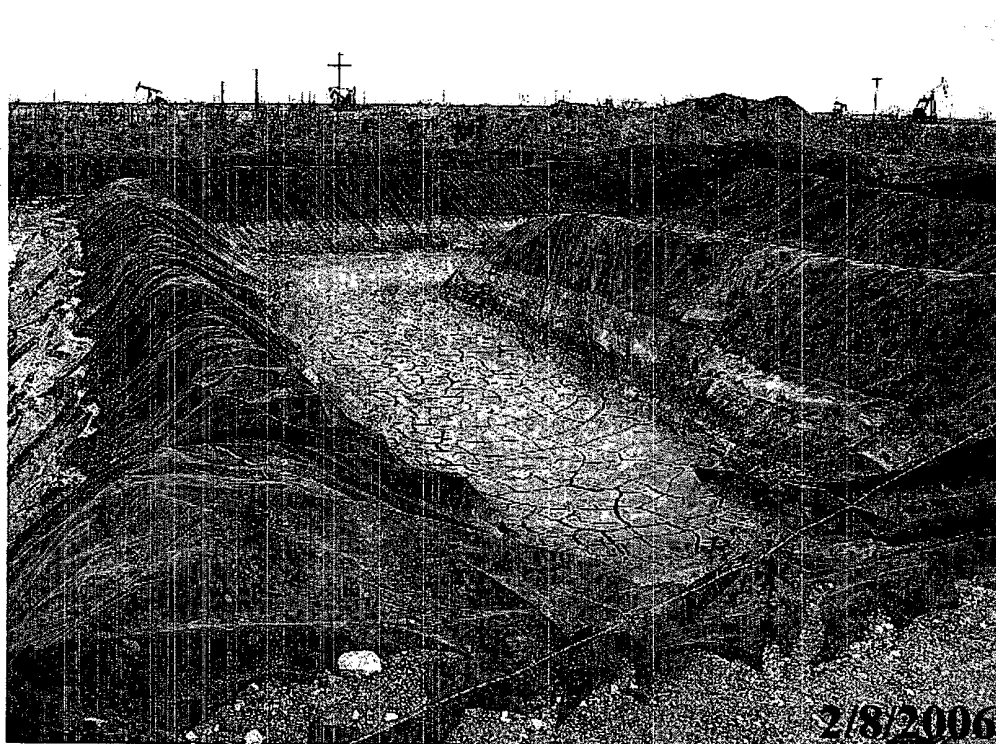
Photograph #3 - Pit and berm looking northeasterly.

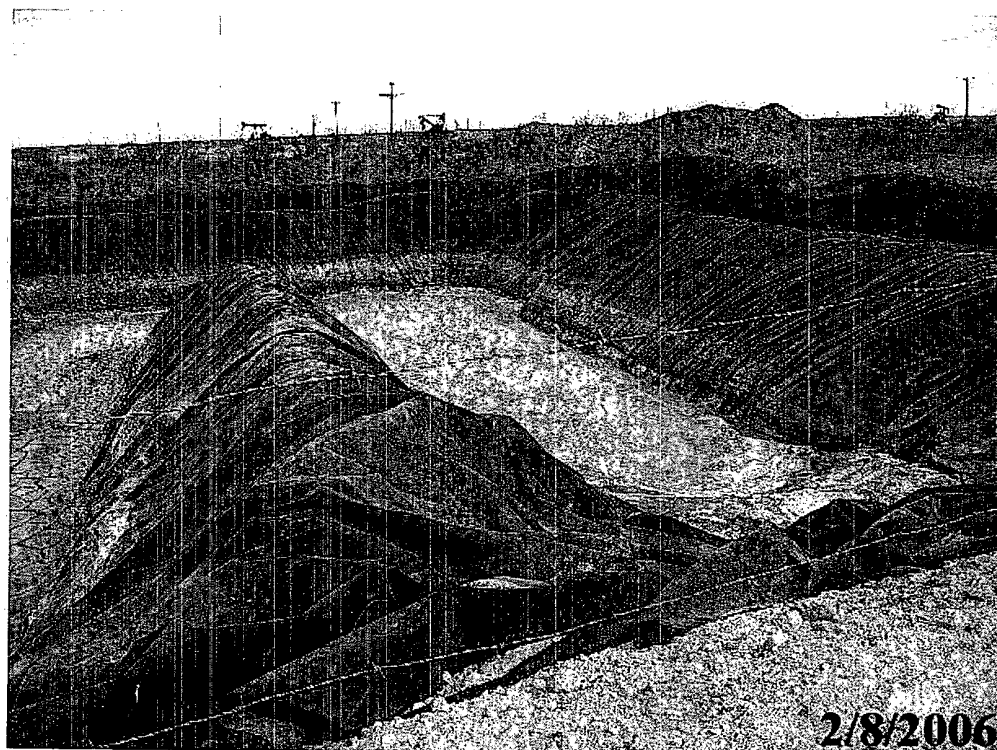
Photograph #4 - Pit and berm looking northeasterly.
