**1RF-443 - MCCLOY WEST
RECYCLING FACILITY
[fBGB1924149220].
Annual Extension
2024-2025**

**[372338] NGL
WATER SOLUTIONS PERMIAN,
LLC May 15, 2024**

Form C-147
Revised October 11, 2022

Type of action: ☐ Permit ☐ Registration
☐ Modification ☒ Extension
☐ Closure ☐ Other (explain) Annual Extension from 6/14/2024 to 6/14/2025

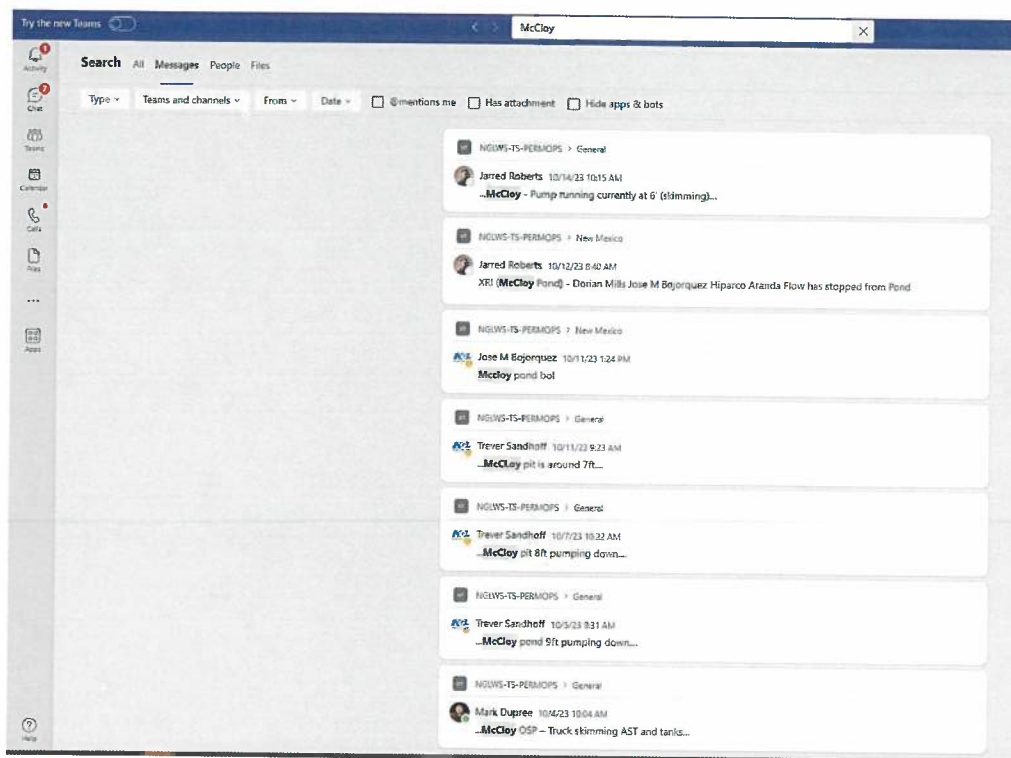
When fracs are complete the pits are pumped down. Communication, inspections, and images are sent through Microsoft Teams. Figure four illustrates operational adjustments, and inspections during frac jobs. Our pumpers check each facility daily and the Leak Detection weekly. Any issues are reported via TEAMS or during our daily Operations call and addressed. Leak detection inspections have never found the presence of water in the system.

Figure 4. Inspections and Issues and occurrences are communicated via Microsoft TEAMS.
