Re: Compliance Plan
San Juan 28-7 Unit 183M
Rio Arriba County, New Mexico
OCD Incident No. NCS1901627746

Re: Status Report – 3rd Quarter 2020
San Juan 28-7 Unit 183M
Rio Arriba County, New Mexico
OCD Incident No. NCS1901627746

On behalf of Hilcorp Energy Company (Hilcorp), Timberwolf Environmental, LLC (Timberwolf) presents this report to document remedial activities conducted during the third quarter of 2020 (3Q20) at the San Juan 28-7 Unit 183M (Site). Activities conducted during 3Q20 consisted of the following:

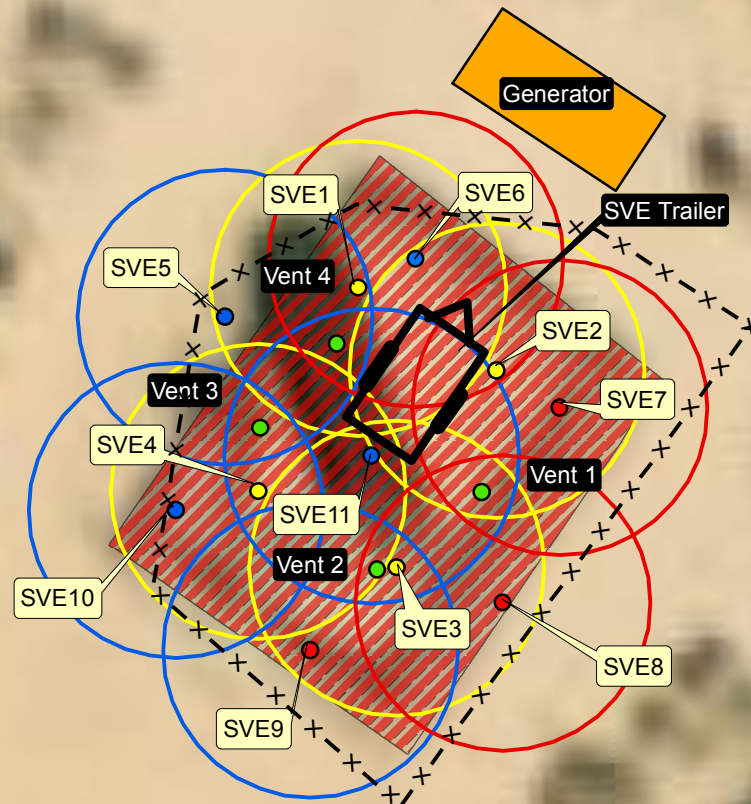
Figure 4
SVE System Overview

The SVE system creates a treatment field of approximately 0.15 acres and treats soil to a depth of approximately 30 ft bgs for a total volume of approximately 7,021 cubic yards of soil. The SVE wells, measured radius of influence of 25 ft, and leg configurations are shown in Figure 4.

The SVE system was designed with three independent legs (i.e., Leg 1, Leg 2, and Leg 3). Legs 1 and 3 provide vacuum extraction to the deep SVE wells; Leg 2 is piped to the shallow wells.
