Incident ID	NAPP2118846106
District RP	
Facility ID	
Application ID

Closure Report Attachment Checklist: *Each of the following items must be included in the closure report.*

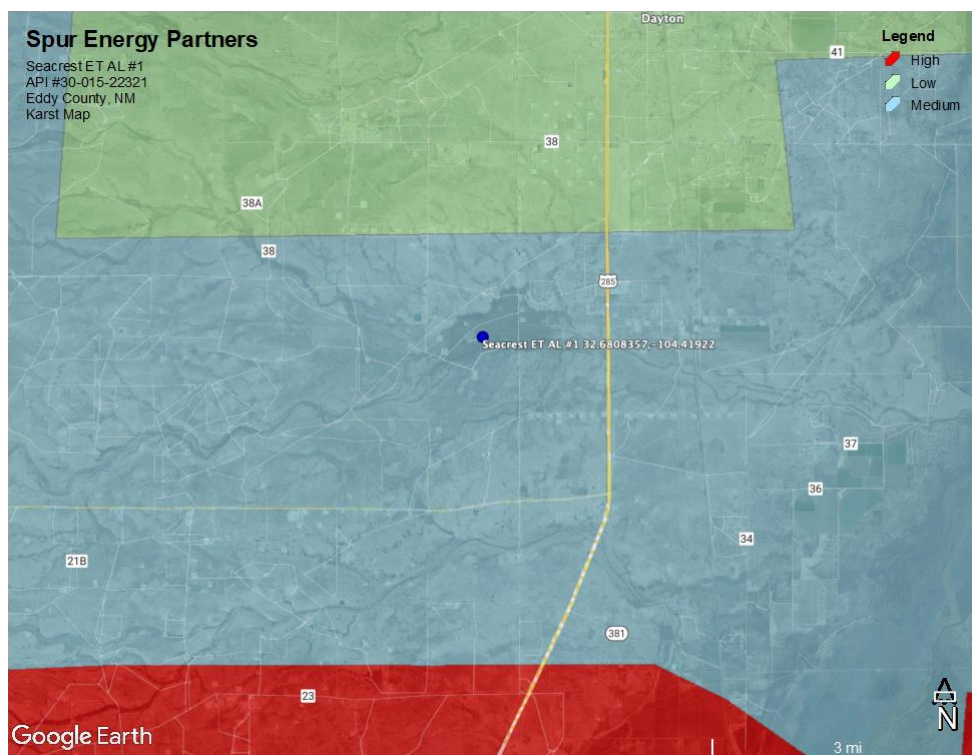
Soil Survey: Per the New Mexico Bureau of Geology and Mineral Resources, the geology is in the Piedmont alluvial deposits (Holocene to lower Pleistocene)-Includes deposits of higher gradient tributaries bordering major stream valleys, alluvial veneers of the piedmont slope, and alluvial fans. May locally include uppermost Pliocene deposits (QP). According to the United States Department of Agriculture Natural Resources Conservation Service soil survey, the soil in this area is comprised of the Pima silt loam, with 0 to 1 percent slopes. The drainage courses in this area is well-drained. The karst geology in the area of the Seacrest is not in High Karst. See the map below.

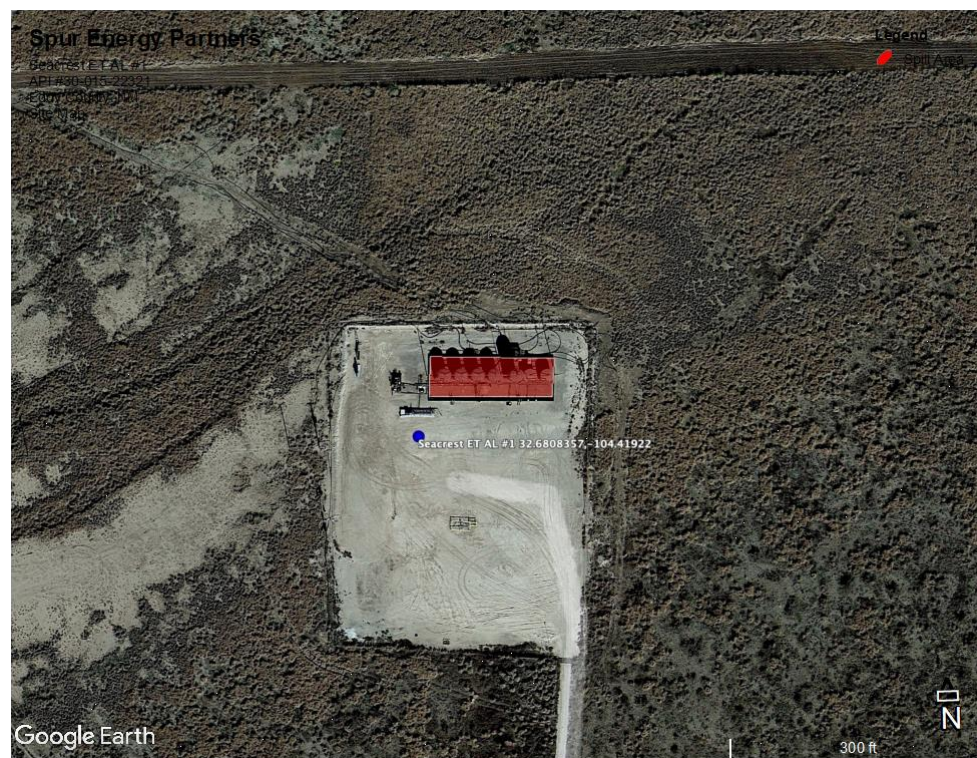
REMEDIATION ACTIVITIES
