Re: *Administrative application (application reference No. pMES0-501843249) for a non-standard 90.80-acre Pictured Cliffs gas spacing unit comprising Lots 3 and 4 and the E/2 SW/4 (SW/4 quarter equivalent) of Irregular Section 19, Township 30 North, Range 13 West, NMPM, Undesignated Harper Hill-Fruitland Sand Pictured Cliffs Pool (78160), San Juan County, New Mexico, to be dedicated Yates Petroleum Corporation's proposed Vierson Federal Well No. 3 (API No. 30-045-32462), to be drilled at an unorthodox gas well location 1825 feet from the South line and 1520 feet from the West line (Unit K) of Irregular Section 9.*

Subject: Yates Petroleum Corporation's Verson Federal #3 (19-30n-13w)
Application Reference # pMESO-501843249

As requested, I inspected Ladd's P&A Butte Well #1 on March 7, 2005. The well was plugged in 1987 and the 1/4 mile long road is blocked. The well site is 100' x 150' and located on a tear drop shaped badland hill. This is smaller than Yates' staked location of 130' x 170'.

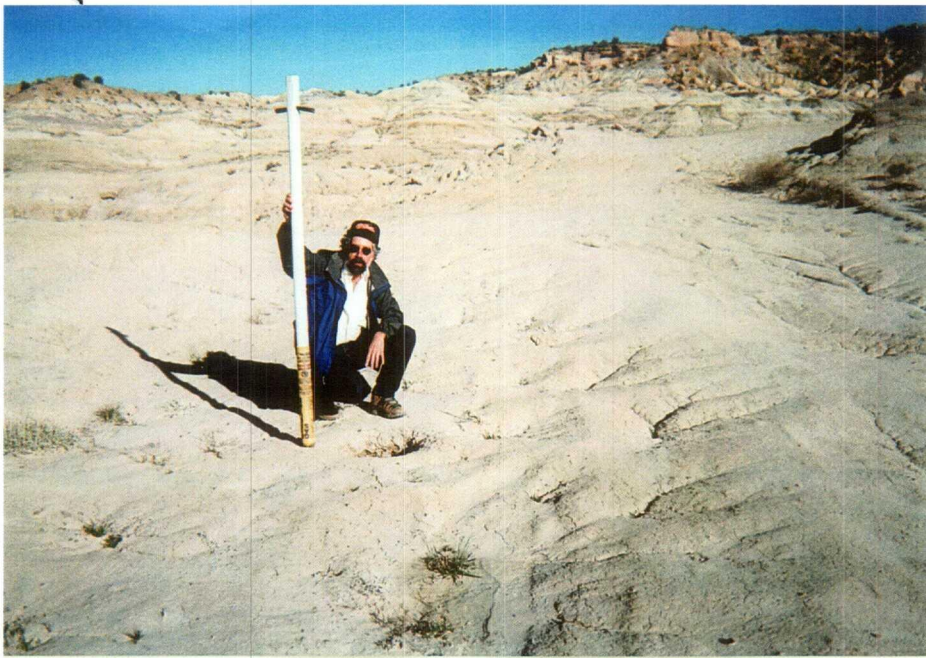
These limitations have led to a pseudo-karst environment (see pictures). There are numerous sinkholes in the road, one of which is 6' deep. There are more sinkholes on the pad, the two largest of which are 5' deep and 5' to 10' wide. Both of these are within 60' of the P&A marker.

TOP LEFT - Six foot high marker at sink hole.

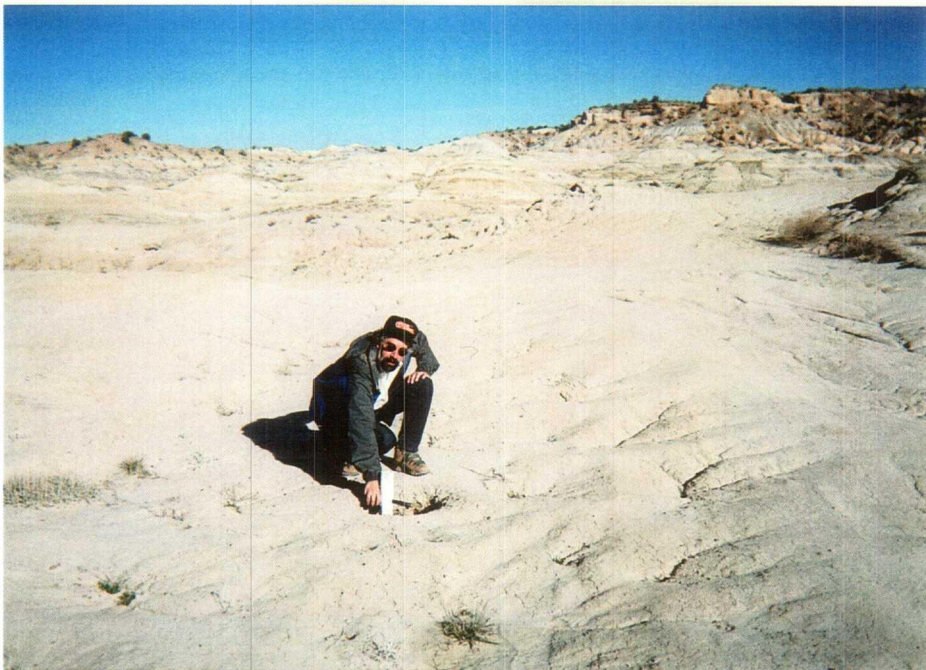
MIDDLE LEFT - Six foot marker in sink hole in road.

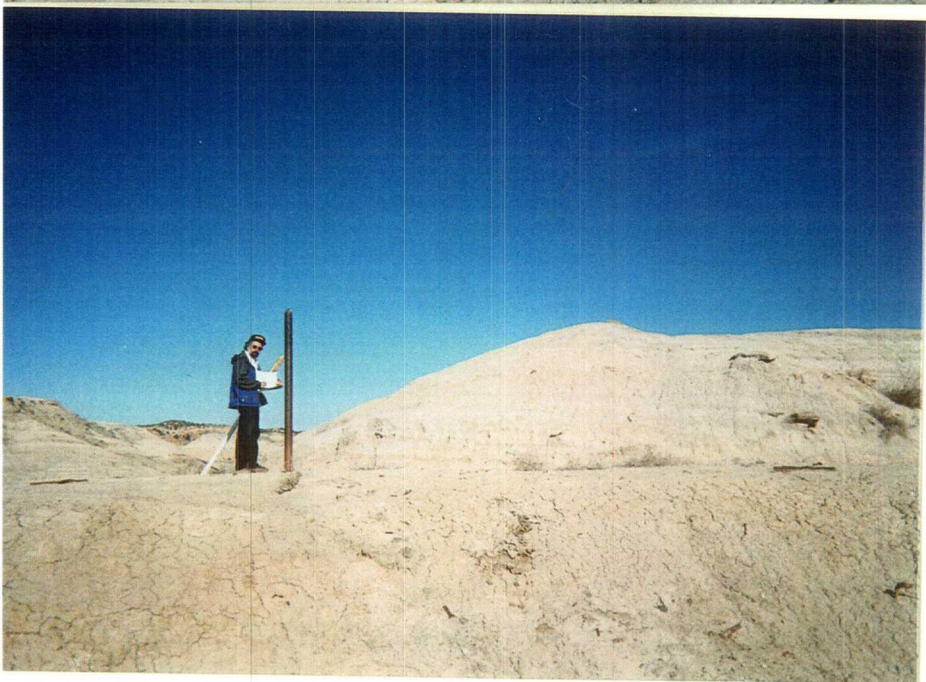
LOWER LEFT - Looking W at P&A marker from old reserve pit. Edge of pit is 20' from marker & 6' lower.

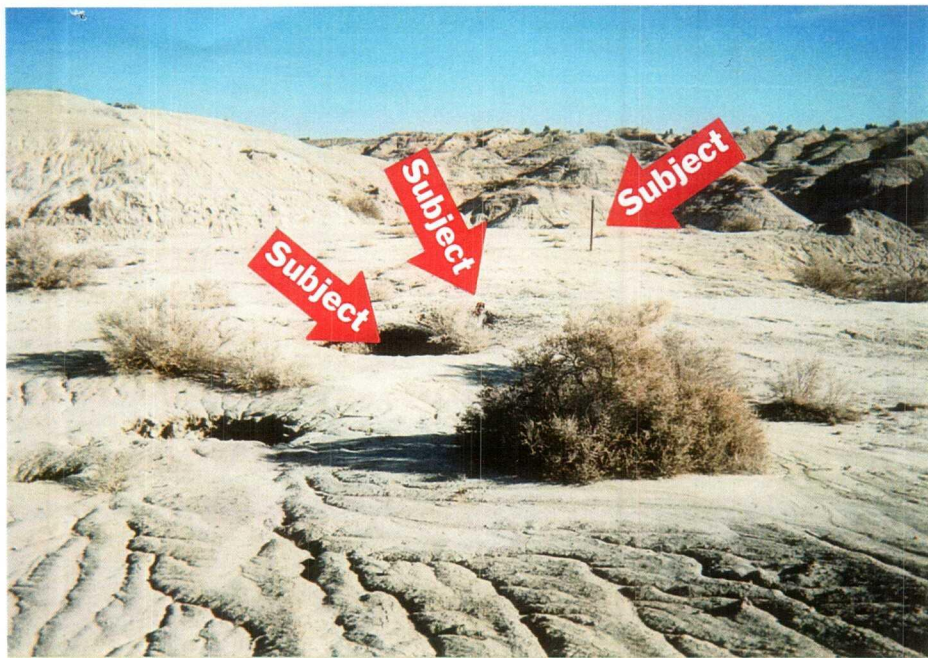
TOP LEFT - Looking North. From left to right are 5' deep x 10' wide sink hole, 5' deep x 5' wide sink hole, and P&A marker.

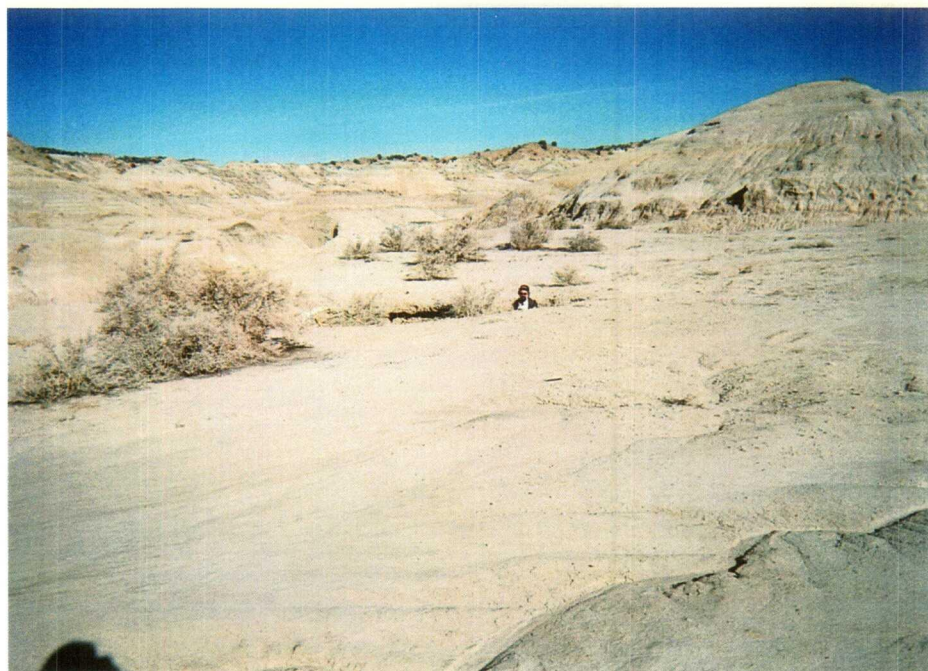
MIDDLE LEFT - Man in 5' deep sink hole 50' from P&A marker.

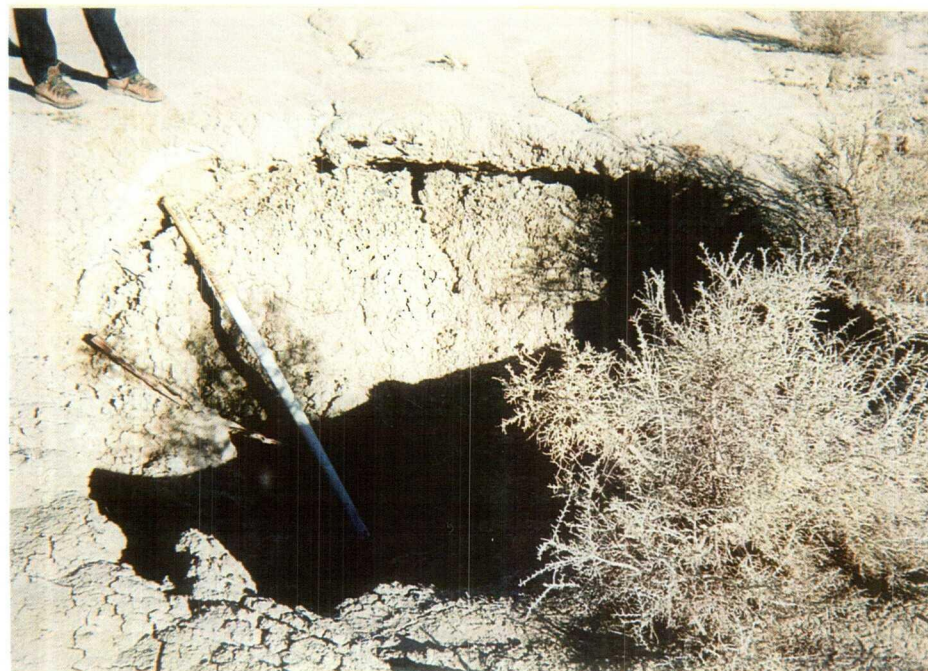
LOWER LEFT - Close up of 5' deep x 10' wide sink hole and 6' long marker. Hole is 60' from P&A marker.
