RE: ICP REPORT

Rice Operating Company – BD SWD System BD jct. G-23 (1R426-286): UL/G sec. 23 T22S R37E

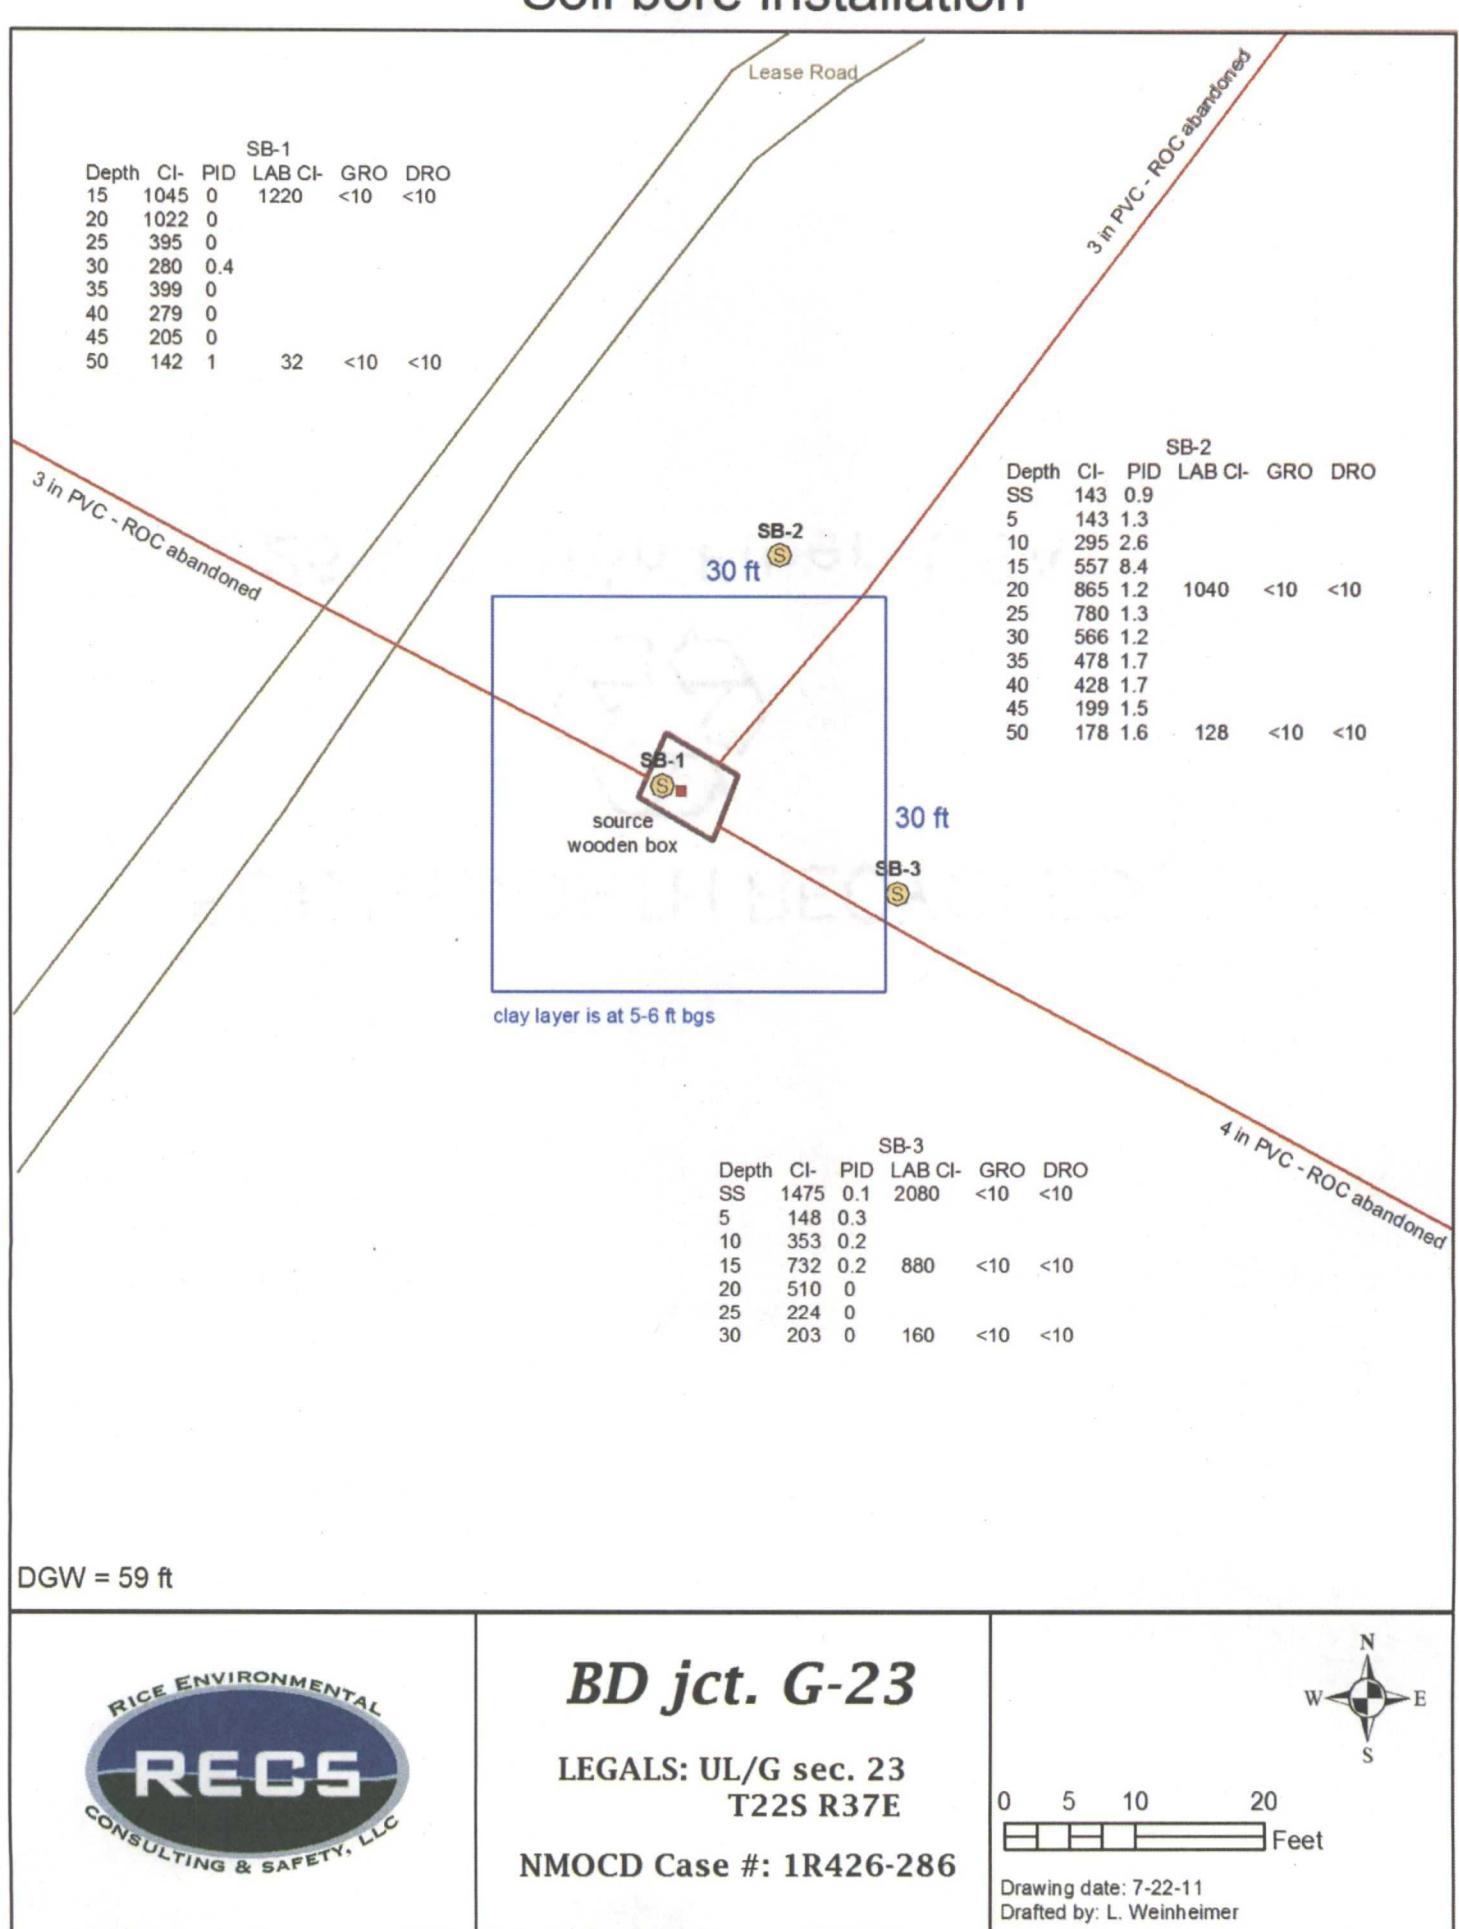
Soil bore installation

Attached is the soil data for G-23, We had some complications on the west with the lease road and unknown pipeline, however we do see a disconnect on the saturated zone. We will try and get more data from the west and south directions.
