Pit or Below-Grade Tank Registration or Closure

**RE: Remediation and Reclamation Reports
Chevron MidContinent Alaska
Marquardt Federal #3
Marquardt Federal #6
Eddy County, New Mexico**

**Re: Remediation and Reclamation Report
Marquardt Federal #6
Unit Letter E, Section 1, T25S, R26E
Eddy County, New Mexico
Lat. N 32° 16120', Long. W 104° 25424'
(2RP # 25)**

Site Drawing With Soil Sample
Locations in Excavated Area

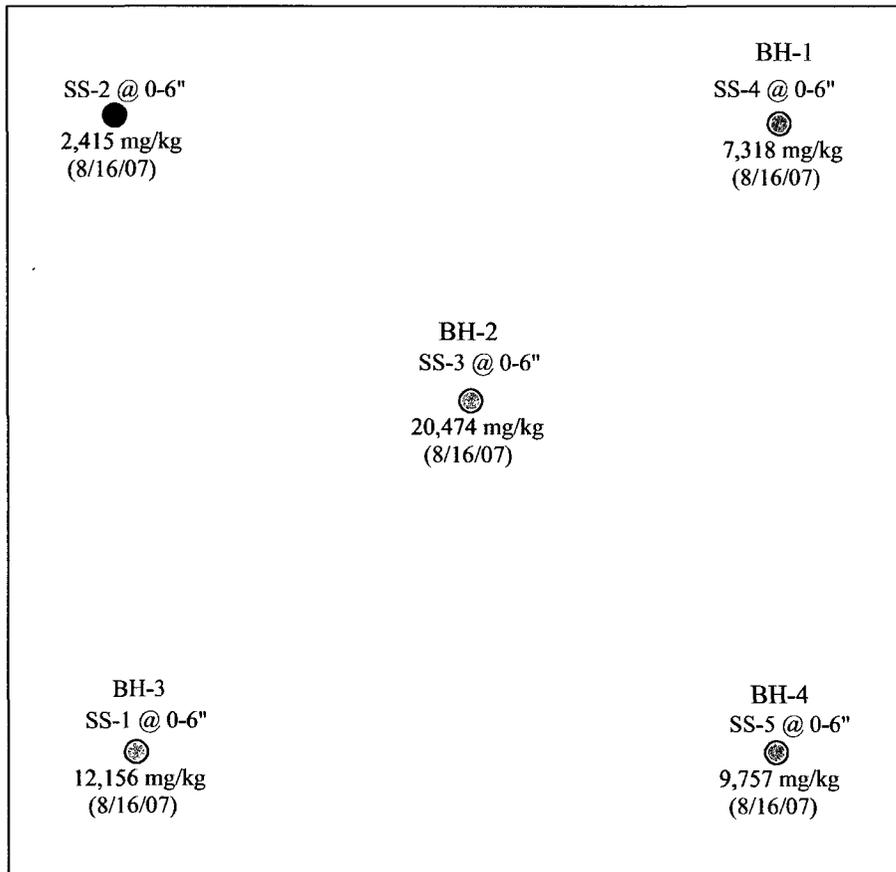
FIGURE # 2

On March 13, 2008, excavation of the pit contents was initiated at the Marquardt Federal #6 site. As the exact location of the pit was unknown, excavation began at the borehole location BH-3, shown on Figure 2. Table 1 provides a summary of the chloride concentrations reported from soil samples collected at the surface and from soil borings installed during the initial investigation.

Site Drawing with Boring
and Sample Locations

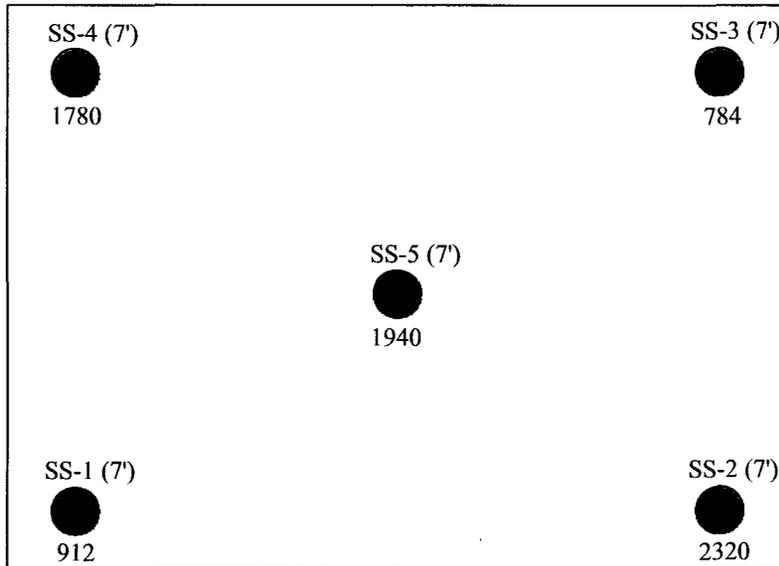
FIGURE # 3

Excavation continued to the north, south, east and west until blue plastic, marking the pit boundaries, was no longer evident. On March 19, 2008, soil samples (SS-1 through SS-5) were collected below the liner, at a depth of seven (7) feet bgs in the center and each corner of the excavated area. All soil samples were placed in clean glass sample jars and delivered under chain-of-custody control to Cardinal Laboratories (Cardinal), located in Hobbs, New Mexico, for chloride analysis. Figure 3 shows the sample locations. Table 2 provides a summary of the laboratory results. Appendix A provides laboratory documentation.

Referring to Table 2, all samples collected from the bottom of the excavation reported chloride concentrations less than 3,000. The entire pit (150' x 210') was excavated to a depth of nine (9) feet bgs, until a layer of compacted limestone rock was encountered, and the bottom of the excavation was covered with a double, 4 ounce felt liner on April 9, 2008. A 20 mil plastic liner was placed above the felt, with enough overhang to completely encapsulate the stockpiled soil from the excavation. Stockpiled soil was placed in the excavation, above the 20 mil plastic, to a depth of approximately three (3) feet bgs and completely encapsulated. Clean soil from the excavation at a depth of seven (7) to nine (9) feet bgs, and from the surrounding area was used to backfill the remainder of the excavation from a depth of approximately three (3) feet bgs to surface. The surface was contoured to grade, and the entire site was re-seeded with BLM Mixture #4 on May 15, 2008. The area will be watered periodically to promote re-vegetation of the site.
