1RP-3518

Subject: Work Plan RGS Trucking Fasken-Luguna 16-2

# Laguna Illegal Dumping Site - Sampling Sketch - 4/7/2015

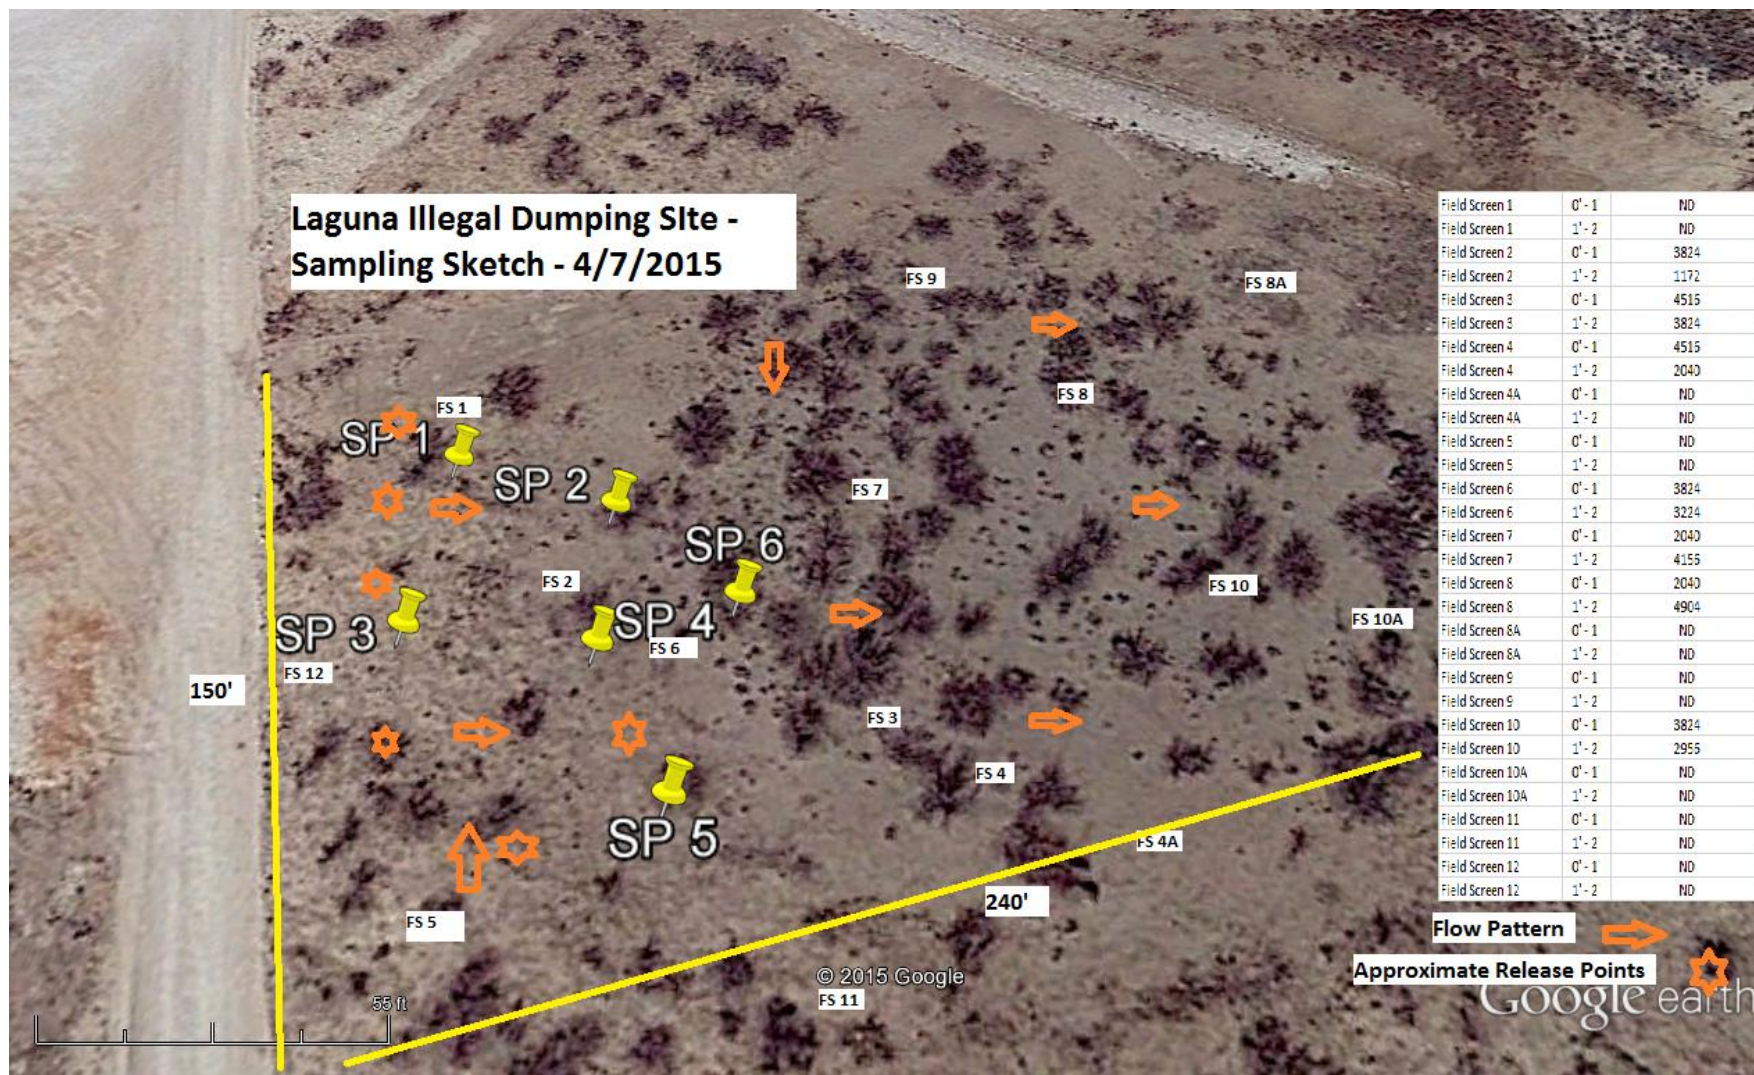
On February 5, One Source Industrial Environmental began investigation at the Laguna Illegal Spill site. One Source used a backhoe to excavate a total of six (6) sample points to a depth of 3' – 7' at which point we encountered rock and were unable to excavate any further with our backhoe. (Note: on the outer edges of the impacted area the depth to rock was 3' but at sample point 6 (SP 6) we were able to excavate to 7'). Field screening was accomplished on March 13, 2015 in order to determine the vertical delineation.

Approximate Release Points

We propose to excavate an area 240' x 120' x 4' and then install a 20 mil plastic liner at the bottom of the excavation to prevent the future migration of the residual chloride impact. Clean soil will be imported as backfill and placed on top of the plastic liner to grade. The contaminated soil will be manifested and hauled off to the nearest disposal facility or landfarm (to be determined). Remedial activities will commence pending approval of this work plan by the NMOCD.

- 1) Sweep caprock to remove additional ~Cl before installation of liner.
- 2) Pad liner to prevent damage from caprock
