**NM1-62**

**Permit  
Application**

**Volume 4  
Part 5 of 11**

## PROJECT PHOTOGRAPHS

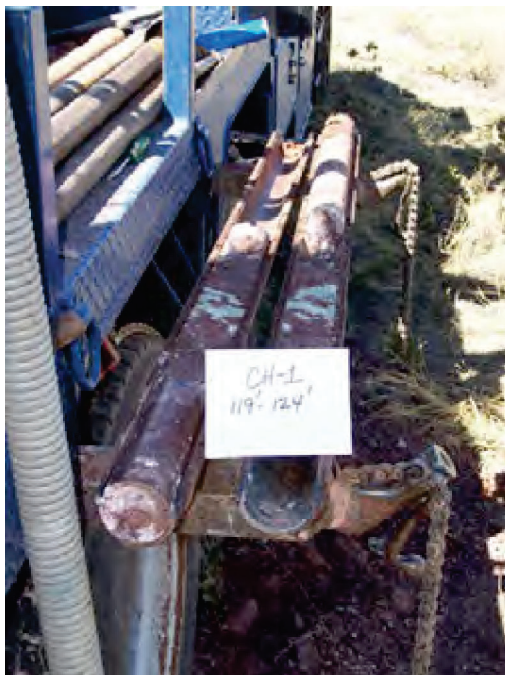
Photograph 7. Core sample of claystone with grey clay inclusions (Chinle) in CH-1.

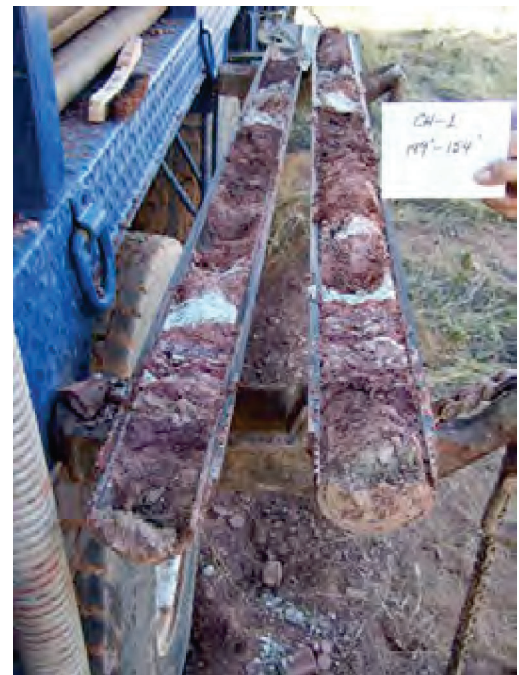
Photograph 8. Core sample at base of CH-1 (Chinle).

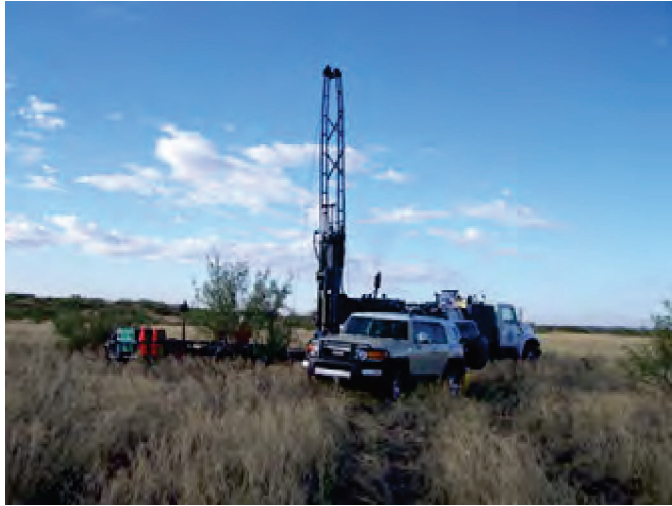
Photograph 9. Rodgers set up to drill CH-2.

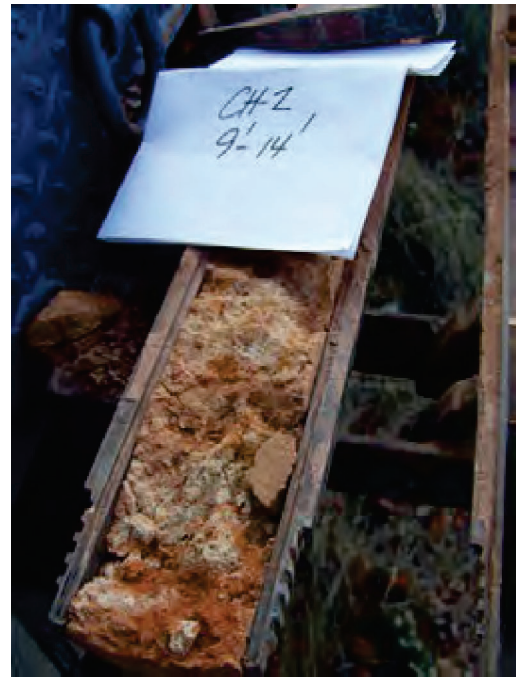
Photograph 10. Core sample of OAG in CH-2.

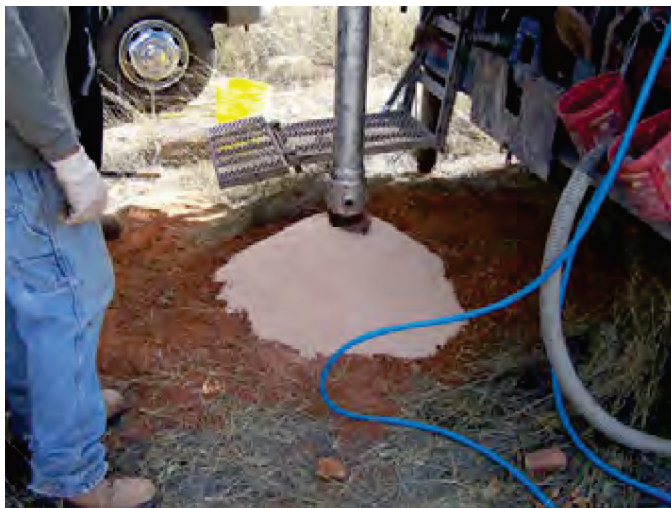
Photograph 11. HSA drilling through caliche in CH-2.

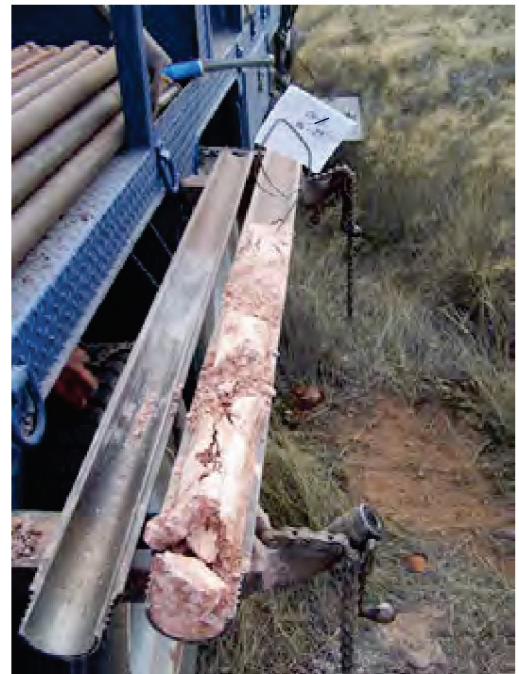
Photograph 12. Core sample of CH-2 at the base of the OAG near the top of Chinle.
