Report Type: Closure Report NVLB1011352696						
General Site Info	ormation:					
Site:		James A Battery				
Company:		ConocoPhillips				
Section, Township and Range		Unit Letter J	Sec. 2	T 22S	R 30E	
Lease Number:		Associated API No.	30-015-25699		·	· · · ·
County:		Eddy				
GPS:		3	2.418694			-103.849278
Surface Owner:		State			-	
Mineral Owner:		N/A				
Directions:		Depart from Loving. H Carter Rd (CR-712) for right onto Jal Hwy (NM Turn slightly left onto Arrive at location. Site	Depart from Loving. Head toward Amy Ave on N 8th St (US-285) for 0.4 mi. Turn right onto Carter Rd (CR-712) for 1.4 mi. Turn right onto Potash Mines Rd (NM-31) for 6.5 mi. Turn right onto Jal Hwy (NM-128) for 8.7 mi. Turn left onto Cimarron Rd (CR-796) for 2.6 mi. Turn slightly left onto Cimarron Rd (CR-796) for 3.9 mi. Turn right onto CR-796A for 1.9 mi. Arrive at location. Site is on the right			
Release Data:						
Date Released:		4/22/2010

Re: Closure Report ConocoPhillips James A Battery Line Release Unit Letter J, Section 2, Township 22 South, Range 30 East Eddy County, New Mexico 2RP-406 Incident ID nMLB1011352696

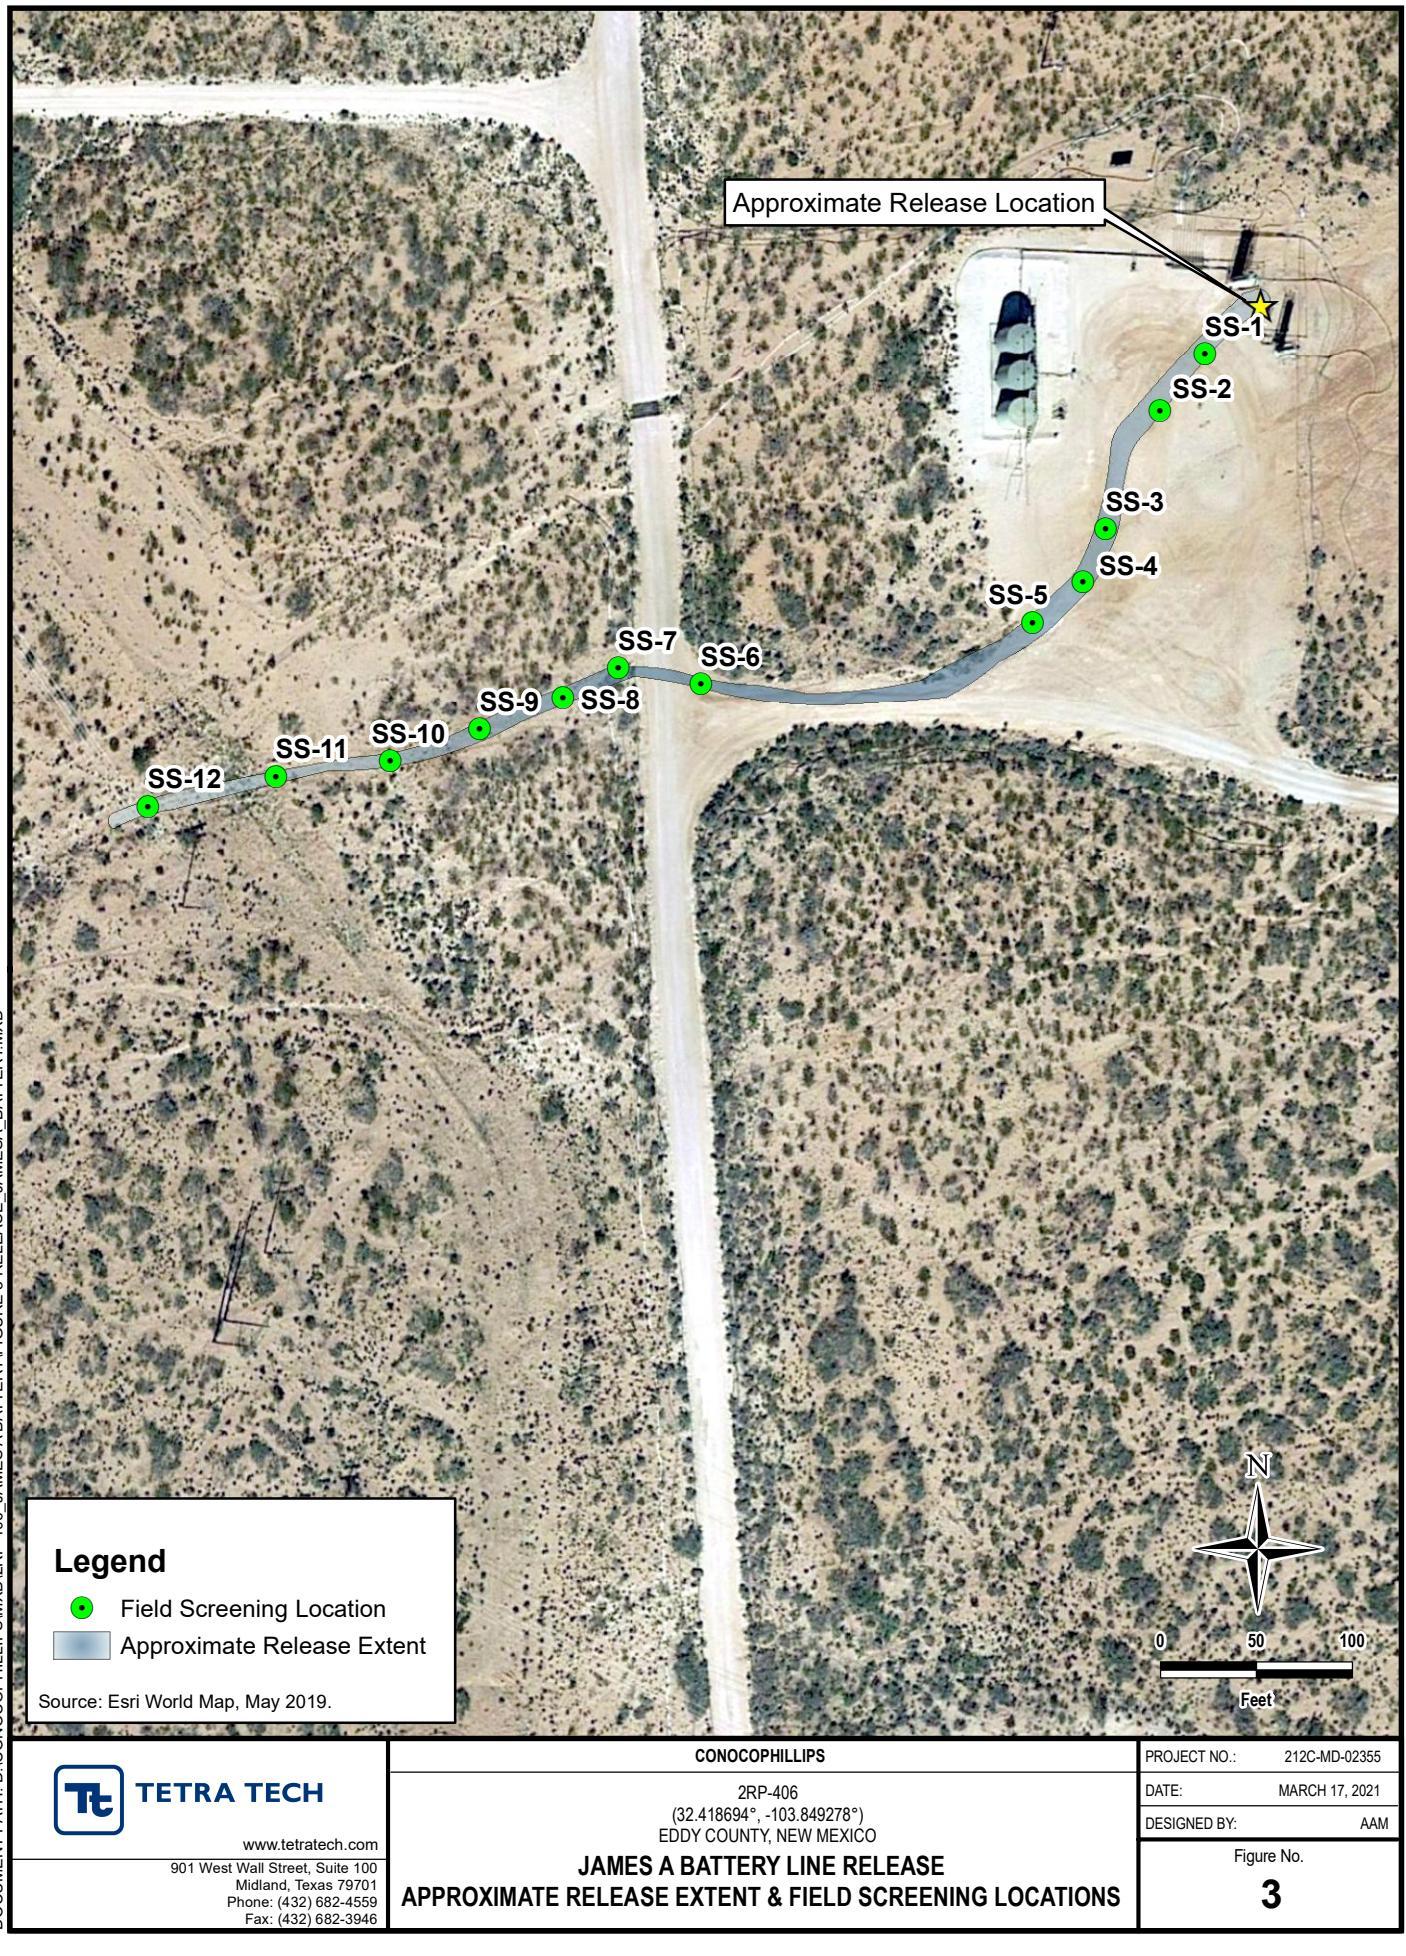
Figure 3 – Approximate Release Extent & Field Screening Locations

A file search on the NMOCD Online Imaging web application revealed no records of investigation, assessment, or remediation activities taken at the Site, nor communications between agencies regarding the 2RP-406 release. The reported release point from the C-141 is in the pasture east of the battery pad. Based on a review of available historical aerial imagery, the approximate release point occurred approximately 515 ft west-northwest of the coordinates provided on the initial C-141. A cursory review of aerial imagery from October 2010 indicated an approximate footprint that matched the extent described in the initial C-141 (Figure 3).

parts per million (ppm) to 850 ppm. Salinity concentrations measured in soils associated with the remaining nine (9) production pad and pasture locations (SS-4 through SS-12) ranged from 100 ppm to 228 ppm. The field screening results from locations SS-4 through SS-12 indicate salinity concentrations which could be inferred as concentrations below the Site RRAL of 600 mg/kg. The field screening results in this area are likely attributed to undocumented remedial actions conducted in the off-pad portions of the former release footprint. Conversely, the salinity concentrations in SS-1 through SS-3 potentially indicate chloride concentrations slightly above the Site RRAL on the battery production pad.

However, the Site is located in an area with abundant potash reserves, and so naturally occurring soluble mineral salts such as sylvite (KCI) would lead to natural variations of chloride in the soils of the region. Given the age of the release and the naturally occurring mineral salts in soil concentrations at depth, there is no evidence that the elevated salinity concentrations on the active battery production pad are attributable to the 2RP-406 release.

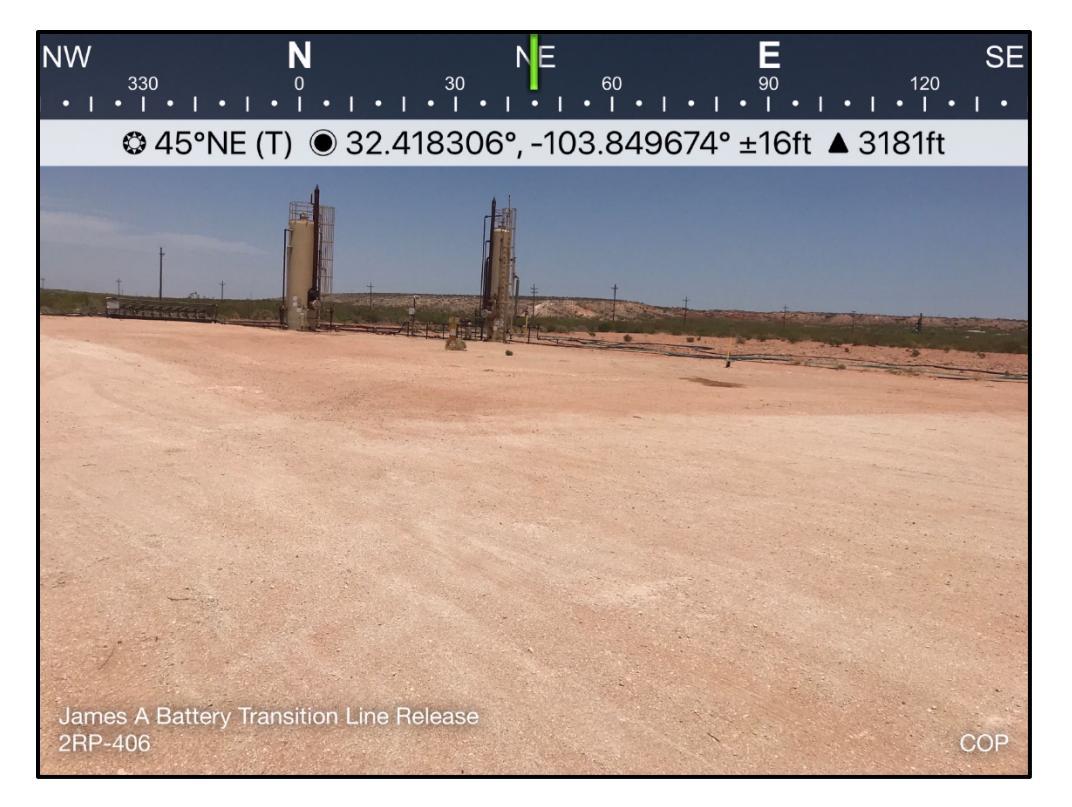
TETRA TECH, INC. PROJECT NO. 212C-MD-02355	DESCRIPTION	View facing northeast of former release area on production pad from visual Site inspection. Release Location: 32.418694°, -103.849278°	1
	SITE NAME	James A Battery Line Release	6/11/2020

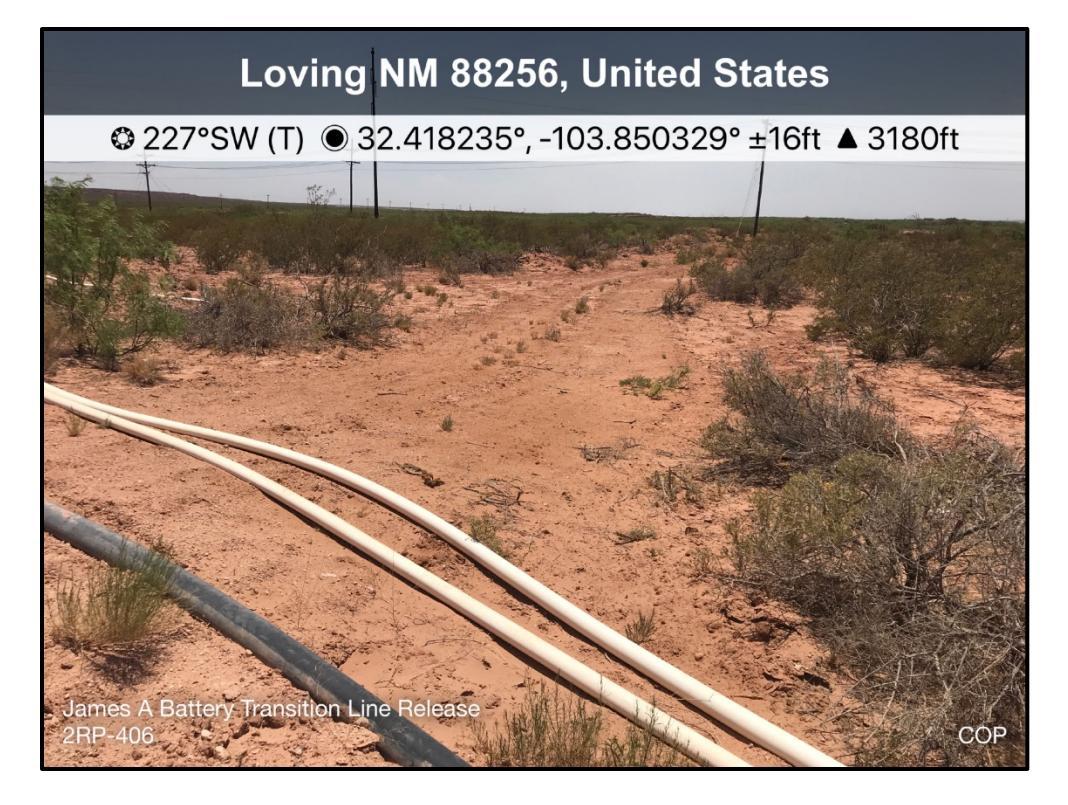
TETRA TECH, INC. PROJECT NO.	DESCRIPTION	View facing southwest of flowlines in the former release area in the pasture. No stained or odorous soils observed during the visual Site inspection.	2
212C-IMD-02355	SITE NAME	James A Battery Line Release	6/11/2020

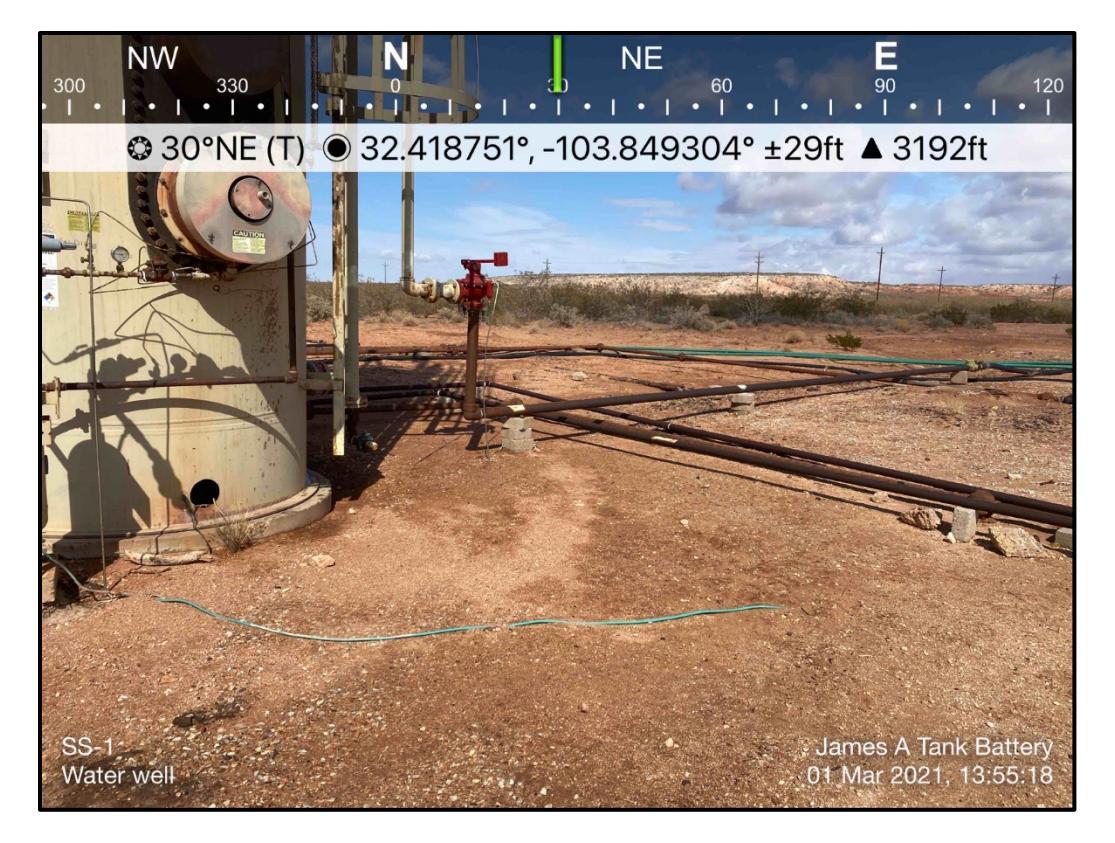
TETRA TECH, INC. PROJECT NO. 212C-MD-02355	DESCRIPTION	View facing NE of SS-1 soil screening location on production pad.	3
	SITE NAME	James A Battery Line Release	3/1/2021

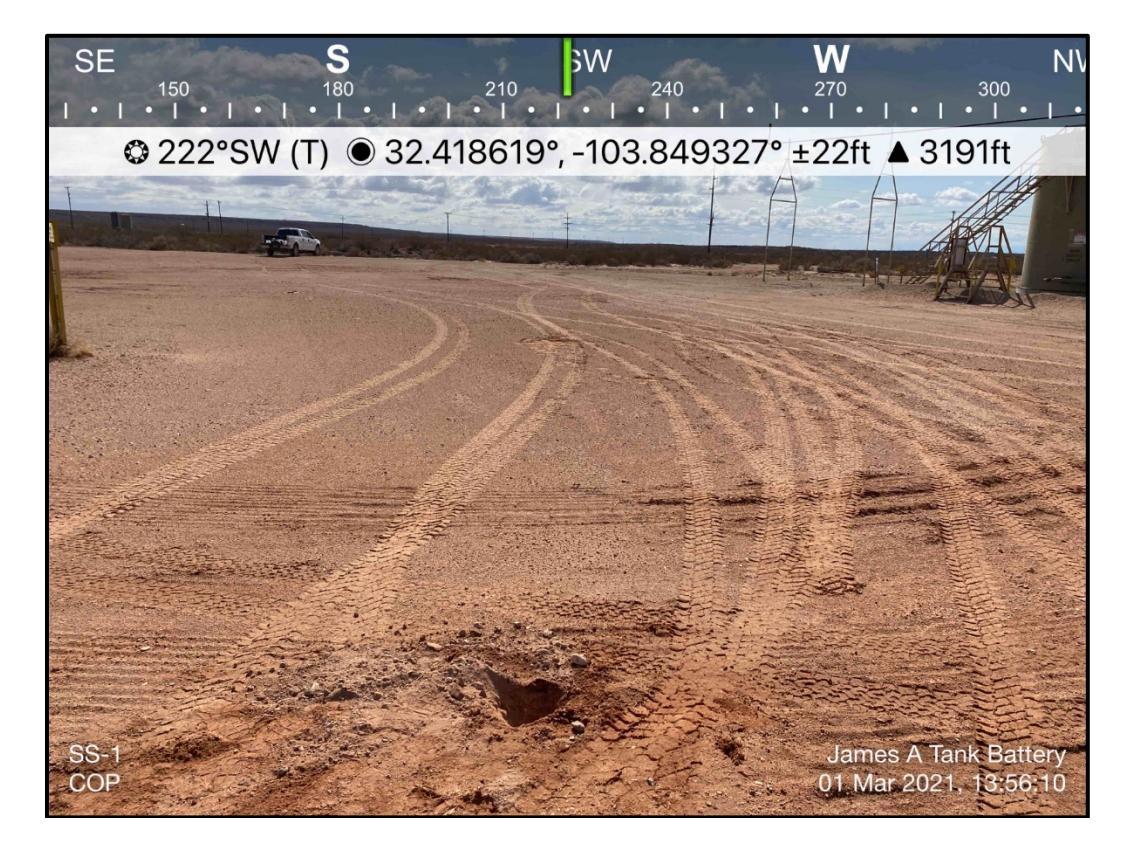
TETRA TECH, INC.	DESCRIPTION	View facing SW from SS-1 soil screening location of production pad.	4
212C-MD-02355	SITE NAME	James A Battery Line Release	3/1/2021

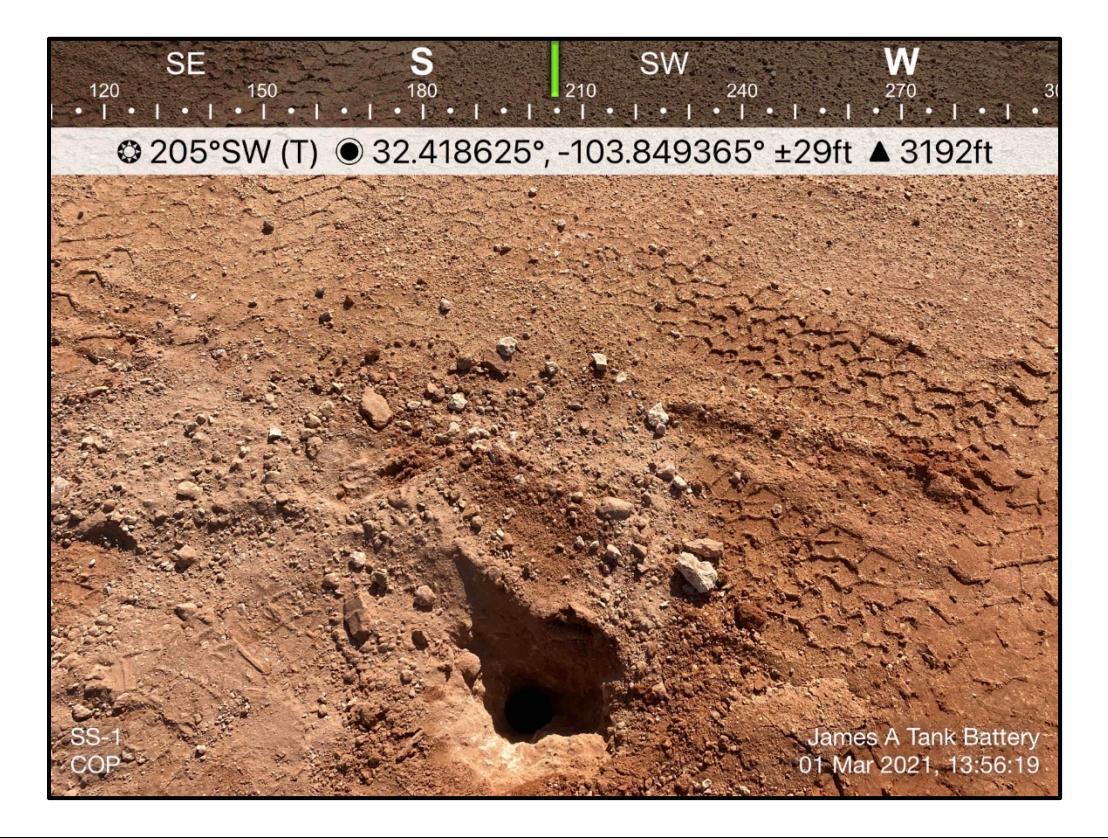
TETRA TECH, INC. PROJECT NO. 212C-MD-02355	DESCRIPTION	Oblique view of SS-1 soil screening location.	5
	SITE NAME	James A Battery Line Release	3/1/2021

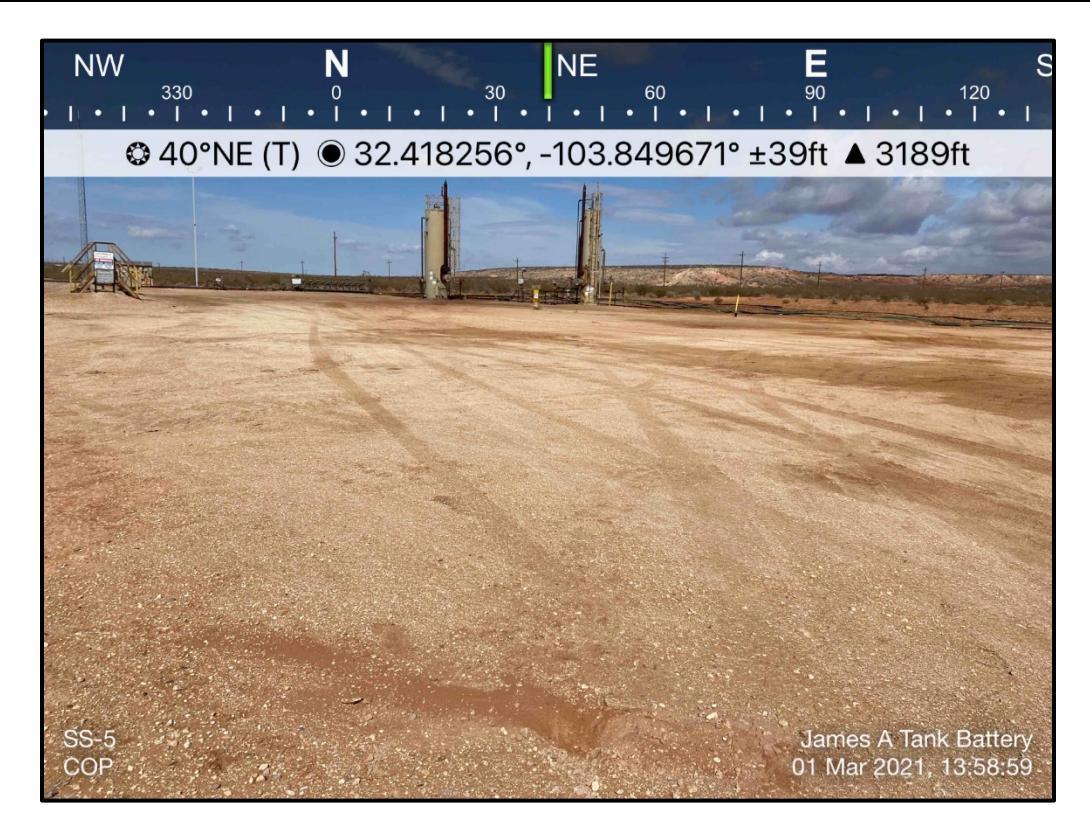
TETRA TECH, INC. PROJECT NO. 212C-MD-02355	DESCRIPTION	View facing NE of SS-5 soil screening location on production pad.	6
	SITE NAME	James A Battery Line Release	3/1/2021

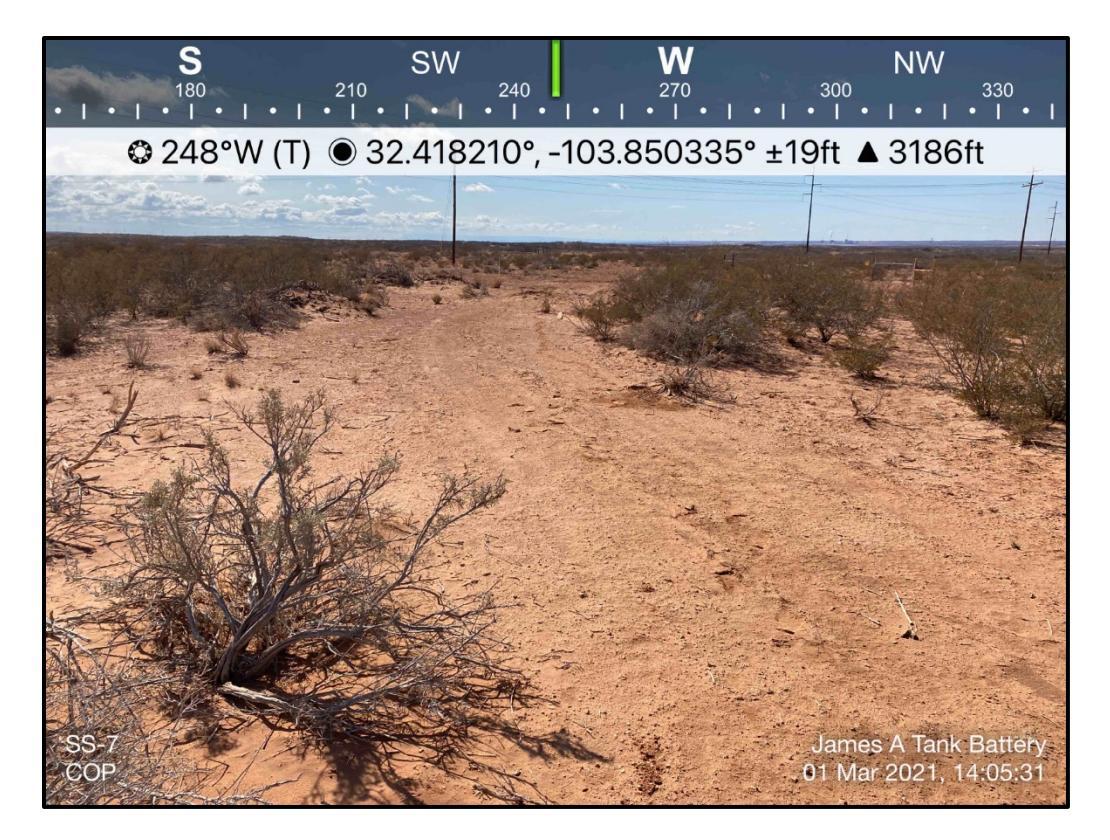
TETRA TECH, INC. PROJECT NO. 212C-MD-02355	DESCRIPTION	View facing SW of SS-7 soil screening location in pasture near SW of production pad.	7
	SITE NAME	James A Battery Line Release	3/1/2021

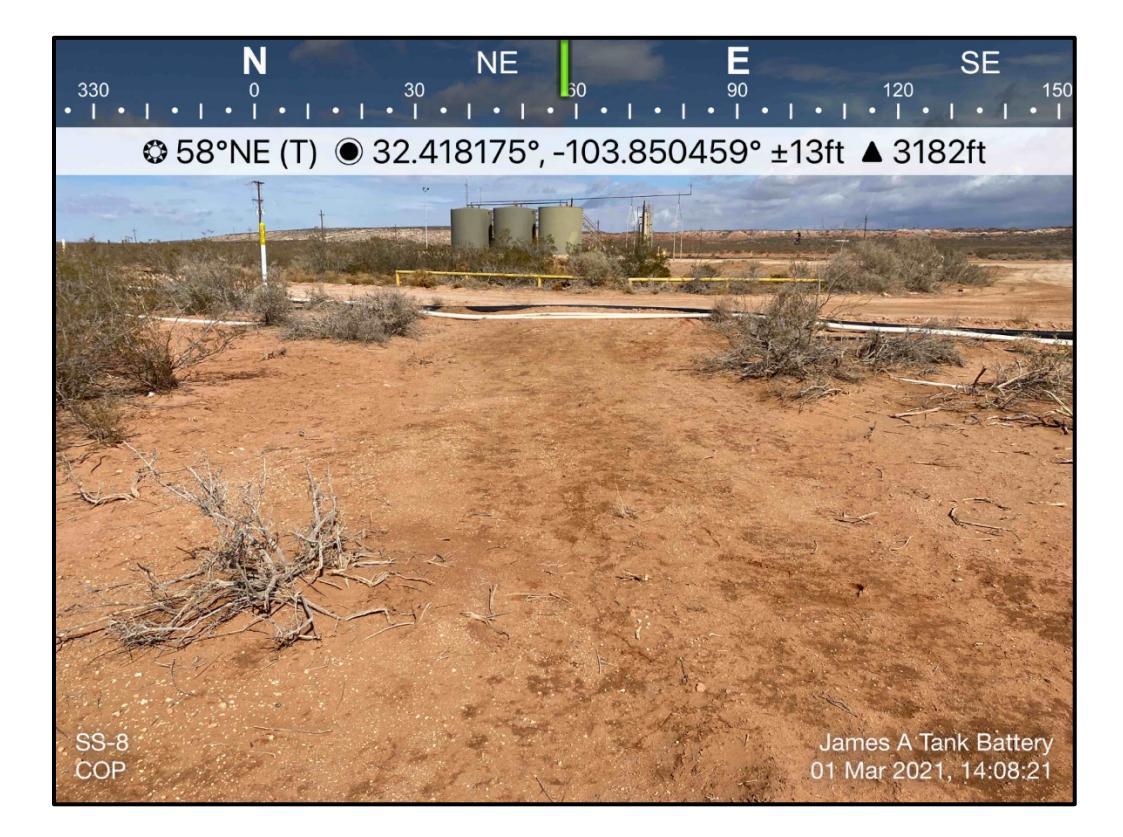
TETRA TECH, INC.	DESCRIPTION	View facing NE of SS-8 soil screening location in pasture, note production pad in background.	8
212C-MD-02355	SITE NAME	James A Battery Line Release	3/1/2021

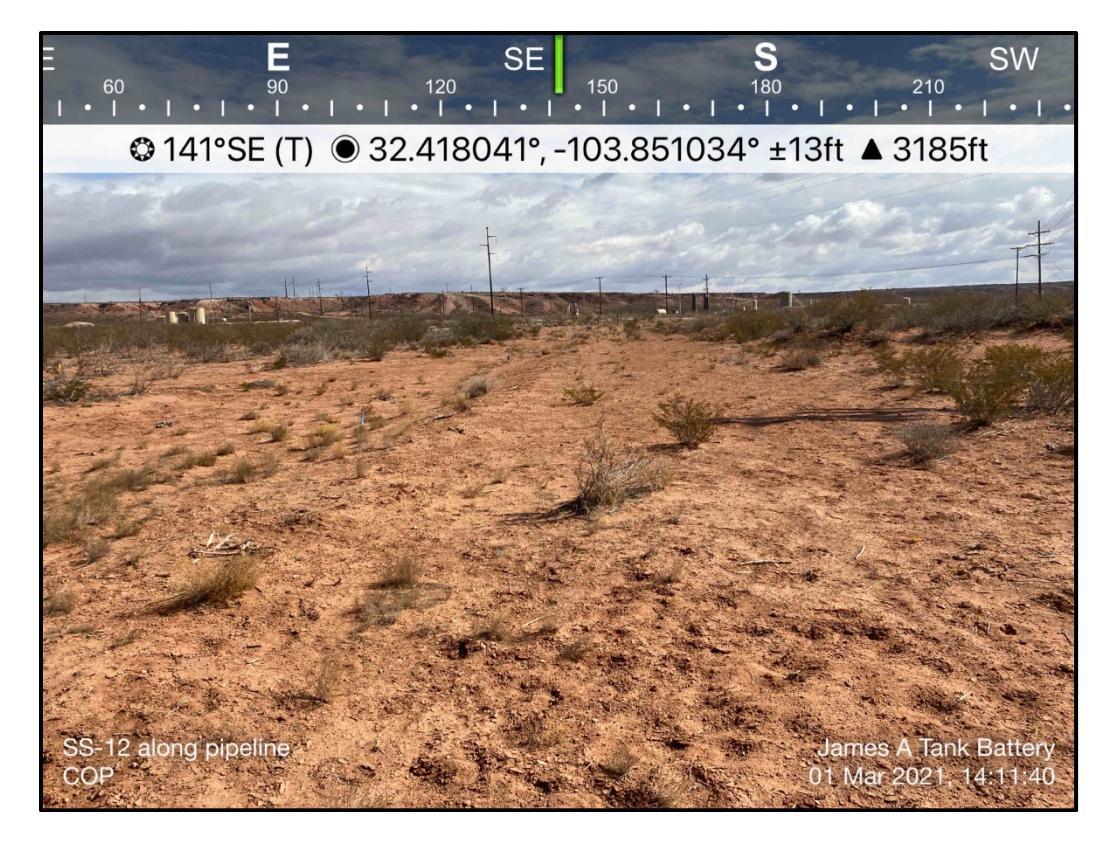
TETRA TECH, INC. PROJECT NO. 212C-MD-02355	DESCRIPTION	View facing SE of SS-12 soil screening location in pasture near SW of production pad.	9
	SITE NAME	James A Battery Line Release	3/1/2021

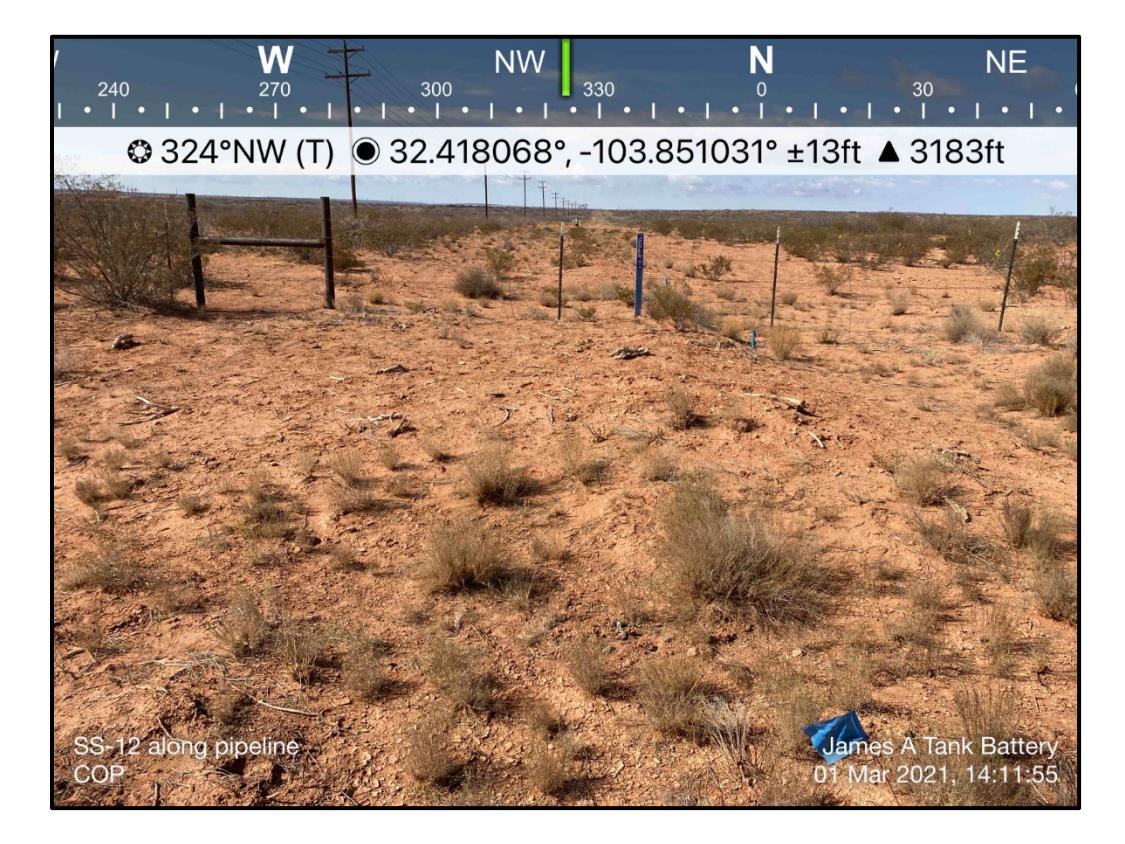
TETRA TECH, INC. PROJECT NO. 212C-MD-02355	DESCRIPTION	View facing NW of SS-12 soil screening location in pasture near SW of production pad.	10
	SITE NAME	James A Battery Line Release	3/1/2021
