Form C-147
Revised April 3, 2017

Recycling Facility and/or Recycling Containment

Type of Facility: ☒ Recycling Facility ☒ Recycling Containment*
Type of action: ☐ Permit ☐ Registration **Extension from 09/20/2023 to 09/20/2024**
☐ Modification ☒ Extension
☐ Closure ☐ Other (explain)

Enduring Resources is requesting a permit extension for the NEU 2207-16B (3RF-28) Water Recycling Facility. In accordance with 19.15.34.10.C NMAC, *“Registered recycling containments may be operated for five years from the date on which the registration is filed with the division. The operator may extend the allowed time on an annual basis thereafter with division approval if, 30 days prior to the registration expiration, the operator files a form C-147 with an attached summary showing all monthly inspections at the containment, including the monitoring of the leak detection system, showing the containment’s integrity has not been compromised.”*

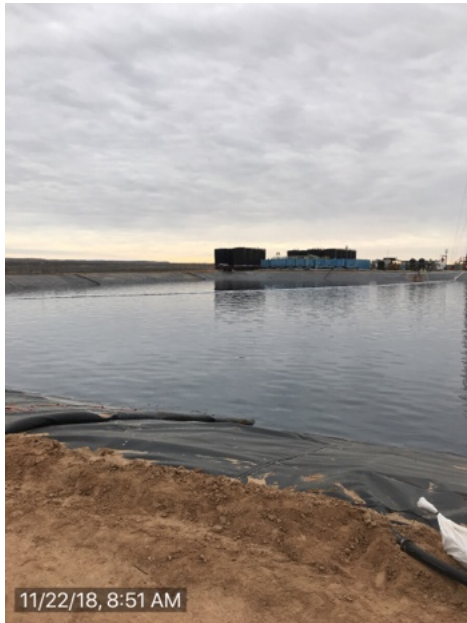
Question	Response	Details
Leak detection was checked, and does not show signs of a release	No	Water in leak detection at 53.55 feet.

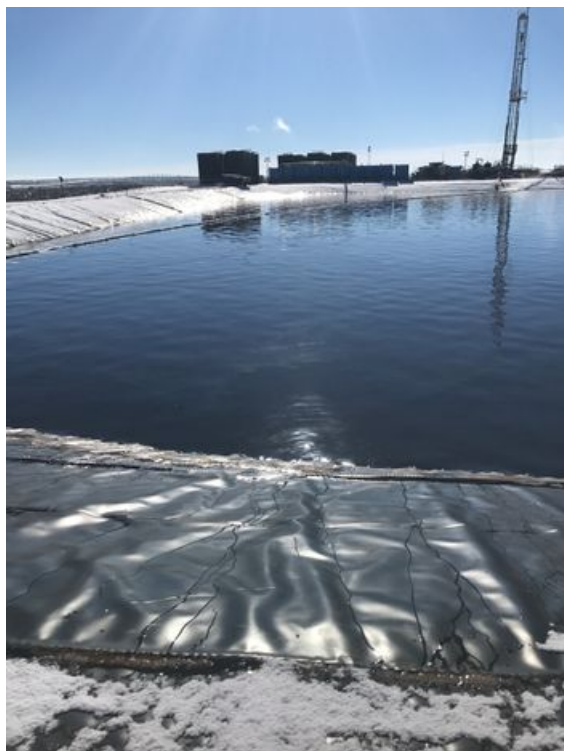
Photo 1

Leak detection had water. Level was at 53.5. Level did not Increase
