**From:** Bratcher, Mike, EMNRD  
**Sent:** Thursday, February 06, 2014 10:07 AM  
**To:** 'jwlowry@basinenv.com'; TASavoie@BassPet.com; SJWalters@BassPet.com  
**Cc:** bblackwood@basinenv.com  
**Subject:** RE: BOPCO's PLU #188Y Injection Line Release -- Line and Backfill Exc. #3

**From:** Joel Lowry <jwlowry@basinenv.com>  
**Sent:** Tuesday, February 04, 2014 7:17 AM  
**To:** Bratcher, Mike, EMNRD; TASavoie@BassPet.com; SJWalters@BassPet.com  
**Cc:** bblackwood@basinenv.com  
**Subject:** BOPCO's PLU 188Y -- Permission to Backfill Excavated Areas adjacent to Fiberglass Injection Line  
**Attachments:** BOPCO's PLU #188Y Information Packet.pdf

Please find attached an information packet that has been prepared for BOPCO's PLU # 188Y produced water release. The release site is located in U/L "D", Sec. 5, Township 24S, Range 30E at 32.25180 North -103.90868 West. The release was attributed to the failure of a section 3" high-pressure fiberglass injection line.

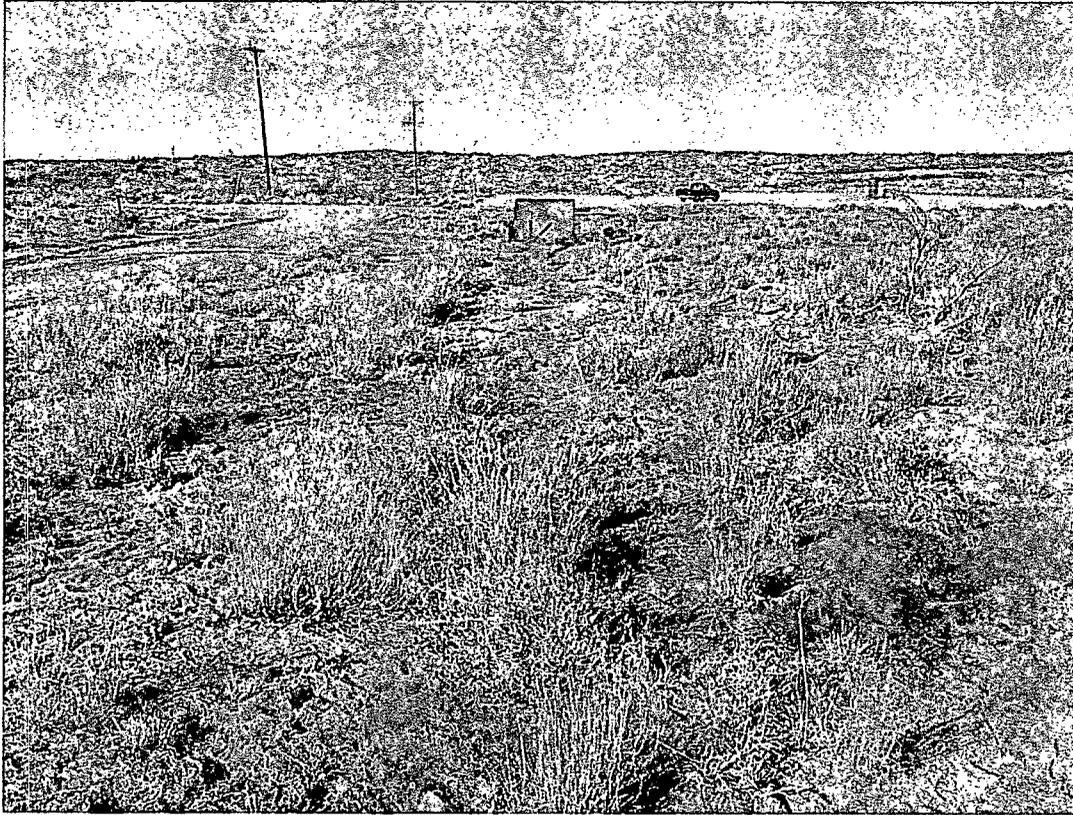
Photograph the initial release at the PLU #188Y Release Site.

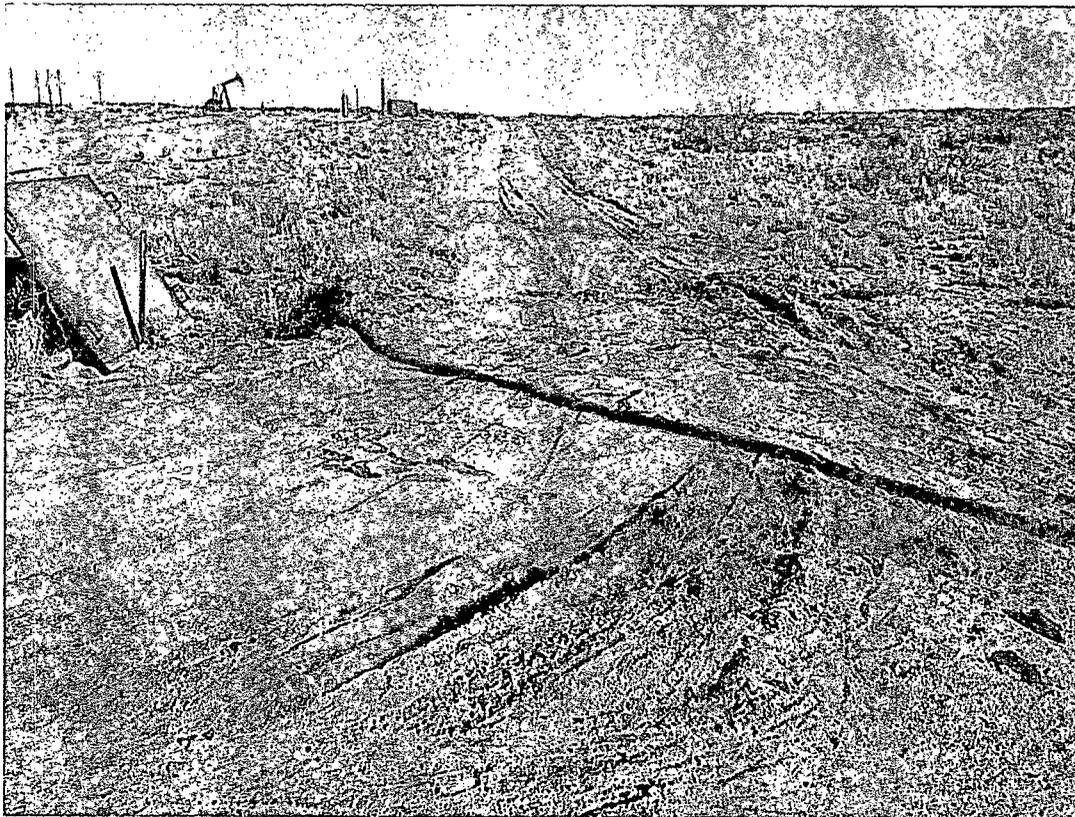
Photograph the initial release and primary pooling area at the PLU #188Y Release Site.

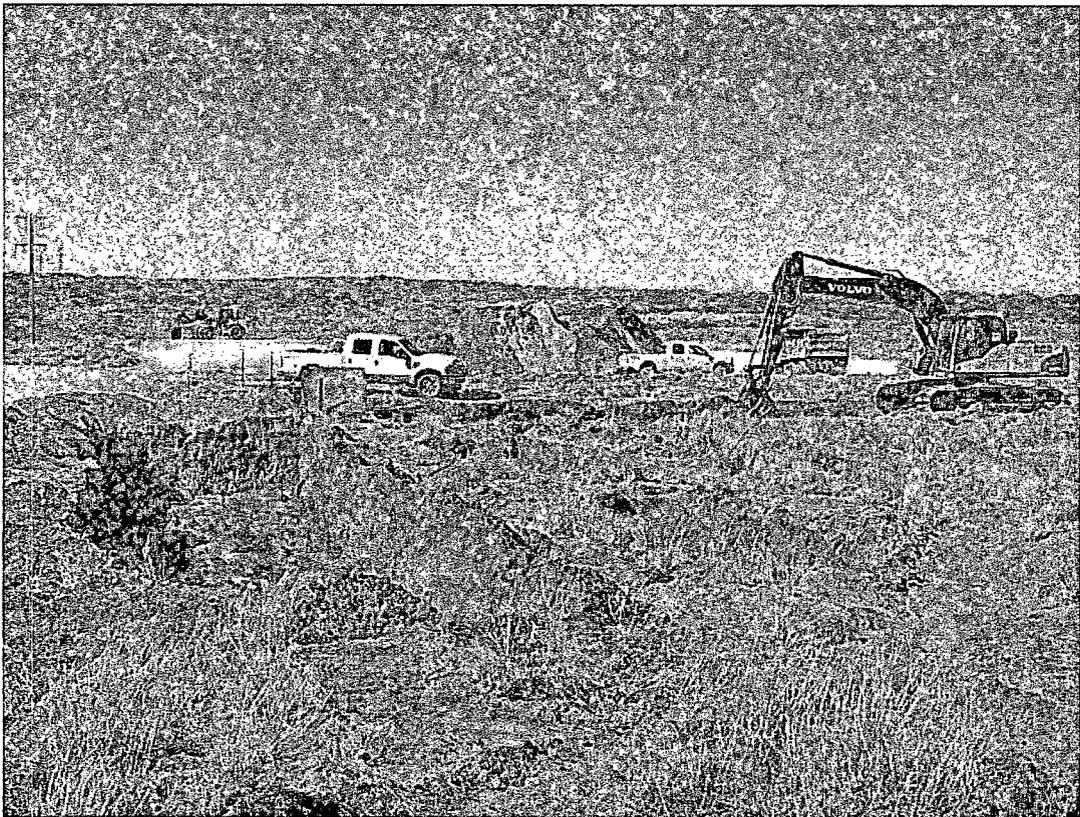
On January 27, 2014, Basin began excavating a pooling area west of the release point, located atop multiple active pipelines. Excavation sidewalls were advanced until field tests suggested concentrations of BTEX, TPH and chloride were below NMOCD Regulatory Standards. An approximate 3' buffer of undisturbed soil was left in-situ on one or both sides of all active pipelines as a safety precaution. The floors of the resulting excavations were advanced until concentrations of chloride were below NMOCD Regulatory Standards or to the maximum extent practicable given the congested nature of the active pipelines, instability of the sand and need for appropriated benches. The final dimensions of Exc. 3 were approximately 42' in length, 20' in width and 6' in depth. The final dimensions of Exc. 4 were approximately 70' in length, 15' in width and 4' in depth.

Photograph of the excavations #3, #4, #4b and #4c at the PLU #188Y Release Site.

As per our phone conversation, a 20-Millimeter Polyurethane Liner will be installed in the floor of Excavation #3 at the current depth of approximately 6' bgs. Upon installing the liner, the excavation will be backfilled with locally purchased, non-impacted material. Remaining open excavations east of Regency's 6" gas line will also be backfilled with locally purchased, non-impacted material. If you have any questions or need any additional information, please feel free to contact me by phone or email. Thanks.

Due to the congested nature of the active pipelines and soil instability, BOPCO requests permission to backfill the excavated areas within the pipeline right-of-ways with non-impacted material without delay. If you have any questions or need any additional information, please feel free to contact myself or Jody Walters by phone or email. Jody has indicated that he may be following up with you shortly. Thanks.

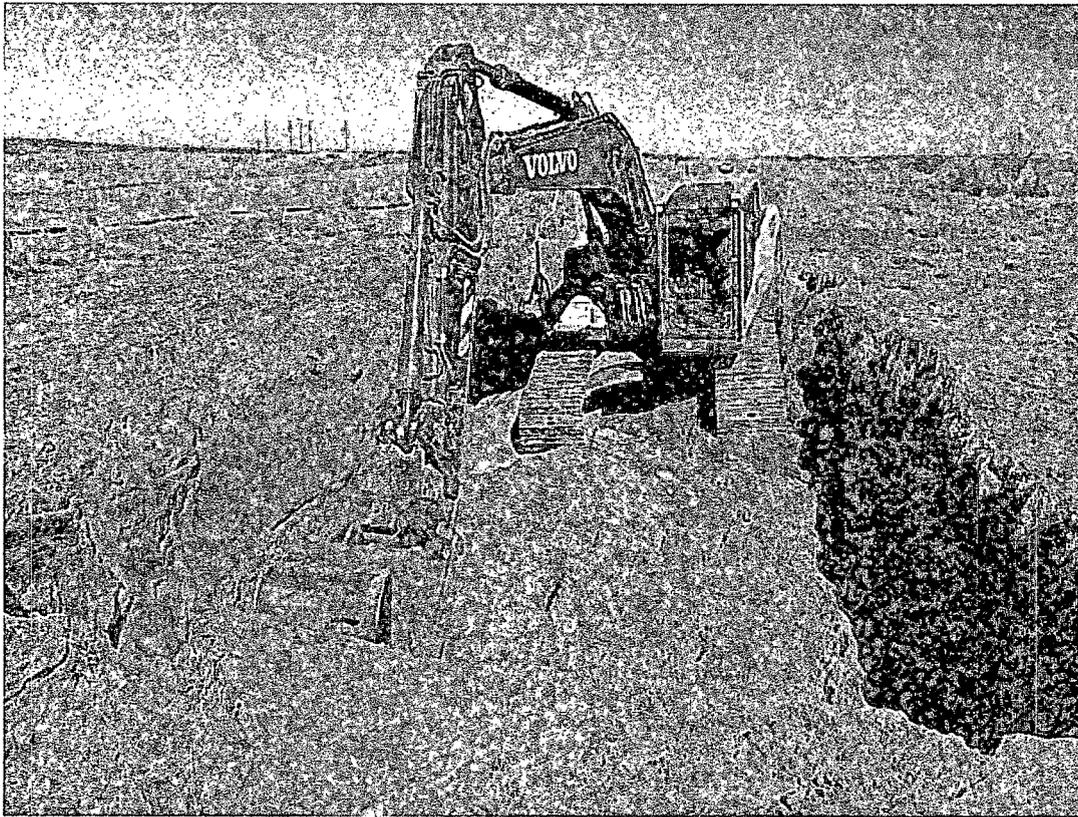
On January 28, 2014, a series of test trenches (Exc. 3 TT and Exc. 4 TT) were advanced within the areas exhibiting chloride concentrations above NMOCD Regulatory Standards in an effort to determine the vertical extent of soil impact. Test Trench Exc. 3 TT was advanced in the floor of Exc. 3 to approximately 18' bgs. During the advancement of the test trench, soil samples were collected at 8', 12' 16' and 18' bgs and submitted to the laboratory for analysis of chloride concentrations. Laboratory analytical results indicated chloride concentrations ranged from 17,000 ppm for the soil sample collected at 12' bgs to 96.0 ppm for the soil sample collected at 18' bgs. Test Trench Exc. 4 TT was advanced in the floor of Exc. 4 to approximately 18' bgs. During the advancement of the test trench, soil samples were collected at 4', 8' 12' and 18' bgs and submitted to the laboratory for analysis of chloride concentrations. Laboratory analytical results indicated chloride concentrations ranged from 6,000 ppm for the soil sample collected at 8' bgs to 928 ppm for the soil sample collected at 18' bgs. Laboratory analytical results suggest soil containing concentrations of chloride above NMOCD Regulatory Standards does not extend below 18' bgs in the areas of Exc. 3 and Exc. 4. Laboratory results for TPH analysis of soil samples Exc. 3 TT @ 8' and Exc. 4 TT @ 4' are still pending; field tests suggest they are below NMOCD Regulatory Standards. Additionally, field test results suggest chloride concentrations in soil samples Exc. 4b Floor @ 4'. Exc. 4c Floor @ 4' and Exc. 4 East Floor were below NMOCD Regulatory Standards.

Photograph the advancement of the Test Trench within Excavation #3 at the PLU #188Y Release Site.
