From: Amy Ruth <aruth@diversifiedfsi.com>
Sent: Friday, October 11, 2013 9:45 AM
To: Bratcher, Mike, EMNRD
Cc: SJWalters@BassPet.Com; Michael Patterson; Stephen McGhee
Subject: RE: Concern about BOPCO PLU #139

Site Diagram with Field Sample Data

BOPCO PLU #139
2RP-901
 UL/J, Sec 24, T24S R30E
 Eddy County, NM
 Drafted By: A.C. Ruth, 10/9/13
 Not to Scale

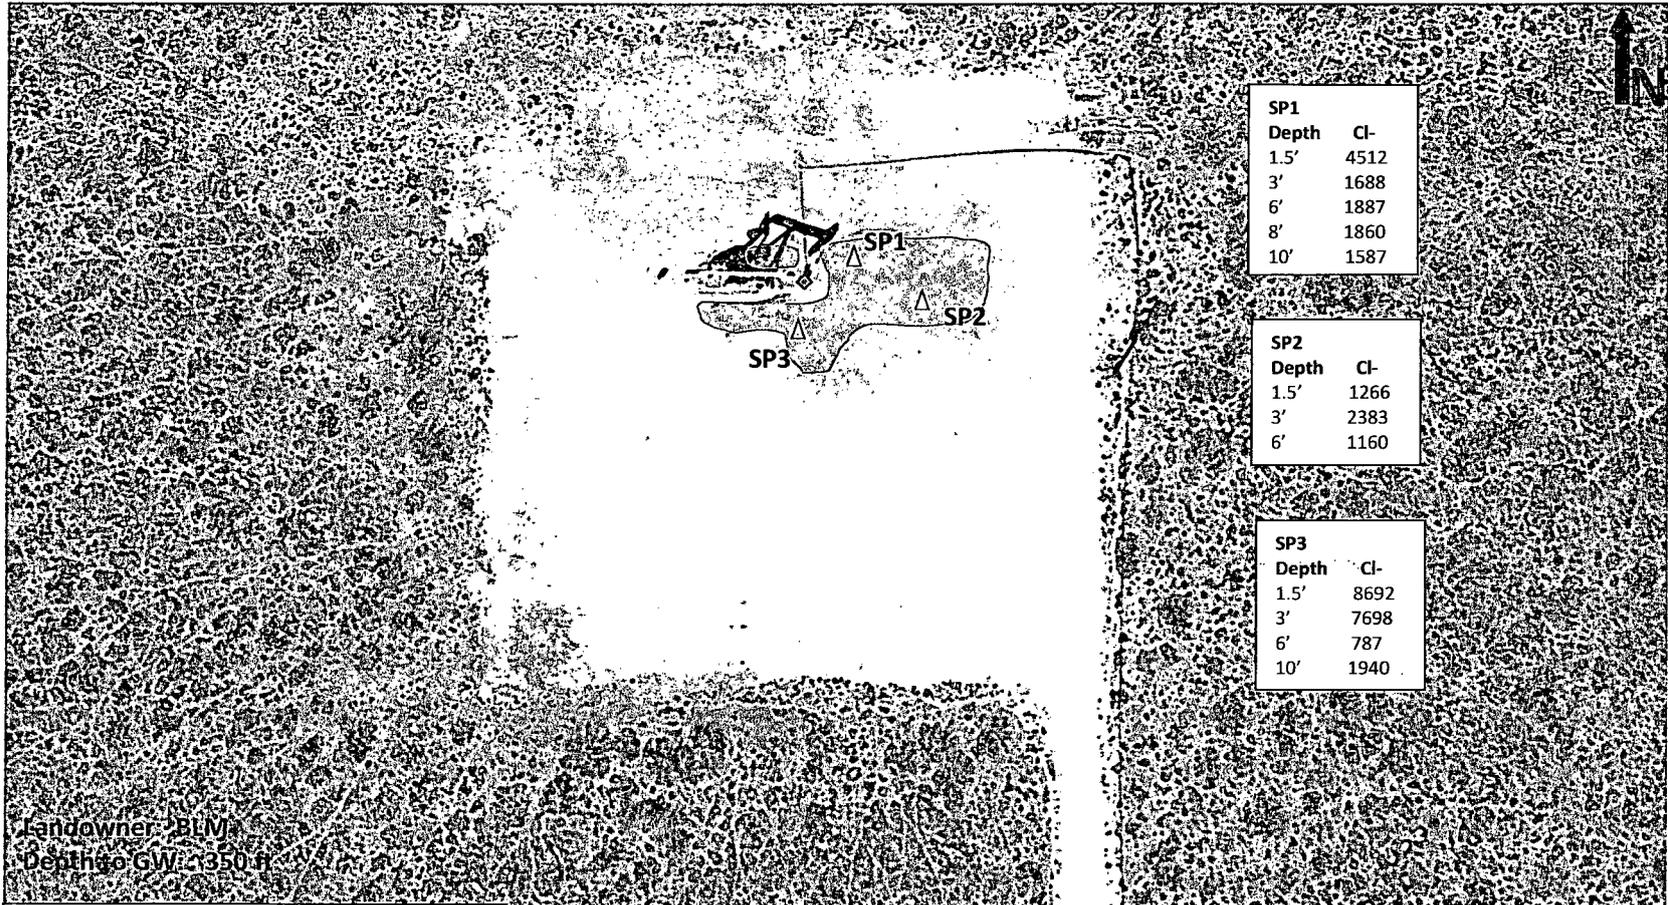
I just left you a voicemail because I've got a situation on the BOPCO PLU #139 and need to ask for your advice. At this site, I delineated the leak in the field using Standard Method 4500 cl- B, as always (field data is on the attached plat). The site was excavated to 3' bgs, a 20 mil liner was installed, one of the 3 sample points (SP3) was installed with a PVC pipe for possible drilling, and the excavation was backfilled. I realized today that I had inadvertently disposed of the samples for this site without submitting them to the lab.

SP1		
Depth	CI-	
1.5'	4512	
3'	1688	
6'	1887	
8'	1860	
10'	1587

SP2		
Depth	CI-	
1.5'	1266	
3'	2383	
6'	1160

SP3		
Depth	CI-	
1.5'	8692	
3'	7698	
6'	787	
10'	1940

Landowner: BLV
 Depth to GW: 350 ft

Thank you so much for your assistance with this site. Per our discussion this morning, BOPCO will drill the site at SP3 to delineate that point. Due to the problem with the unavailable lab data and the difficulty of retrieving new samples from under the liner, our field data along with drilling lab data at SP3 will be sufficient in this case. Again, thanks and talk to you soon.
