### Report Type: Work Plan

<b>Site:</b>	Electra Federal #5 - Water Line	
<b>Company:</b>	COG Operating LLC	
<b>Section, Township and Range</b>	Unit A - Section 21 - Township 17S - Range 30E	
<b>Lease Number:</b>	30-015-34211	
<b>County:</b>	Eddy County	
<b>GPS:</b>	32.82343	103.96848
<b>Surface Owner:</b>	Federal	
<b>Mineral Owner:</b>		
<b>Directions:</b>	From the intersection of Hwy 82 and CR-219 in Loco Hills, travel north on CR-219 for 0.4 mi, turn right (east) go 0.5 miles to Well pad (Apache El Federal #10, spill area is located approx. 300' SE of well pad.

**Re: Work Plan for the COG Operating LLC., Electra Federal #5 Flow line, Unit A, Section 21, Township 17 South, Range 30 East, Eddy County, New Mexico.**

Electra Federal #5  
Spill Assessment Map

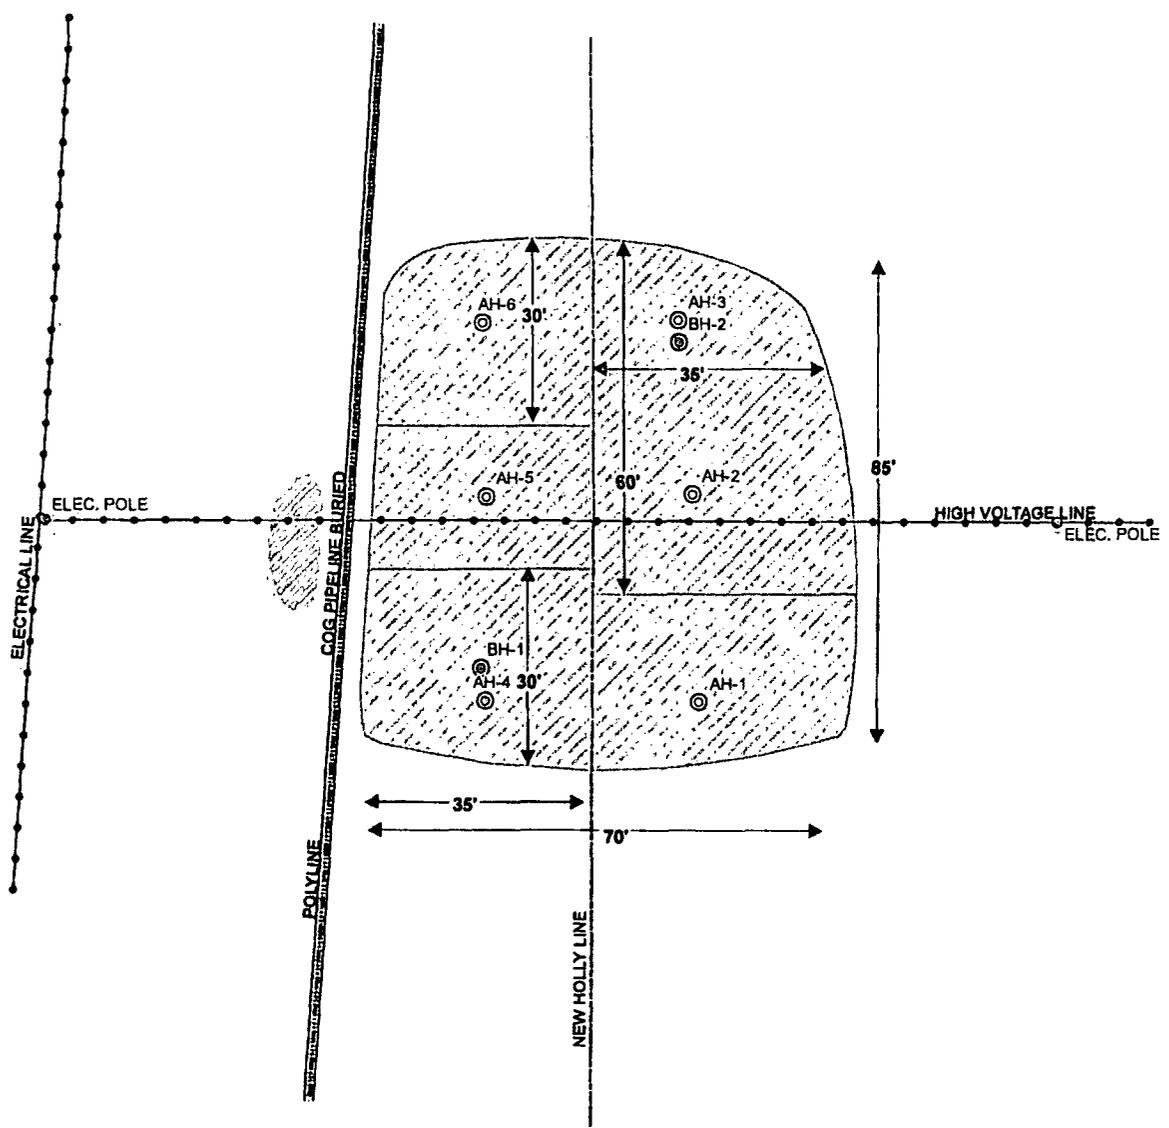
Figure 3

On December 7, 2010, Tetra Tech personnel inspected and sampled the spill area. Six auger holes (AH-1 through AH-6) were installed using a stainless steel hand auger to assess the impacted soils. Select samples were analyzed for TPH analysis by EPA method 8015 modified, BTEX by EPA Method 8021B and chloride by EPA method 300.0. Copies of laboratory analysis and chain-of-custody documentation are included in Appendix C. The sampling results are summarized in Table 1. The auger hole locations are shown on Figure 3.

Referring to Table 1, all submitted samples were below the RRAL for TPH and BTEX. Elevated chloride concentrations were detected in the majority of the auger holes. Auger hole (AH-1) did not show chloride impact to the soils. The areas of AH-5 and AH-6 showed a shallow impact to the soils, which were vertically defined at 1.0' and 4.0', respectively. The remaining auger holes (AH-2, AH-3 and AH-4) showed chloride impact which was not vertically defined.

personnel supervised the installation of two (2) boreholes (BH-1 and BH-2) utilizing an air rotary rig. The results of the sampling are summarized in Table 1. The borehole locations are shown on Figure 3.

Referring to Table 1, a deeper chloride impact was encountered in the areas of BH-1 and BH-2. In the area of borehole (BH-1), the chloride concentration spiked at 15.0' with a concentrations of 13,500 mg/kg, which declined with depth to 225 mg/kg at 60.0' below surface. In addition, borehole (BH-2) spiked at 7.0' with a concentration of 13,300 mg/kg and declined with depth to <200 mg/kg at 70.0' below surface.
