GW-401

Re: Discharge Plan Submittal Request (Designated GW-401)
Integrity Testing report.
Exterran, 1280 Troy King Road, Farmington, N.M. 87401
Section 12, Township 29 North, Range 14 West NMPM

September 2, 2010

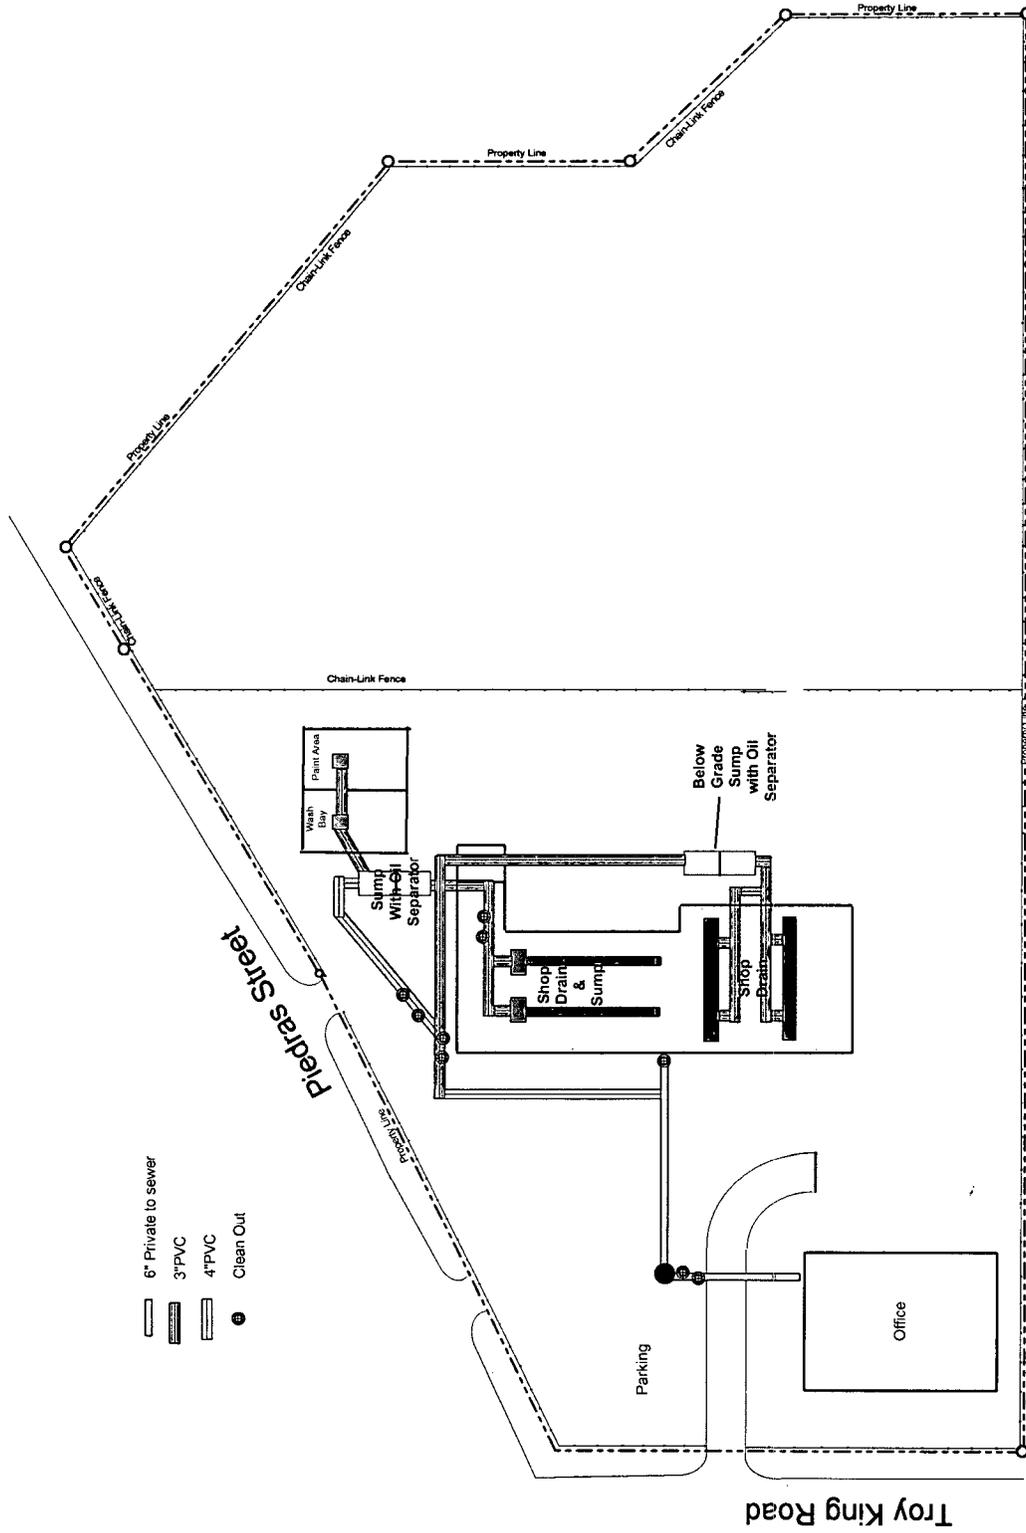
1. Exterran's submittal identified the areas for testing: Area #1 (Main shop), Area #2 (Main Shop), Area #3 (Exterior Sump Drain Discharge line) and Area # 4 (Wash bay 1 & 2 and Sump # 3). OCD cannot identify any of these locations on the submitted attached drawing for the Exterran facility. OCD does not want to assume these areas, please submit another drawing or give information on which lines were identified within the drawing.
1. See attached revised facility map.
2. Please annotate the operating pressure for these lines tested, or note if they operate under atmospheric pressure.
2. Atmospheric testing
3. OCD does not understand pressure testing of a sump to 3 lbs/sqr inch., explain.
3. The drain lines we're pressure tested and sump in the shops and below grade tanks were hydrostatic/ atmospheric tested.

Area # 1 ?
Area # 2 ?
Area # 3 ?
Area # 4 ?
