RE: **Investigation and Characterization Plan  
Rice Operating Company – Vacuum SWD System  
Vacuum F-34 Boot UL F, Sect 34, Township 17S, Range 35E**

## Rice Operating Company – VAC F-34 Boot

## RICE OPERATING COMPANY JUNCTION BOX DISCLOSURE REPORT

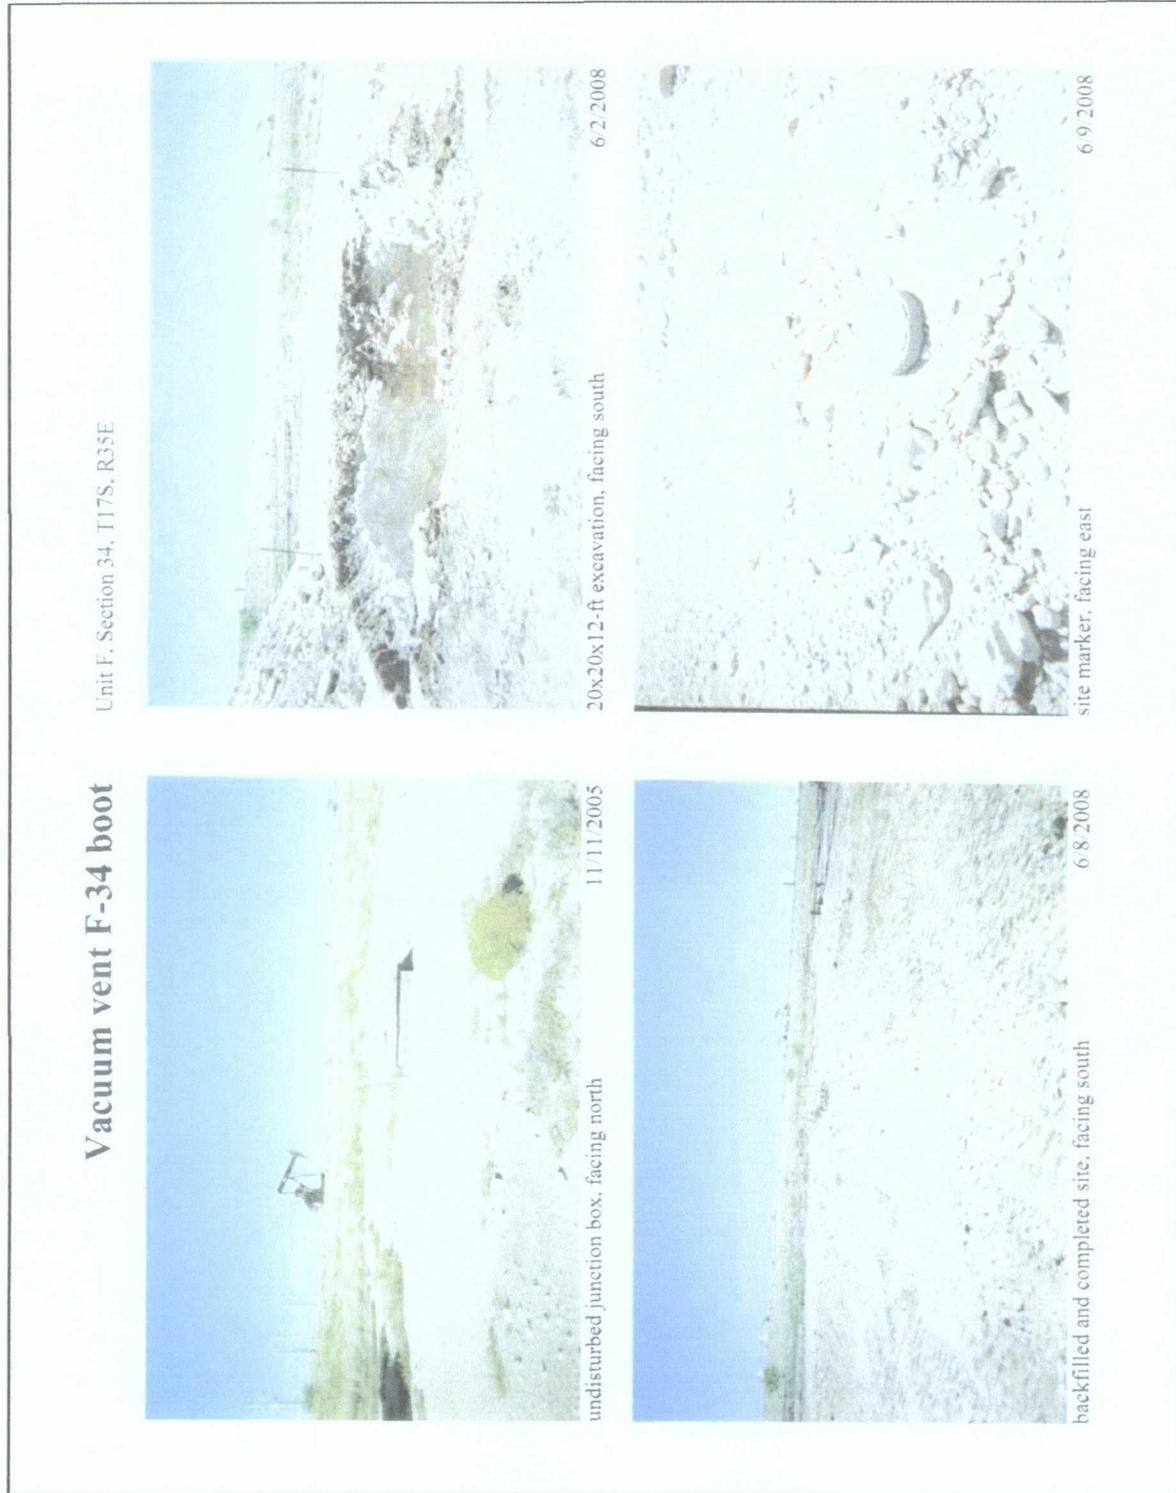
The excavated soil was blended on site, backfilled into the excavation and then contoured to the surrounding terrain (Figure 3). The site was subsequently reseeded to a native prairie mixture. An identification plate was placed on the surface to mark this location for future environmental considerations.

Figure 3 – VAC F-34 Boot photographs taken before and during junction box removal.
