RE: Investigation and Characterization Plan
Rice Operating Company – BD SWD System
BD 0-23 Junction Box UL O, Sect 23, Township 21S, Range 37E

Figure 2 – BD O-23 Junction Box Disclosure Report

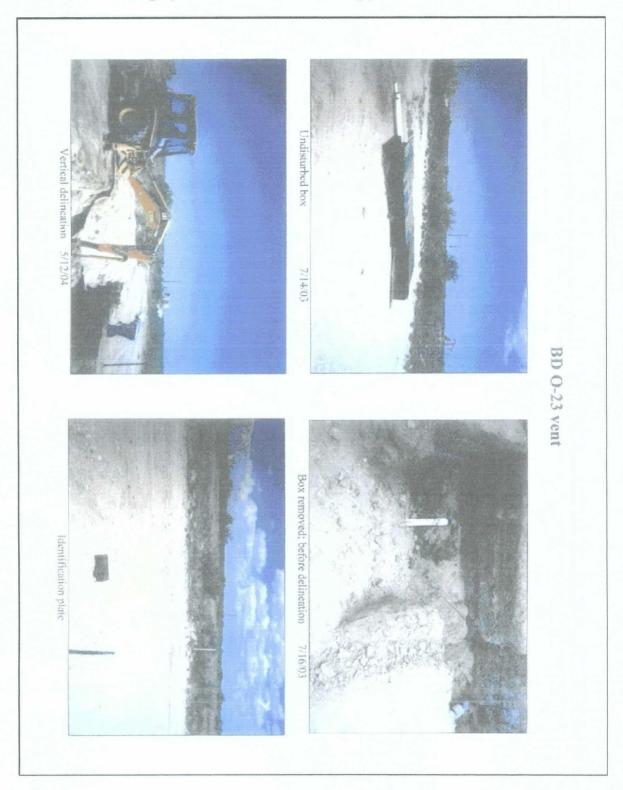
APPENDIX – Photographs taken before and during junction box removal.
