**MODIFICATION
SITE
ASSESSMENT**

**RE: Request for Additional Information - Surface Waste Management Facility Landfill
Permit Application Review
Artesia Aeration: Permit NM-1-0011
Location: Sections 5, 6, and 7, Township 17South, Range 32 East, NMPM
Lea County, New Mexico**

**Groundwater Investigation Report
Artesia Aeration
Section 7, Township 17S, Range 32E
Lea County, New Mexico**

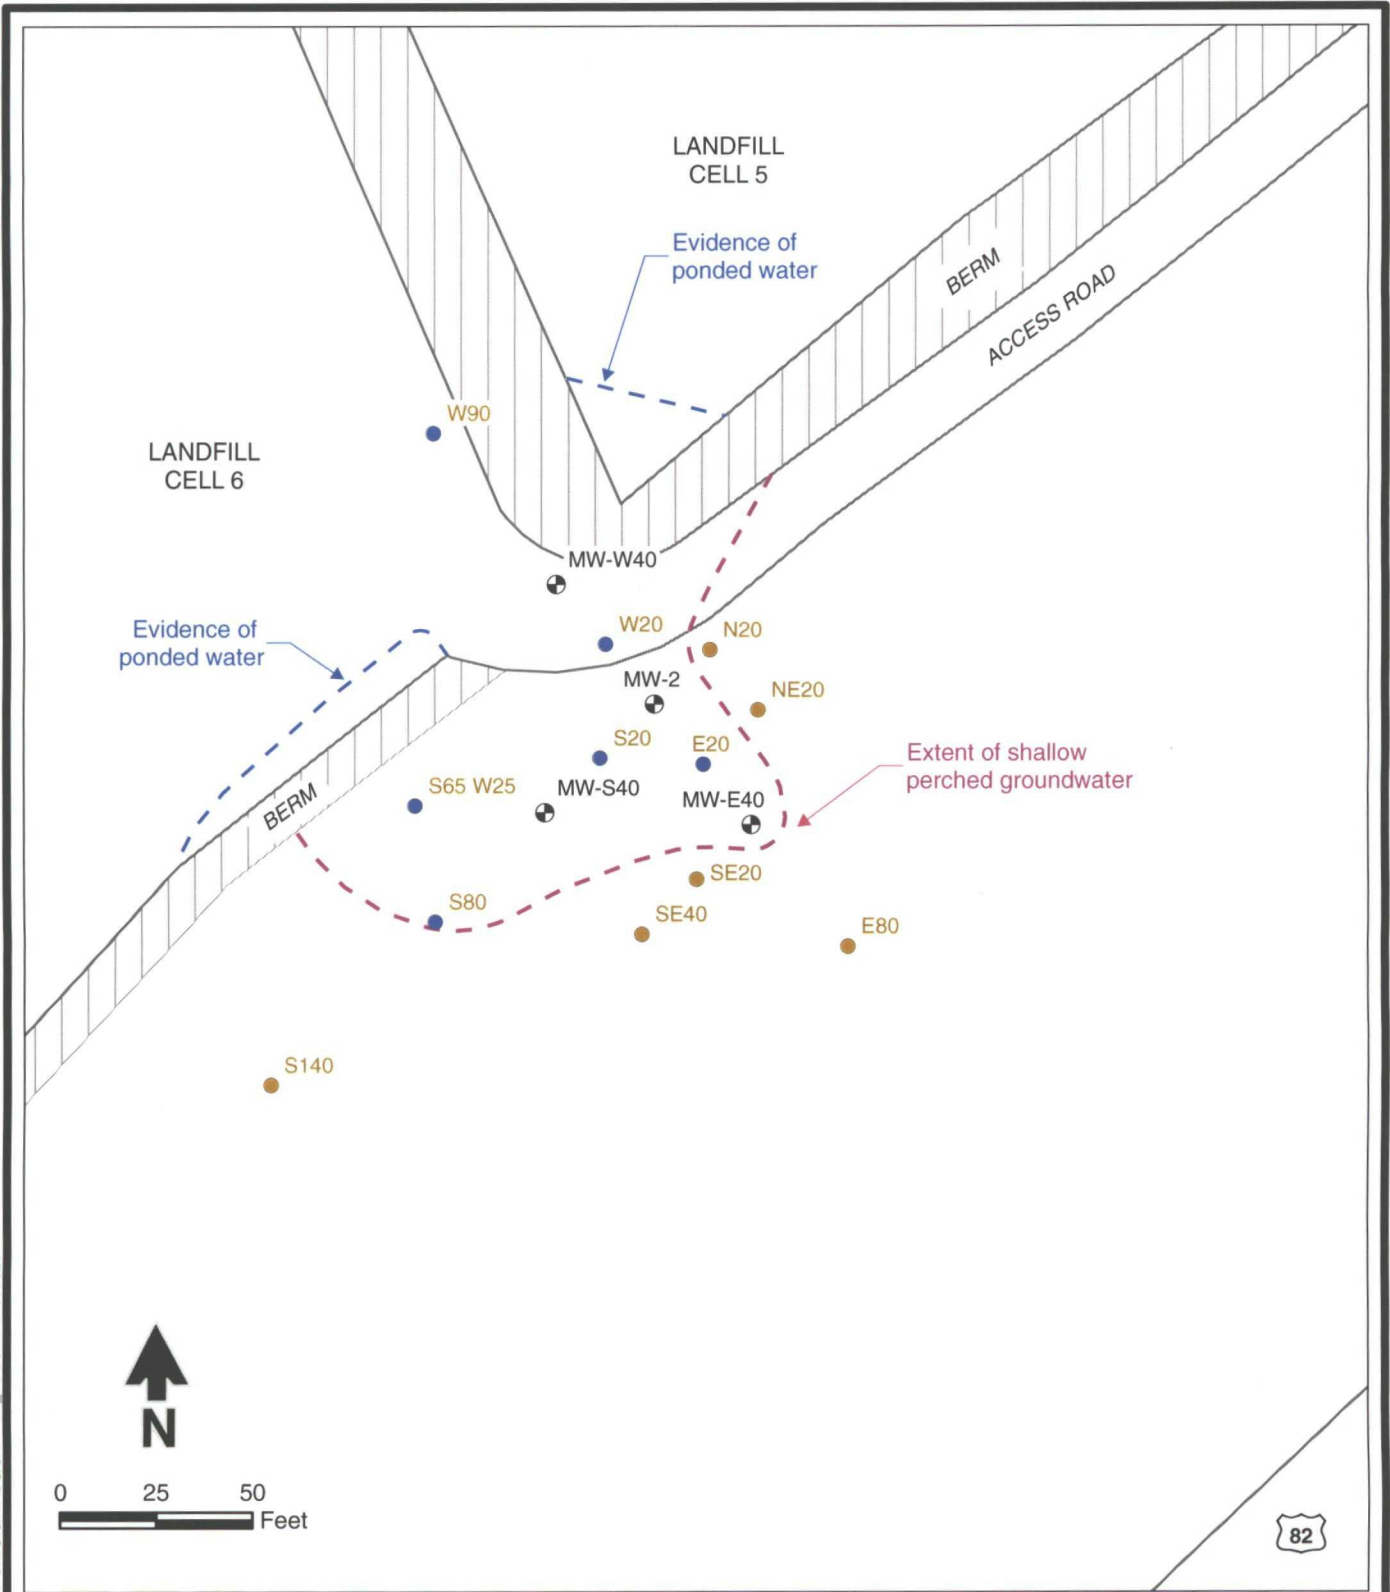
Figure 2

At the time of the field investigation, DBS&A observed evidence of ponded water behind the southern berms of cells 5 and 6 (Figure 2), in the topographic low between MW-2 and landfill cell 6, and in several other low lying spots around MW-2 that have resulted from settling of the backfilled trenches.

The six dry borings defined the extent of the perched groundwater to the north, east, southeast, and south (Figure 2). The perched groundwater was determined to extend from beneath landfill cells 5 and 6 toward Highway 82 for a distance of less than 80 ft (boring E40 contained water; E80 did not contain water). To the south of MW-2, the perched groundwater extends approximately 80 ft. When boring S80 was drilled, it was initially found to contain water, but after a few days went dry. This likely indicates that the boring is located on the outer fringes of the perched groundwater. To the north along the access road, the perched water extends less than 20 ft (boring N20 did not contain water). The extent of perched groundwater beneath landfill cells 5 and 6 was not determined due to site constraints and the inability to drill through landfill cell contents. Both soil borings installed between cells 5 and 6 (W40 and W90) contained significant amounts of water.

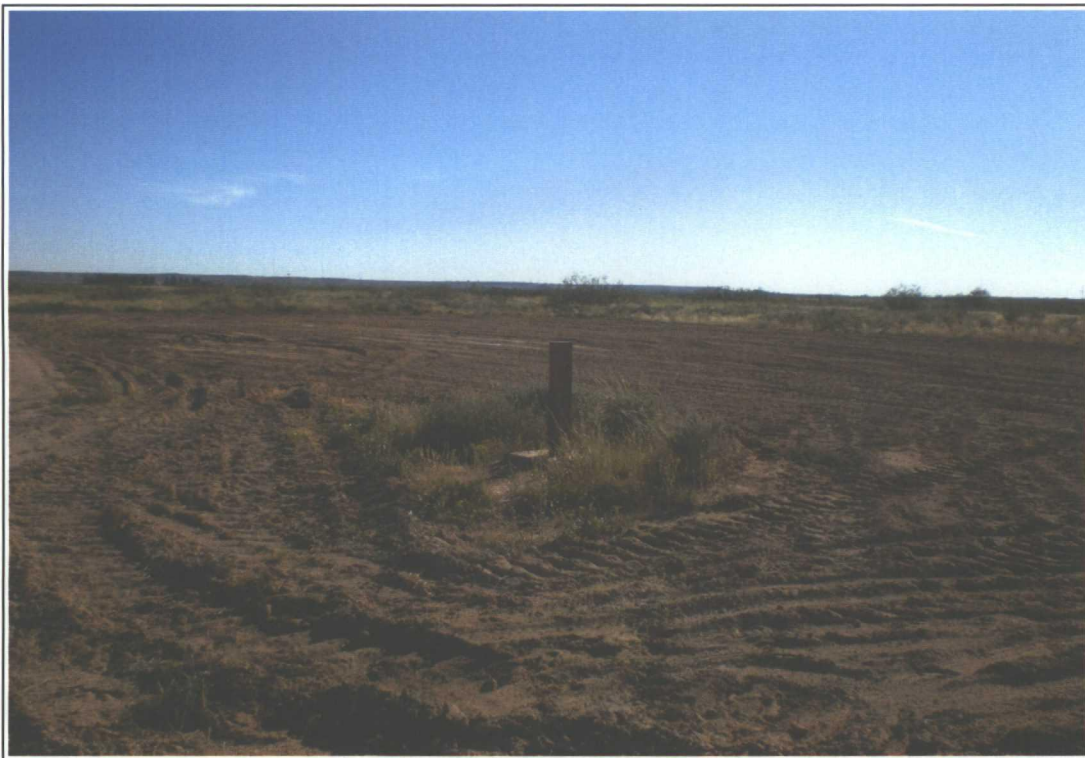
Photograph 1
Regraded area around MW-2 (view to the east).

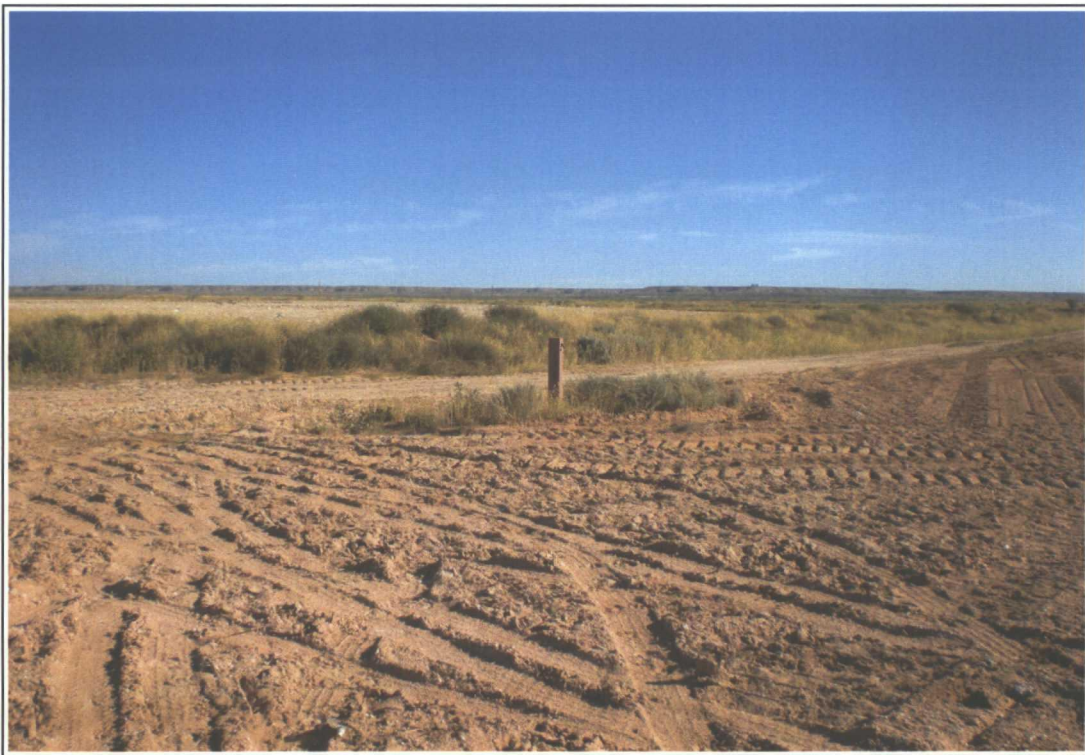
Photograph 2
MW-2 with the berm Cell 5 in the background (view to the northeast).

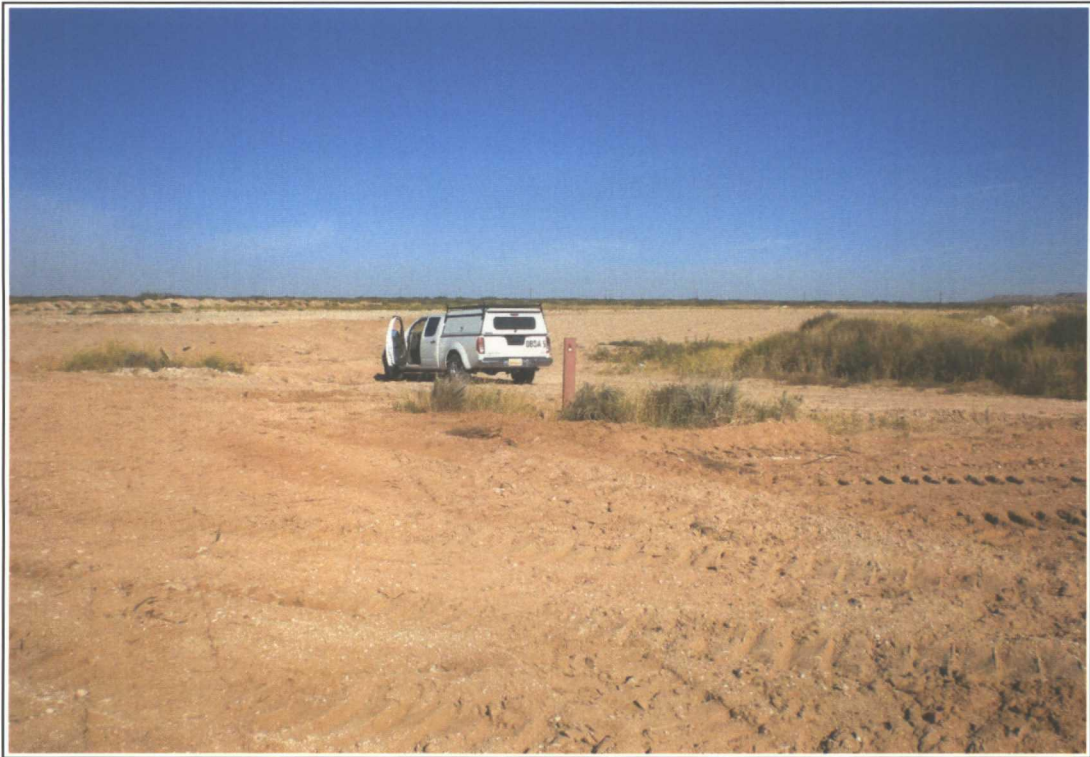
Photograph 3
Topographic low between MW-2 and Cell 6 (view to the northwest).

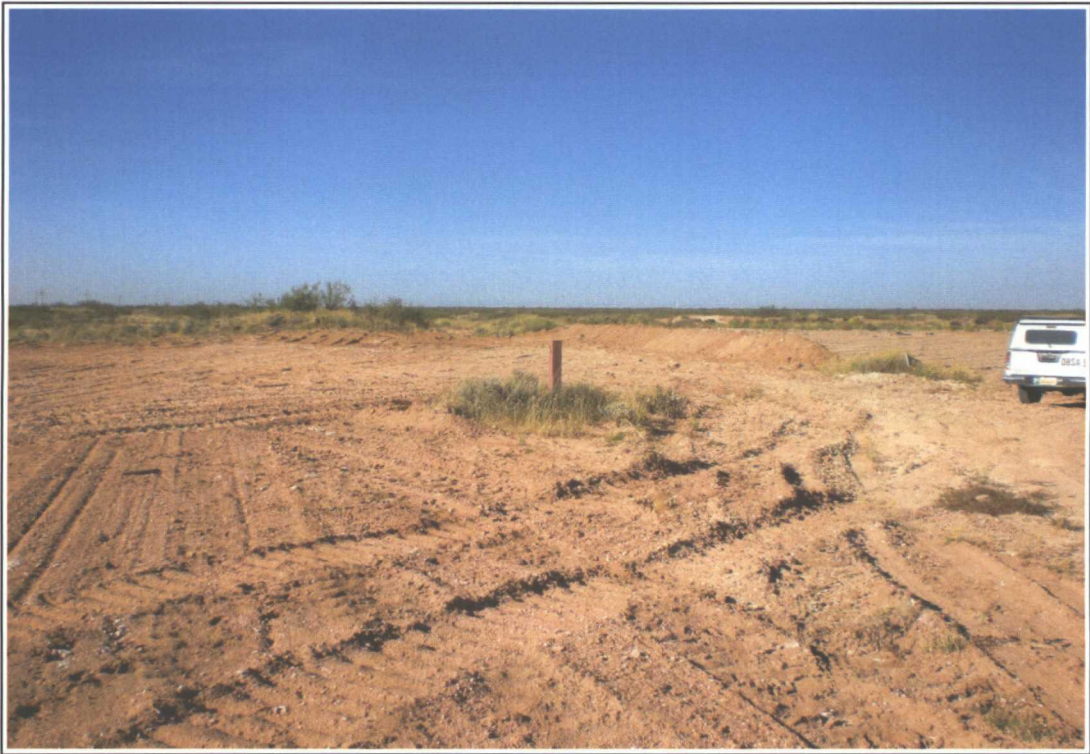
Photograph 4
Regraded area with MW-2 at the center (view to the west).

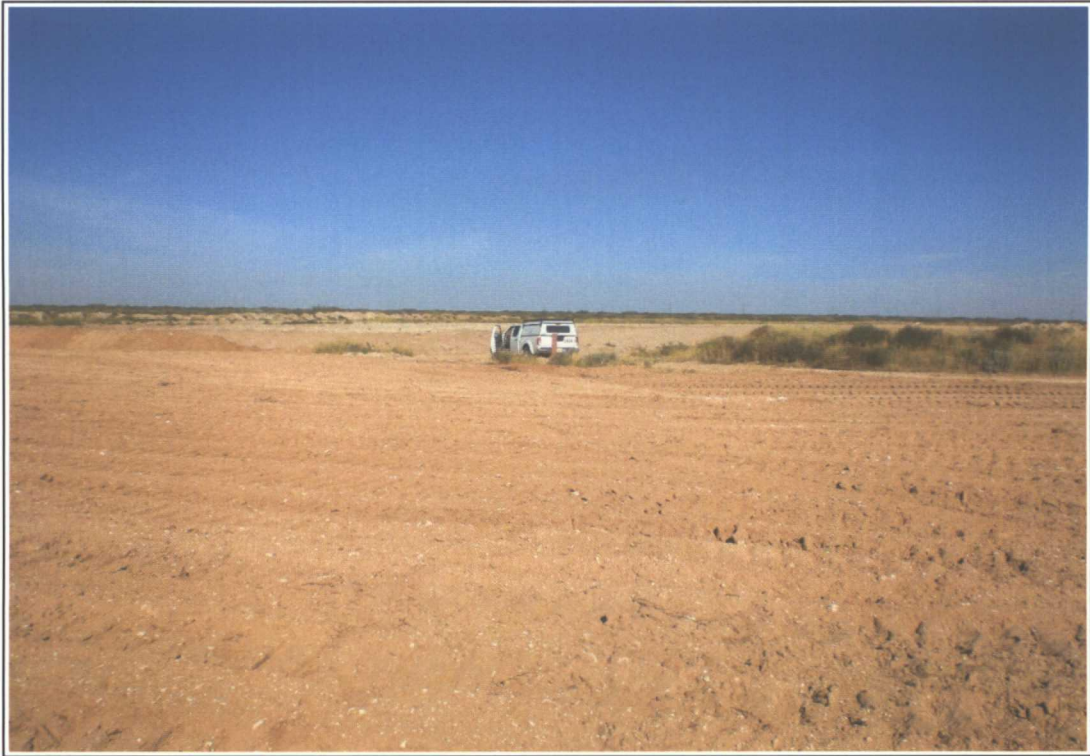
Photograph 5
Regraded area with Cell 6 in the background (view to the northwest).

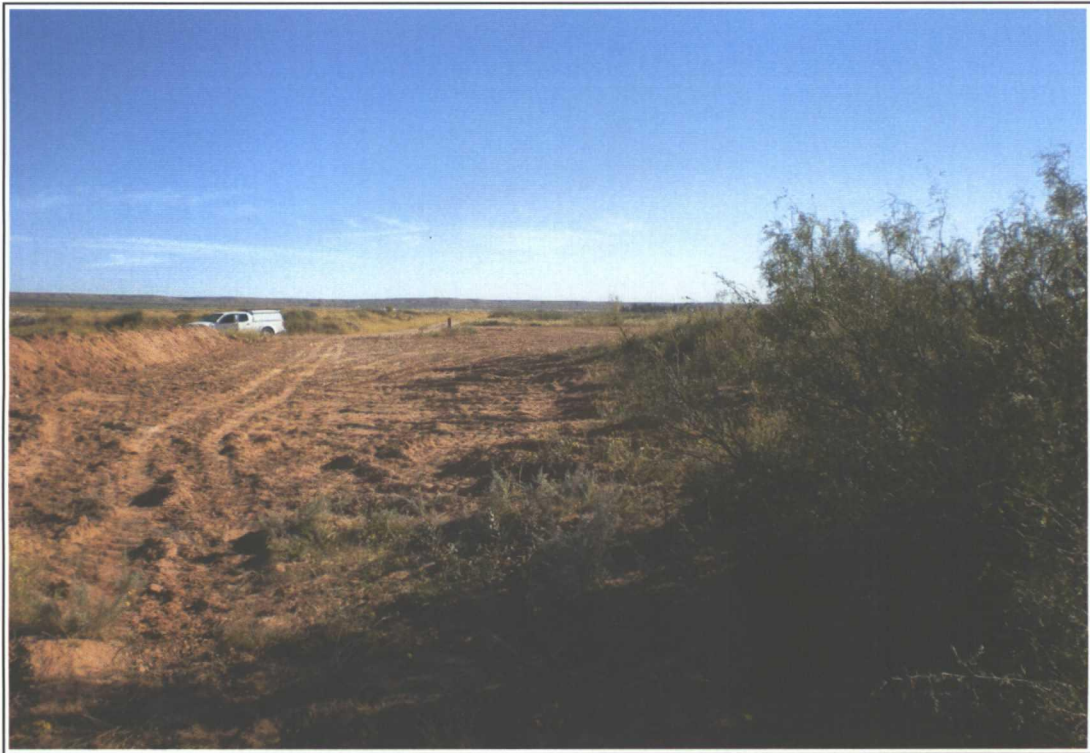
Photograph 6
Regraded area with the southern berm of Cell 6 to the left in the photograph and the southern and western berms of Cell 5 in the background behind the truck (view to the northeast).
