Subject: [EXT] FW: [EXTERNAL] Hilcorp's Kaufman No. 1 - Weekly Update for week of 9/23/19, 9/30/19, and

Attachments: Kaufman No. 1 (Figure 8_2S19 potenitometic).pdf

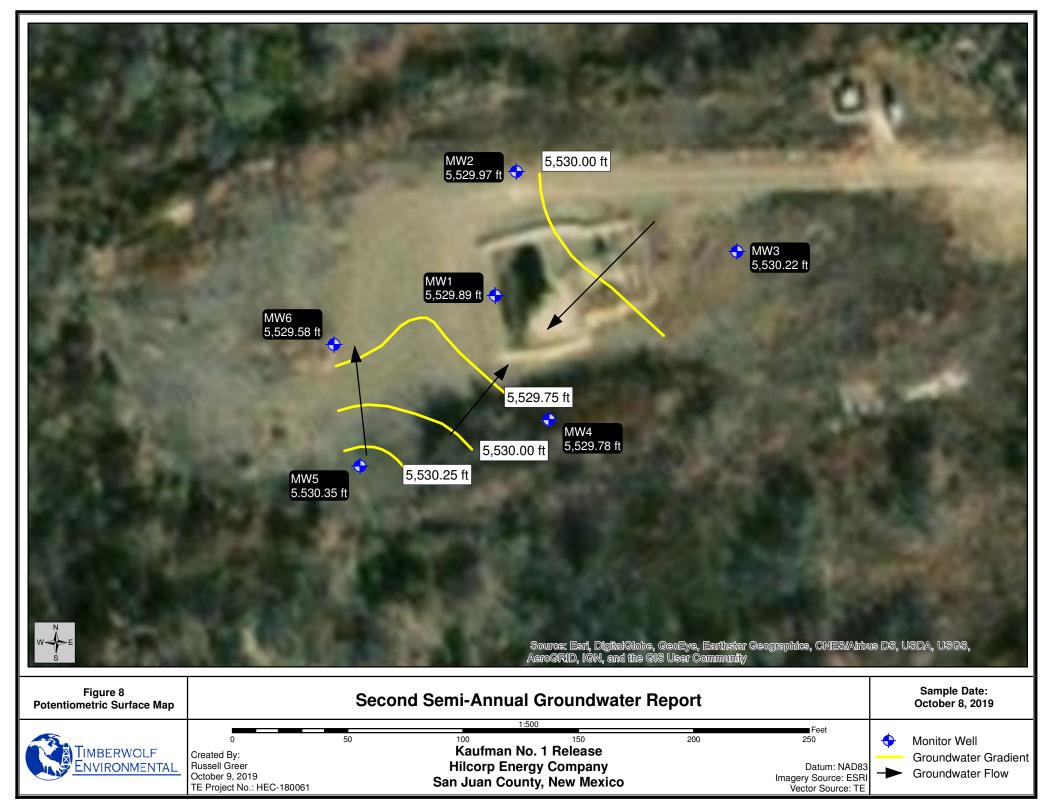
A potentiometric surface map (PSE) was prepared to determine the direction of groundwater flow across the Site (attached). The attached PSE map reveals that groundwater is discharging to the excavation (i.e. former tank battery). The mechanism for discharge is evaporation; which should facilitate stabilizing the benzene plume (i.e., keeping it from moving off-site).
