State of New Mexico
Energy, Minerals and Natural Resources

Form C-103
Revised July 18, 2013

Jicarilla 120 C 4
30-039-06291

Wellbore Schematic

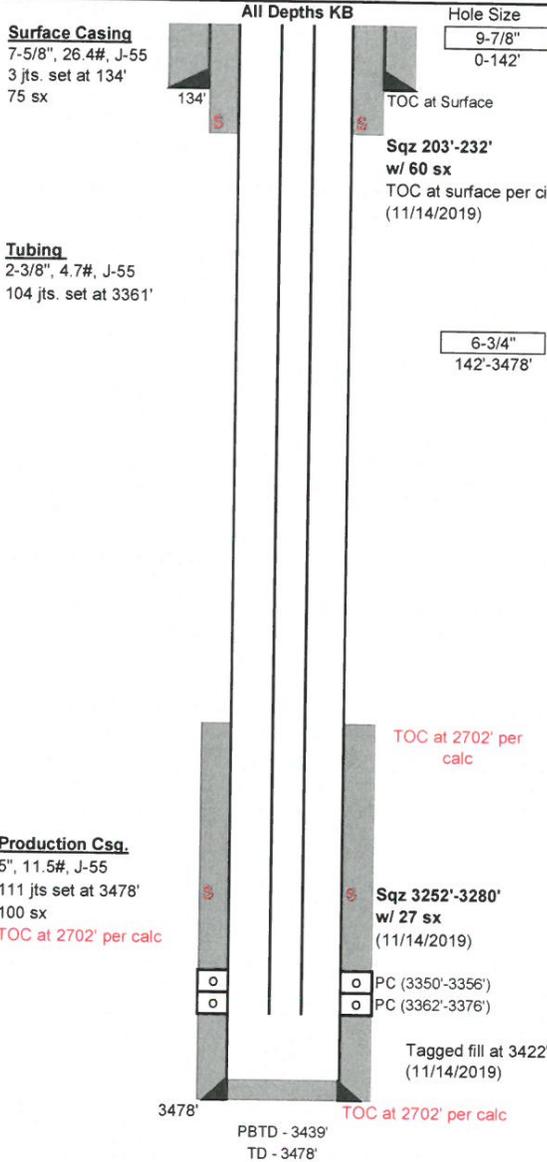
** 2019 Casing repair, squeezed 203'-232' w/ 60 sx cmt, TOC of sqz at surface per circulation. Squeezed 3155'-3282' w/ 27 sx.

Additional Notes:
 11/14/2019- Casing Repair, leaks from 203'-232' and 3252'-3280' were squeezed. Tagged fill at 3422'
