1RP-3979 DELINEATION PLAN Devon Lease Illegal Dumping Spill Lea County, New Mexico

LAI Project No. 17-0201-01

November 7, 2017

Prepared for: Penroc Oil Corporation 1515 Calle Sur, Suite 174 Hobbs, New Mexico 88240

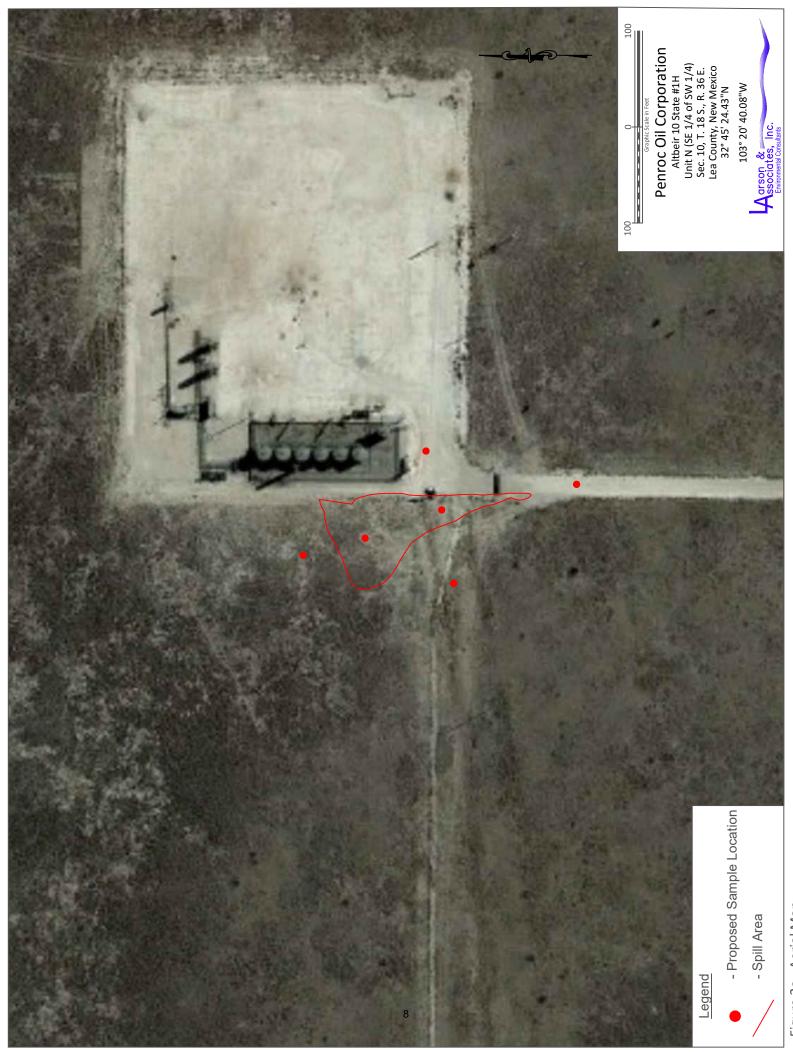
Figure 2a - Aerial Map

LAI personnel collected photographs at the Altbeir 10 State #1H in similar orientation and direction as photographs by Devon. LAI personnel mapped the visible spill area with a Trimble sub-meter GPS receiver. A spill area was observed just off the lease road to the north of the now plugged and abandoned Altbeir 10 State #1 well. The vegetative cover has improved since the spill was initially reported but scarring is visible. LAI mapped the impact area as about 9,400 square feet or about 0.22 acre. Figure 2a presents an aerial map. Appendix B presents photographs.

EPA SW-846 Methods 8021B and 8015M, respectively. Additional samples will be analyzed to determine the vertical extent of these compounds should the laboratory report concentrations above the RRAL. All samples will be analyzed for chloride by EPA Method and 300 until the delineation requirements are achieved. Pending laboratory results, further delineation will be determined to reach cleanup level standards. Figures 2a, 2b, 2c and 2d present the proposed soil sample locations.

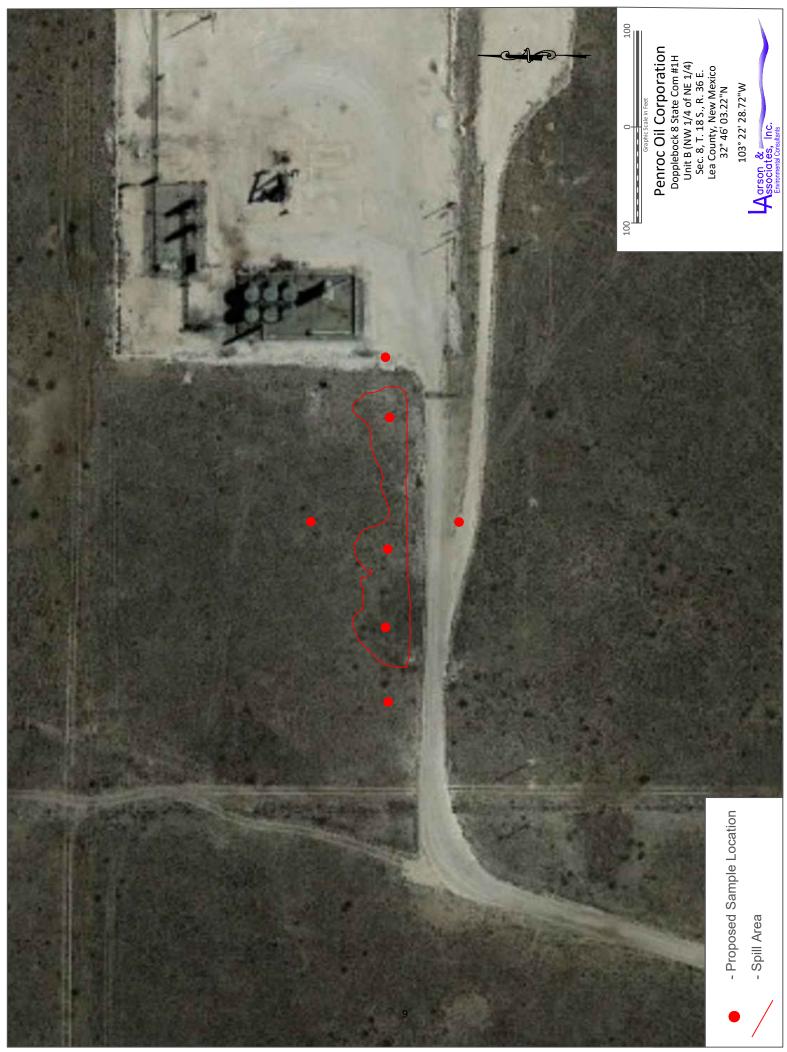
Figure 2b - Aerial Map

LAI personnel collected photographs at the Dopplebock 8 State Com #1H in similar orientation and direction as photographs taken by Devon and mapped the visible spill area using a Trimble sub-meter GPS receiver. An area of discolored vegetation similar to what Devon photographed was visible along the east side of the lease road leading up to the tank battery. The area of discolored vegetation measures approximately 6,200 square feet or about 0.14 acre. There were no visible signs of impact within the tank battery pad. Figure 2b presents an aerial map. Appendix B presents photographs.

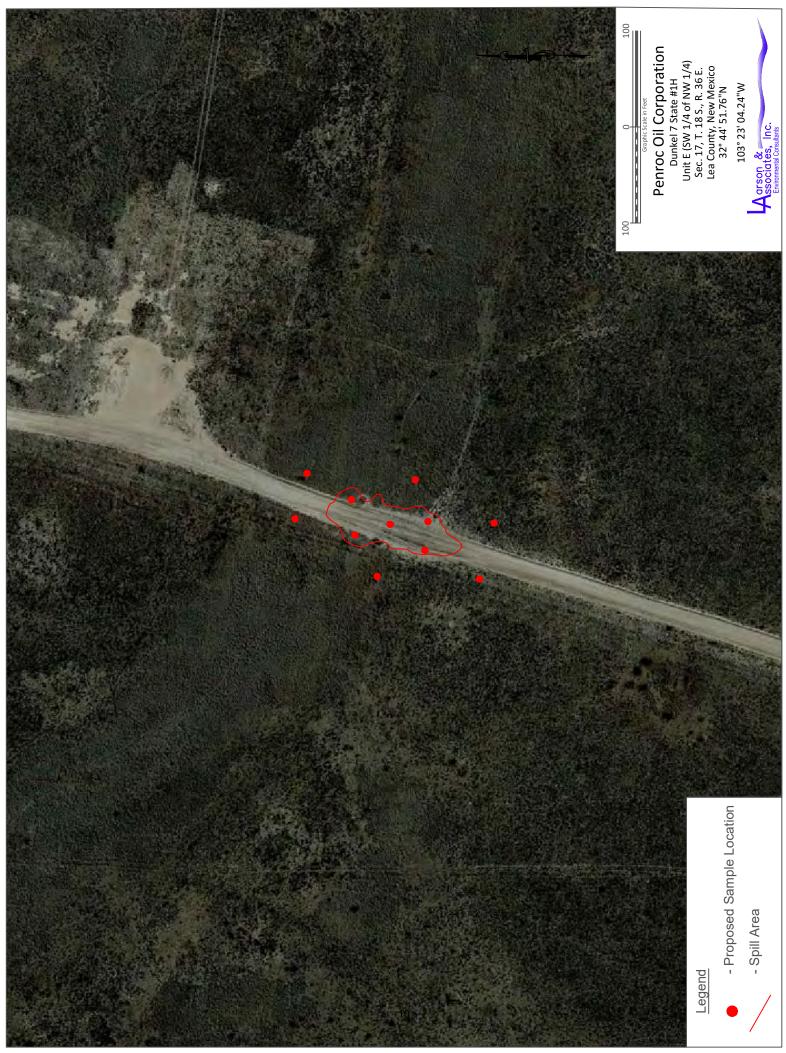
Figure 2c - Aerial Map

LAI personnel collected photographs at the Dunkel 7 State #1H in similar orientation and direction as photographs taken by Devon and mapped the visible spill area using a Trimble sub-meter GPS receiver. An area of discolored vegetation was also observed about 1 mile south of the Dunkel 7 State #1H location and measured about 5,700 square feet or about 0.13 acre. The spill is situated predominately on the lease road with a runoff into the pasture on either side. Figure 2c presents an aerial map. Appendix B presents photographs.

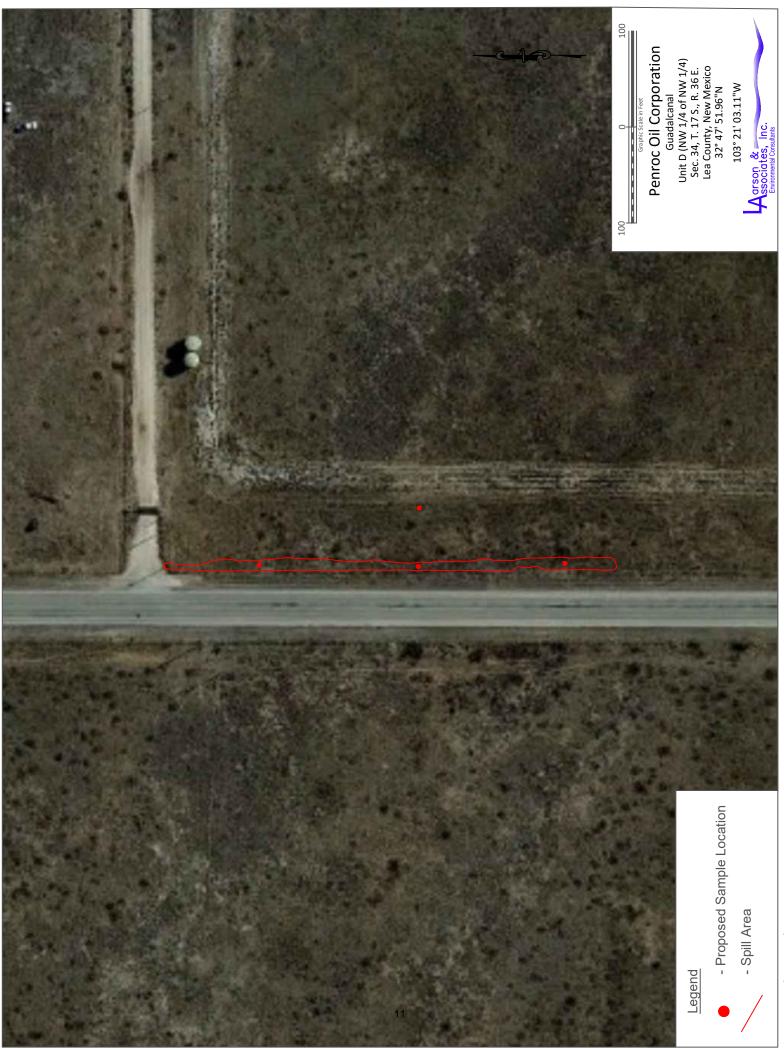
Figure 2d - Aerial Map

LAI personnel conducted a site reconnaissance at the Guadalcanal State Com #1H on November 1, 2017. No impacted vegetation or discolored soil was observed in the vicinity of the well or tank battery. LAI observed an area of discolored soil near the lease entrance about 2 miles west of the location. Figure 2d presents an aerial map. Appendix B presents photographs.

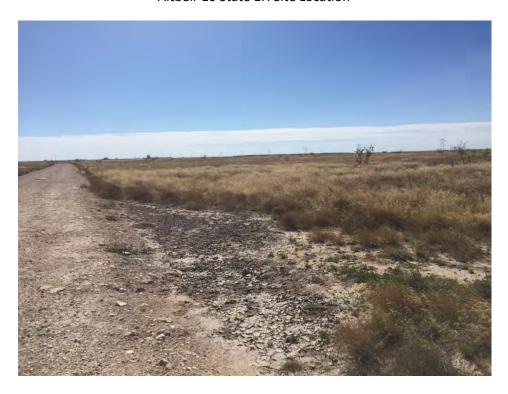
Altbeir Site Prior to Remediation Viewing West, November 1, 2017

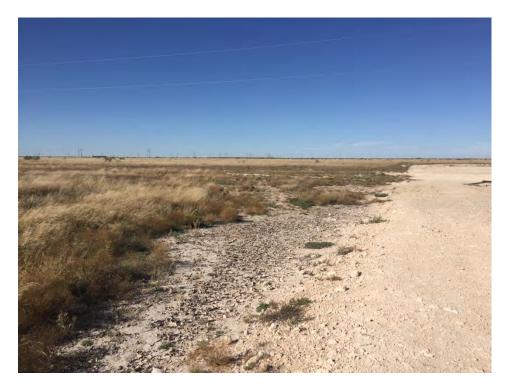
Altbeir Site Prior to Remediation Viewing North, November 1, 2017

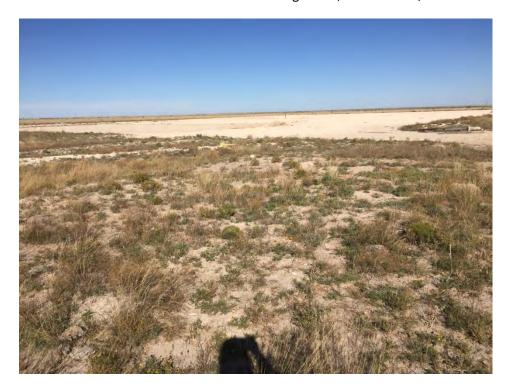
Altbeir Site Prior to Remediation Viewing East, November 1, 2017

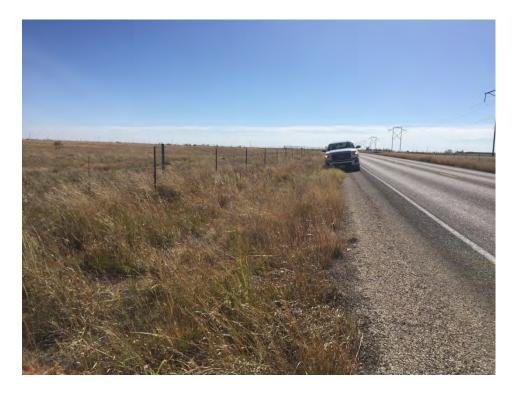
Altbeir Site Prior to Remediation Viewing South, November 1, 2017

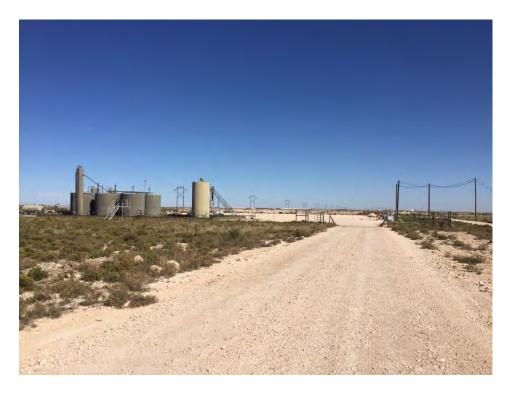
Dopplebock Site Prior to Remediation Viewing North, November 1, 2017

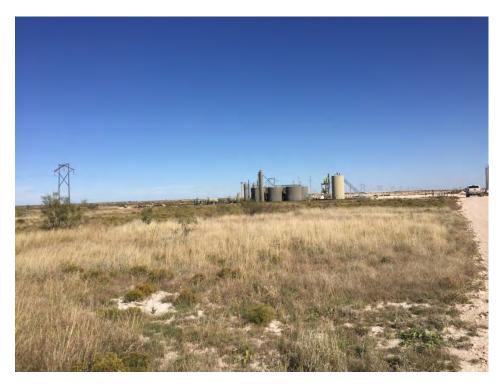
Dopplebock Site Prior to Remediation Viewing Northwest, November 1, 2017

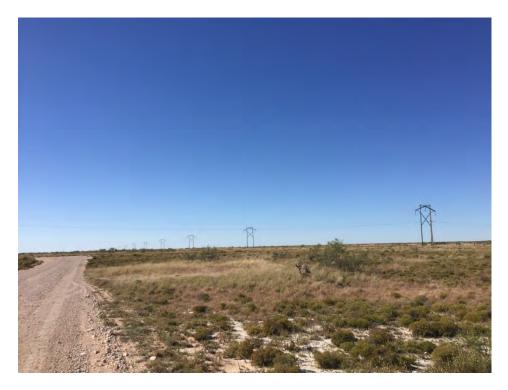
Dopplebock Site Prior to Remediation Viewing South, November 1, 2017

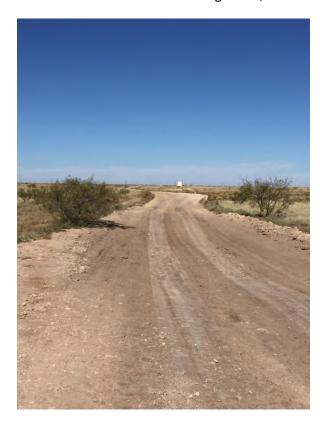
Dunkel 7 State 1H Prior to Remediation viewing North, November 1, 2017

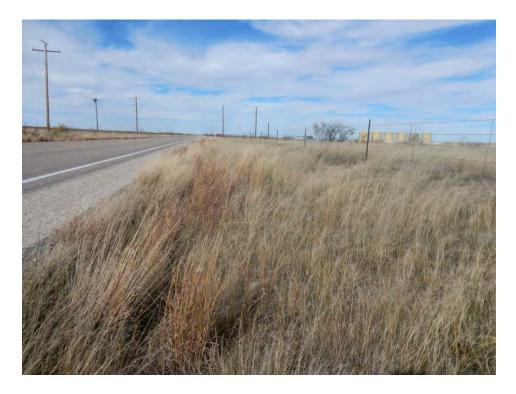
Guadacanal Site Prior to Remediation Viewing North, November 6, 2017

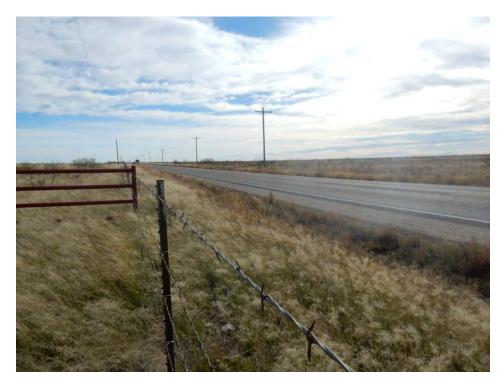
Guadacanal Site Prior to Remediation Viewing South, November 6, 2017
