**From:** [andrew@rthicksconsult.com](mailto:andrew@rthicksconsult.com)  
**To:** [Yu, Olivia, EMNRD](#); "[Yolanda Jimenez](#)"; [stucker@blm.gov](mailto:stucker@blm.gov)  
**Cc:** "[Randall Hicks](#)"; "[David Harwell](#)"  
**Subject:** RE: Advanced Energy - Tomahawk 1RP- 4778  
**Date:** Friday, July 27, 2018 4:42:41 PM

R.T. Hicks Consultants submits the attached characterization and remediation plan for 1RP-4778, commonly known as Advanced Energy Tomahawk site.

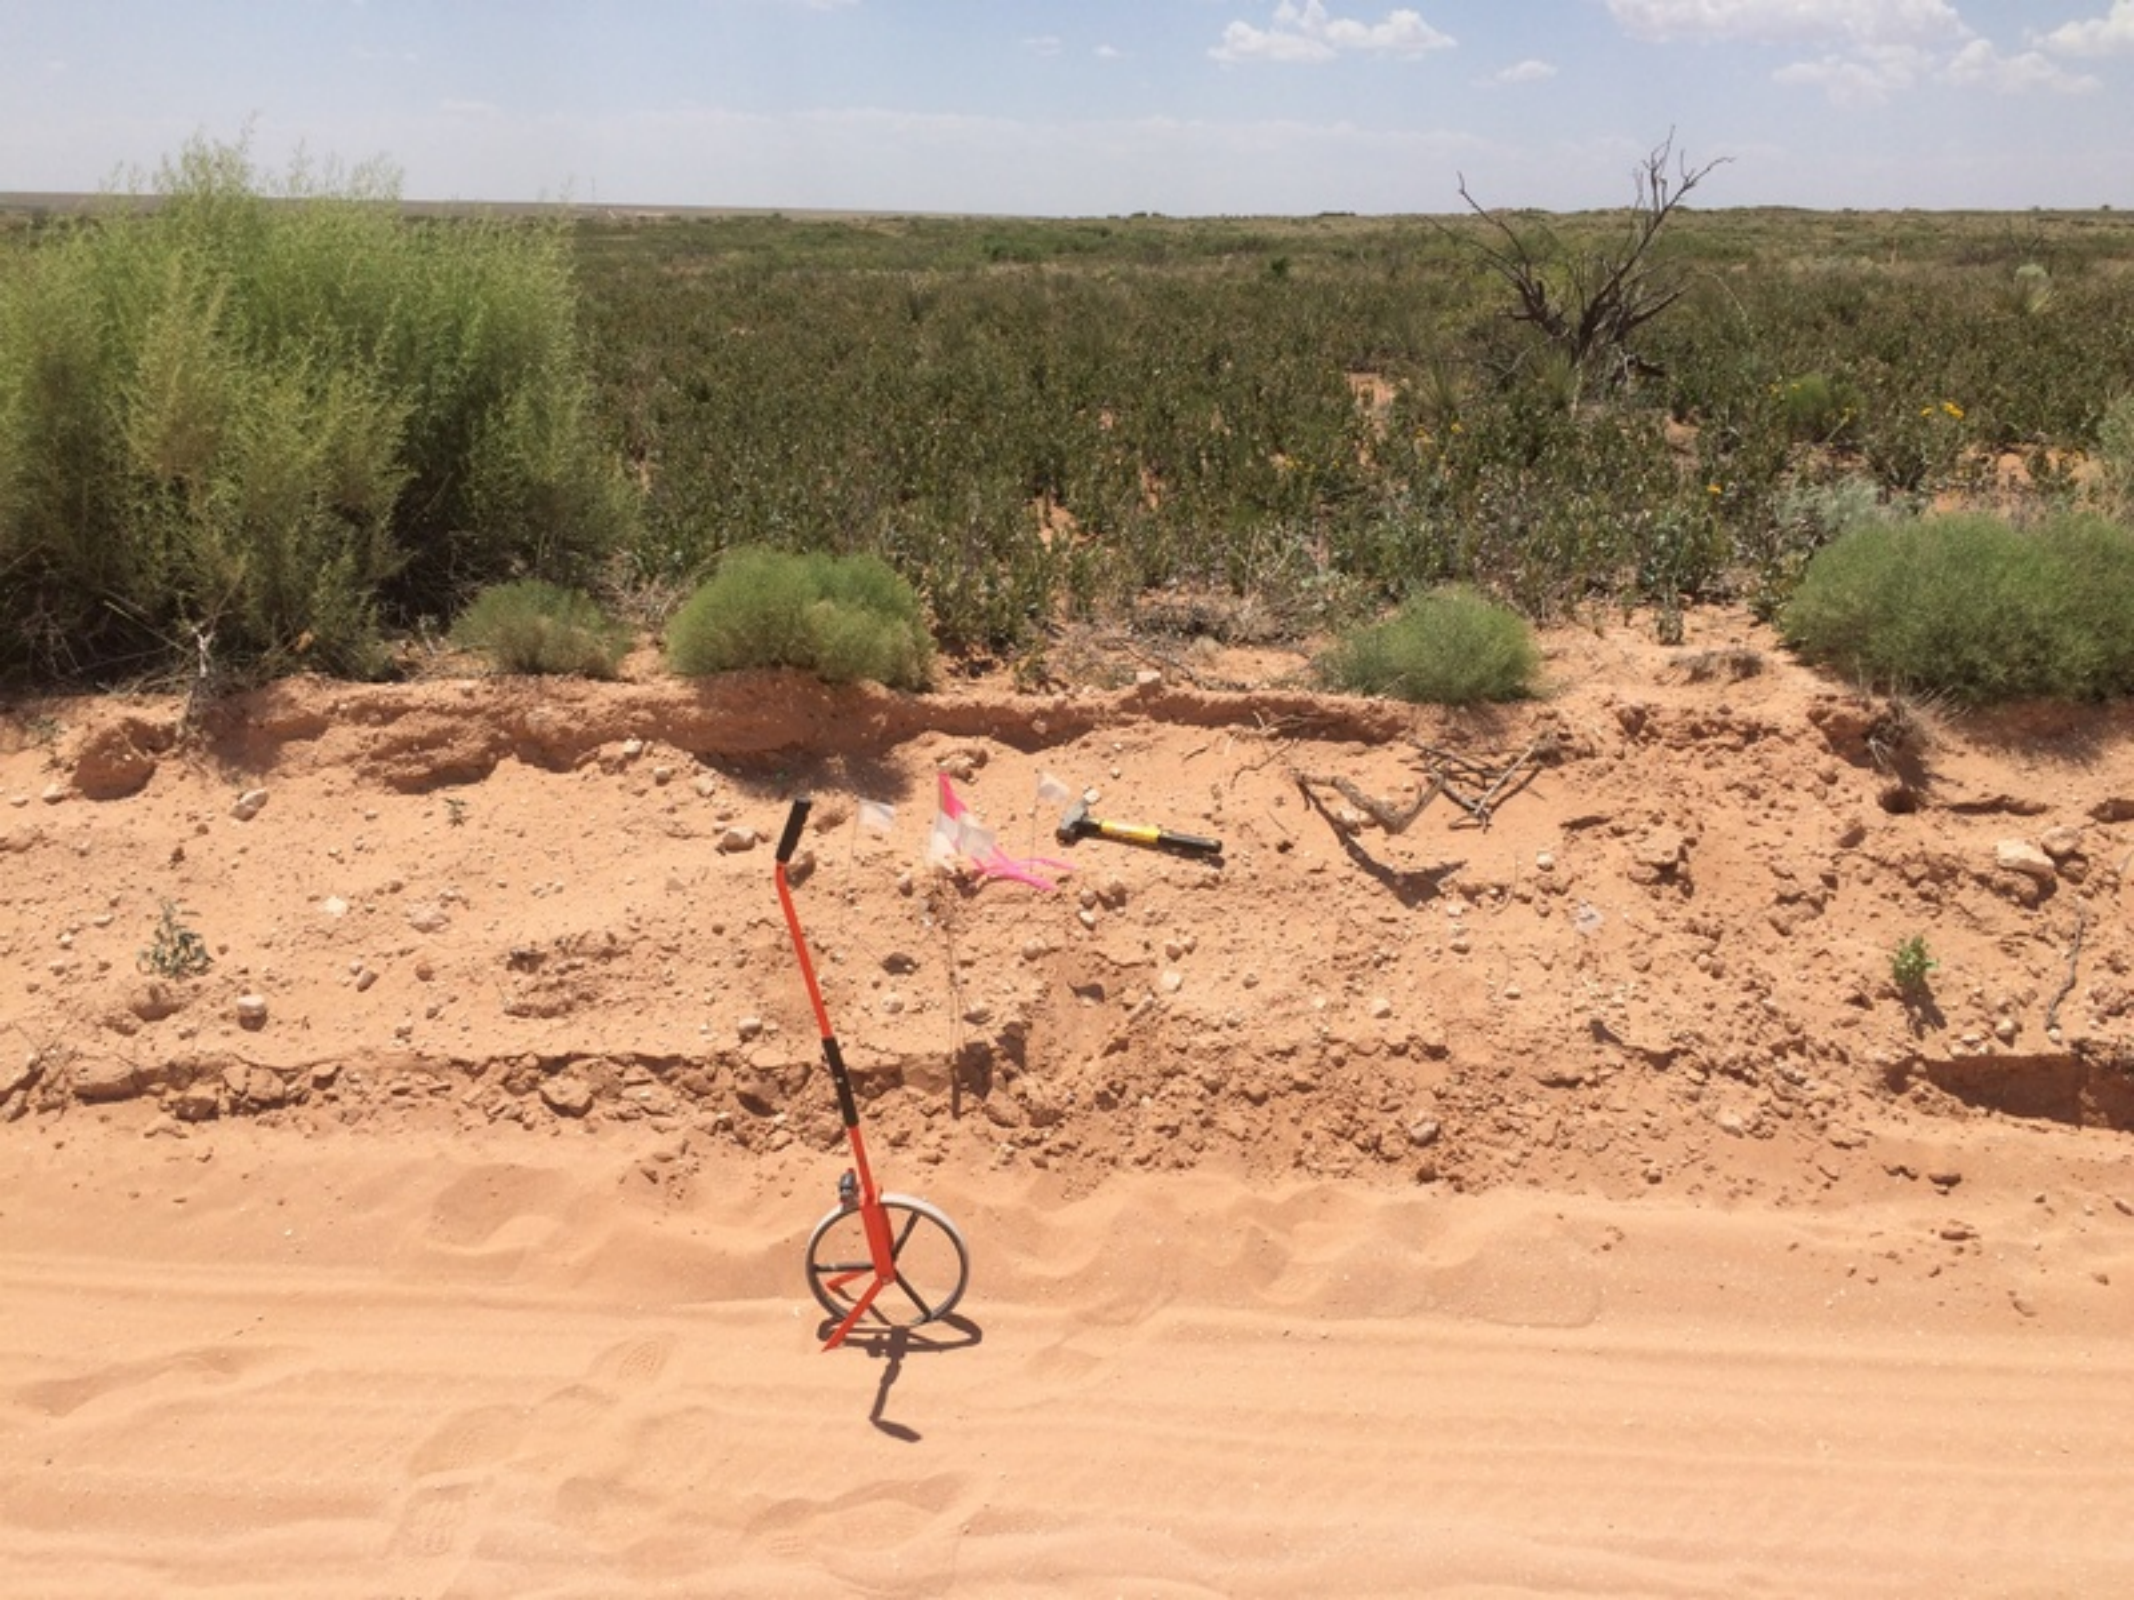
**Boreholde HA-250**

I corresponded with Ms. Tucker at the BLM. She still has the Tomahawk assigned to her. We are prepared to delineate the identified locations (see below email) the week of August 6<sup>th</sup>, which is the next available time for the drill rig. I am in communication with Ms. Tucker regarding the HA-250 location and access - this location will either cause closure of the access road or destroying vegetation by grading a flat area so that the drill rig can center over the release along the ditch in the road. The attached photos shows the proposed location relative to the ditch and vegetation.
