Re: Status Report – 1st Quarter 2020 Fifield 5 No. 1 (SE ¼, SW ¼, Sec. 5, T29N, R11W) Hilcorp Energy Company San Juan County, New Mexico OCD Incident No.: NVF1718155324

On behalf of Hilcorp Energy Company (Hilcorp), Timberwolf Environmental, LLC (Timberwolf) presents this report to document remedial activities conducted during the fourth quarter of 2019 (4Q19) and 1st quarter 2020 (1Q20) at the Fifield 5 No. 1 (Site). Activities conducted included the following:

SVE System Overview

To remediate impacted soil at the Site, Hilcorp installed a soil vapor extraction (SVE) system. The SVE system is comprised of 18 SVE wells, 6 vent wells, and a SVE trailer (Photographs No. 1-3). The power source was not included with the initial system installation. [Note: Hilcorp received an extension from the OCD with a revised start date of 01/03/2020.]

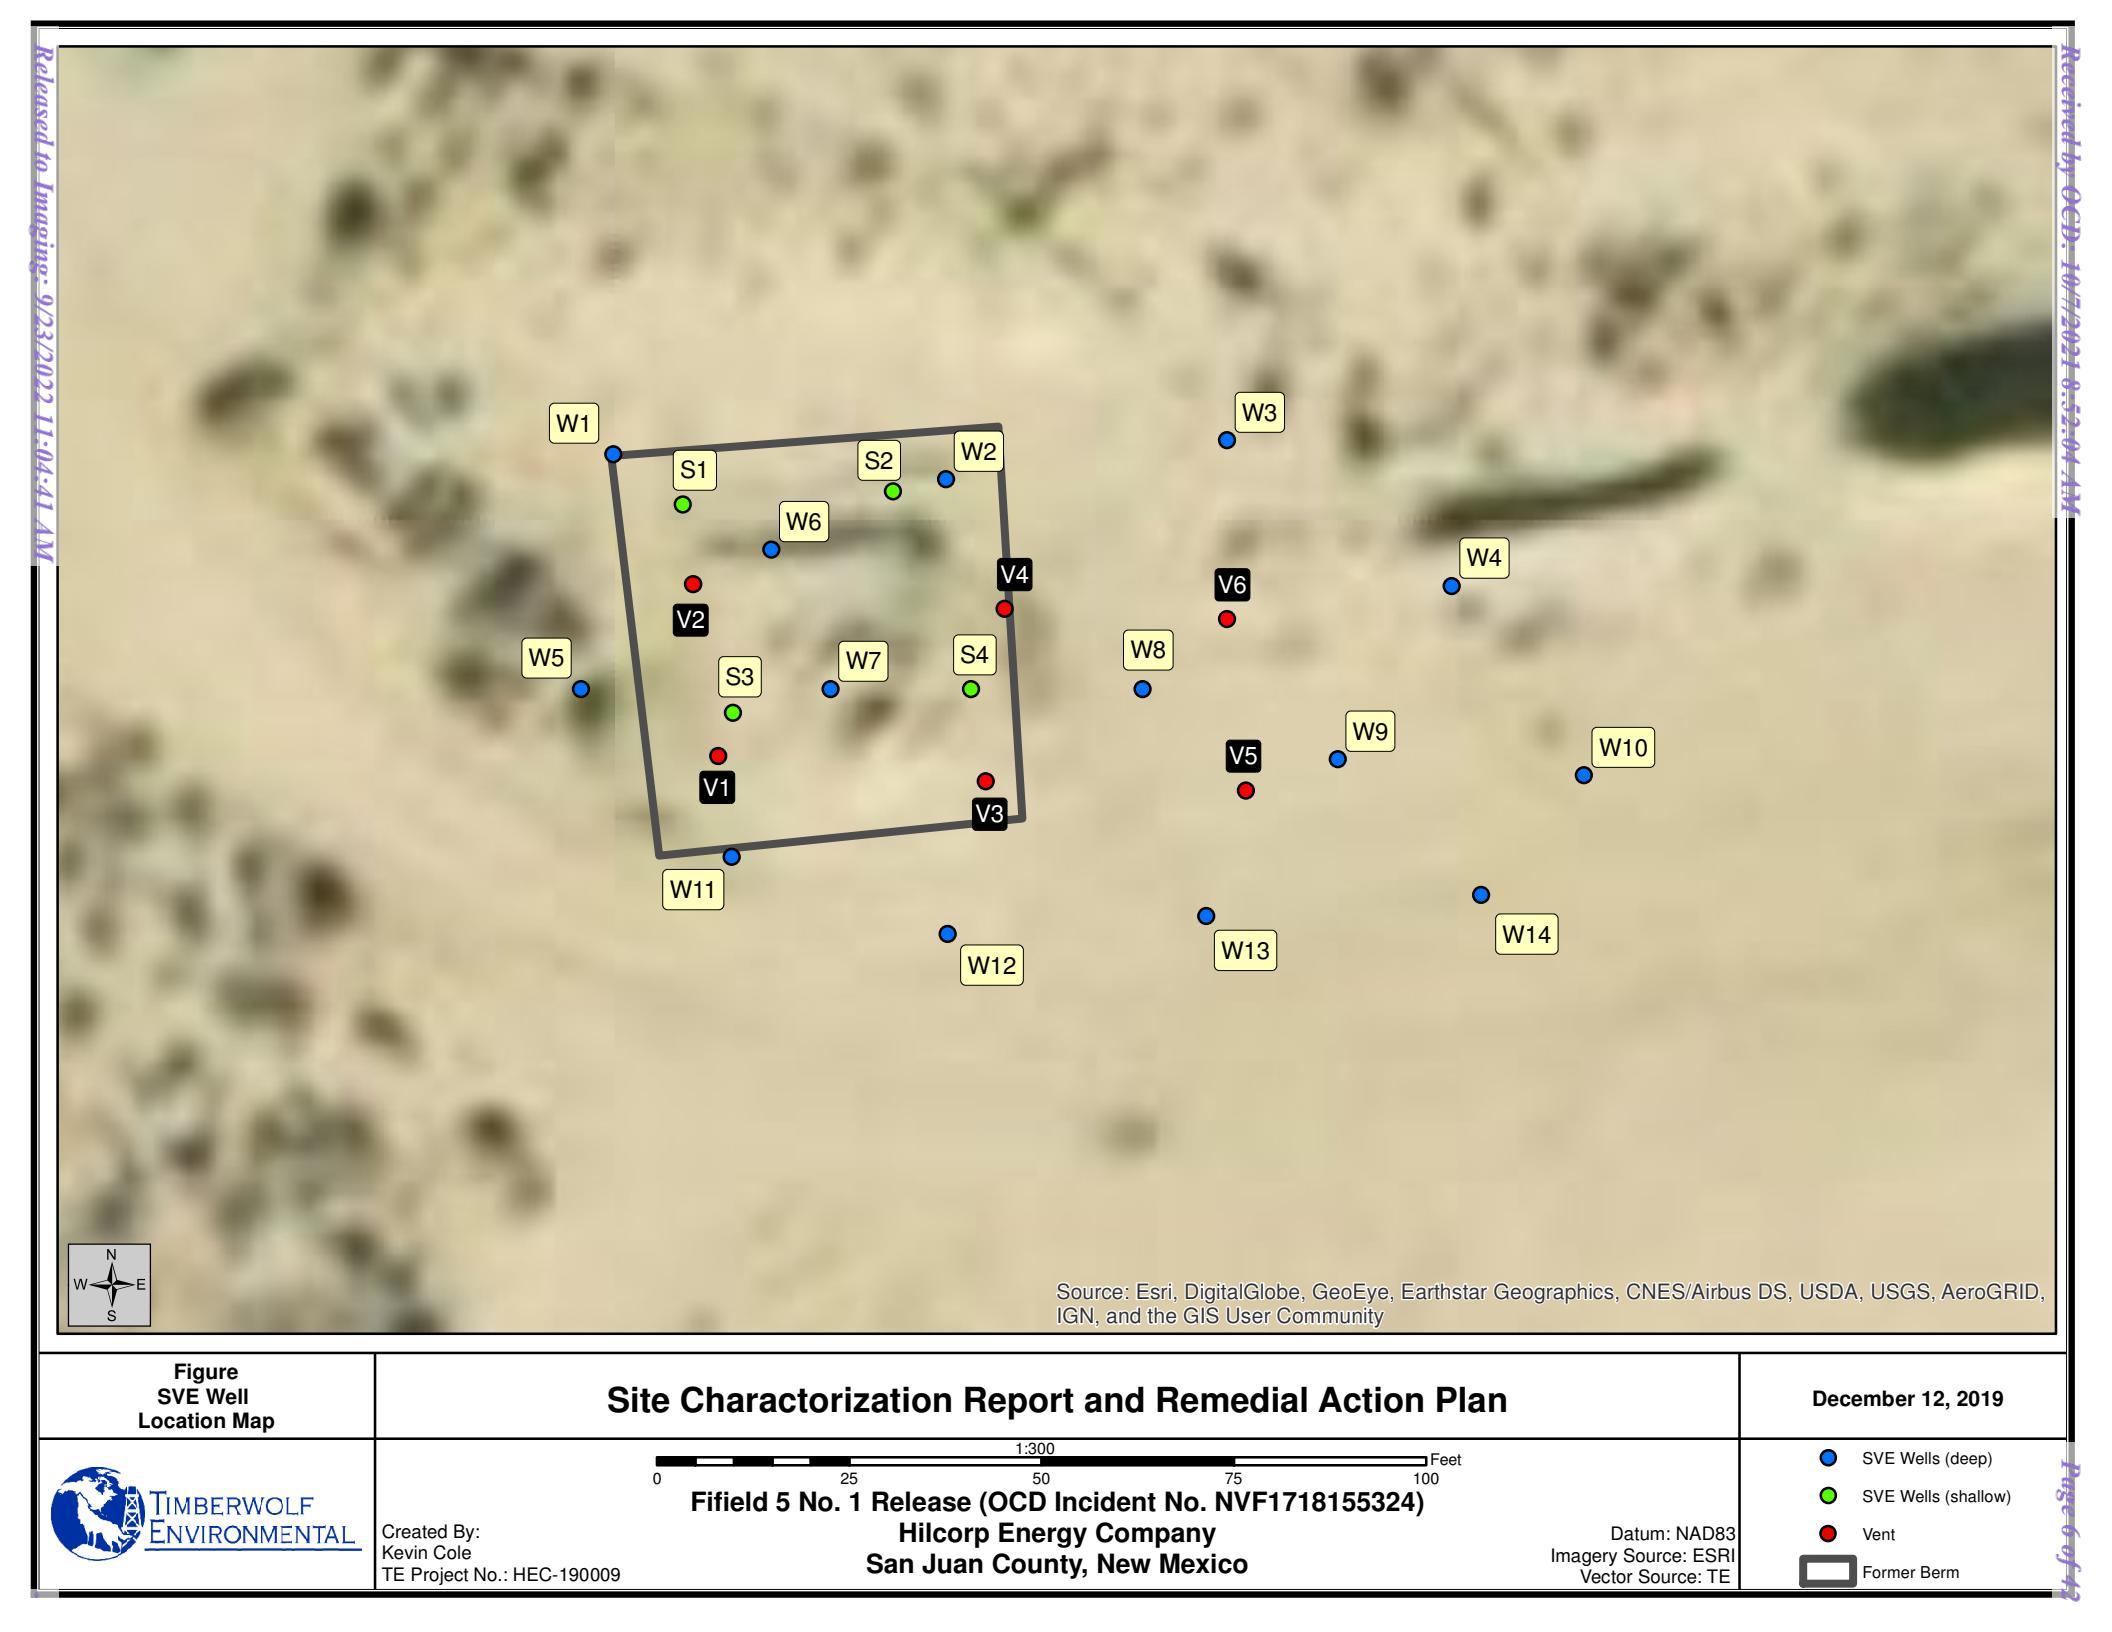
Each well and vent were completed with silica sand pack in the each anulus to approximately 1 ft above the screened interval. A 3-ft bentonite seal was installed above the sand pack; each bentonite seal was hydrated with approximately 8 gallons of water. The remainder of the anulus was sealed with a cement-bentonite grout. SVE wells and vents were installed between 10/24/19 and 10/29/19. A figure with the SVE well and vent locations is attached.
