SITE INFORMATION

Re: Work Plan for the COG Operating LLC., GJ West Coop Unit #7 Flow Line, Unit H, Section 28, Township 17 South, Range 29 East, Eddy County, New Mexico.

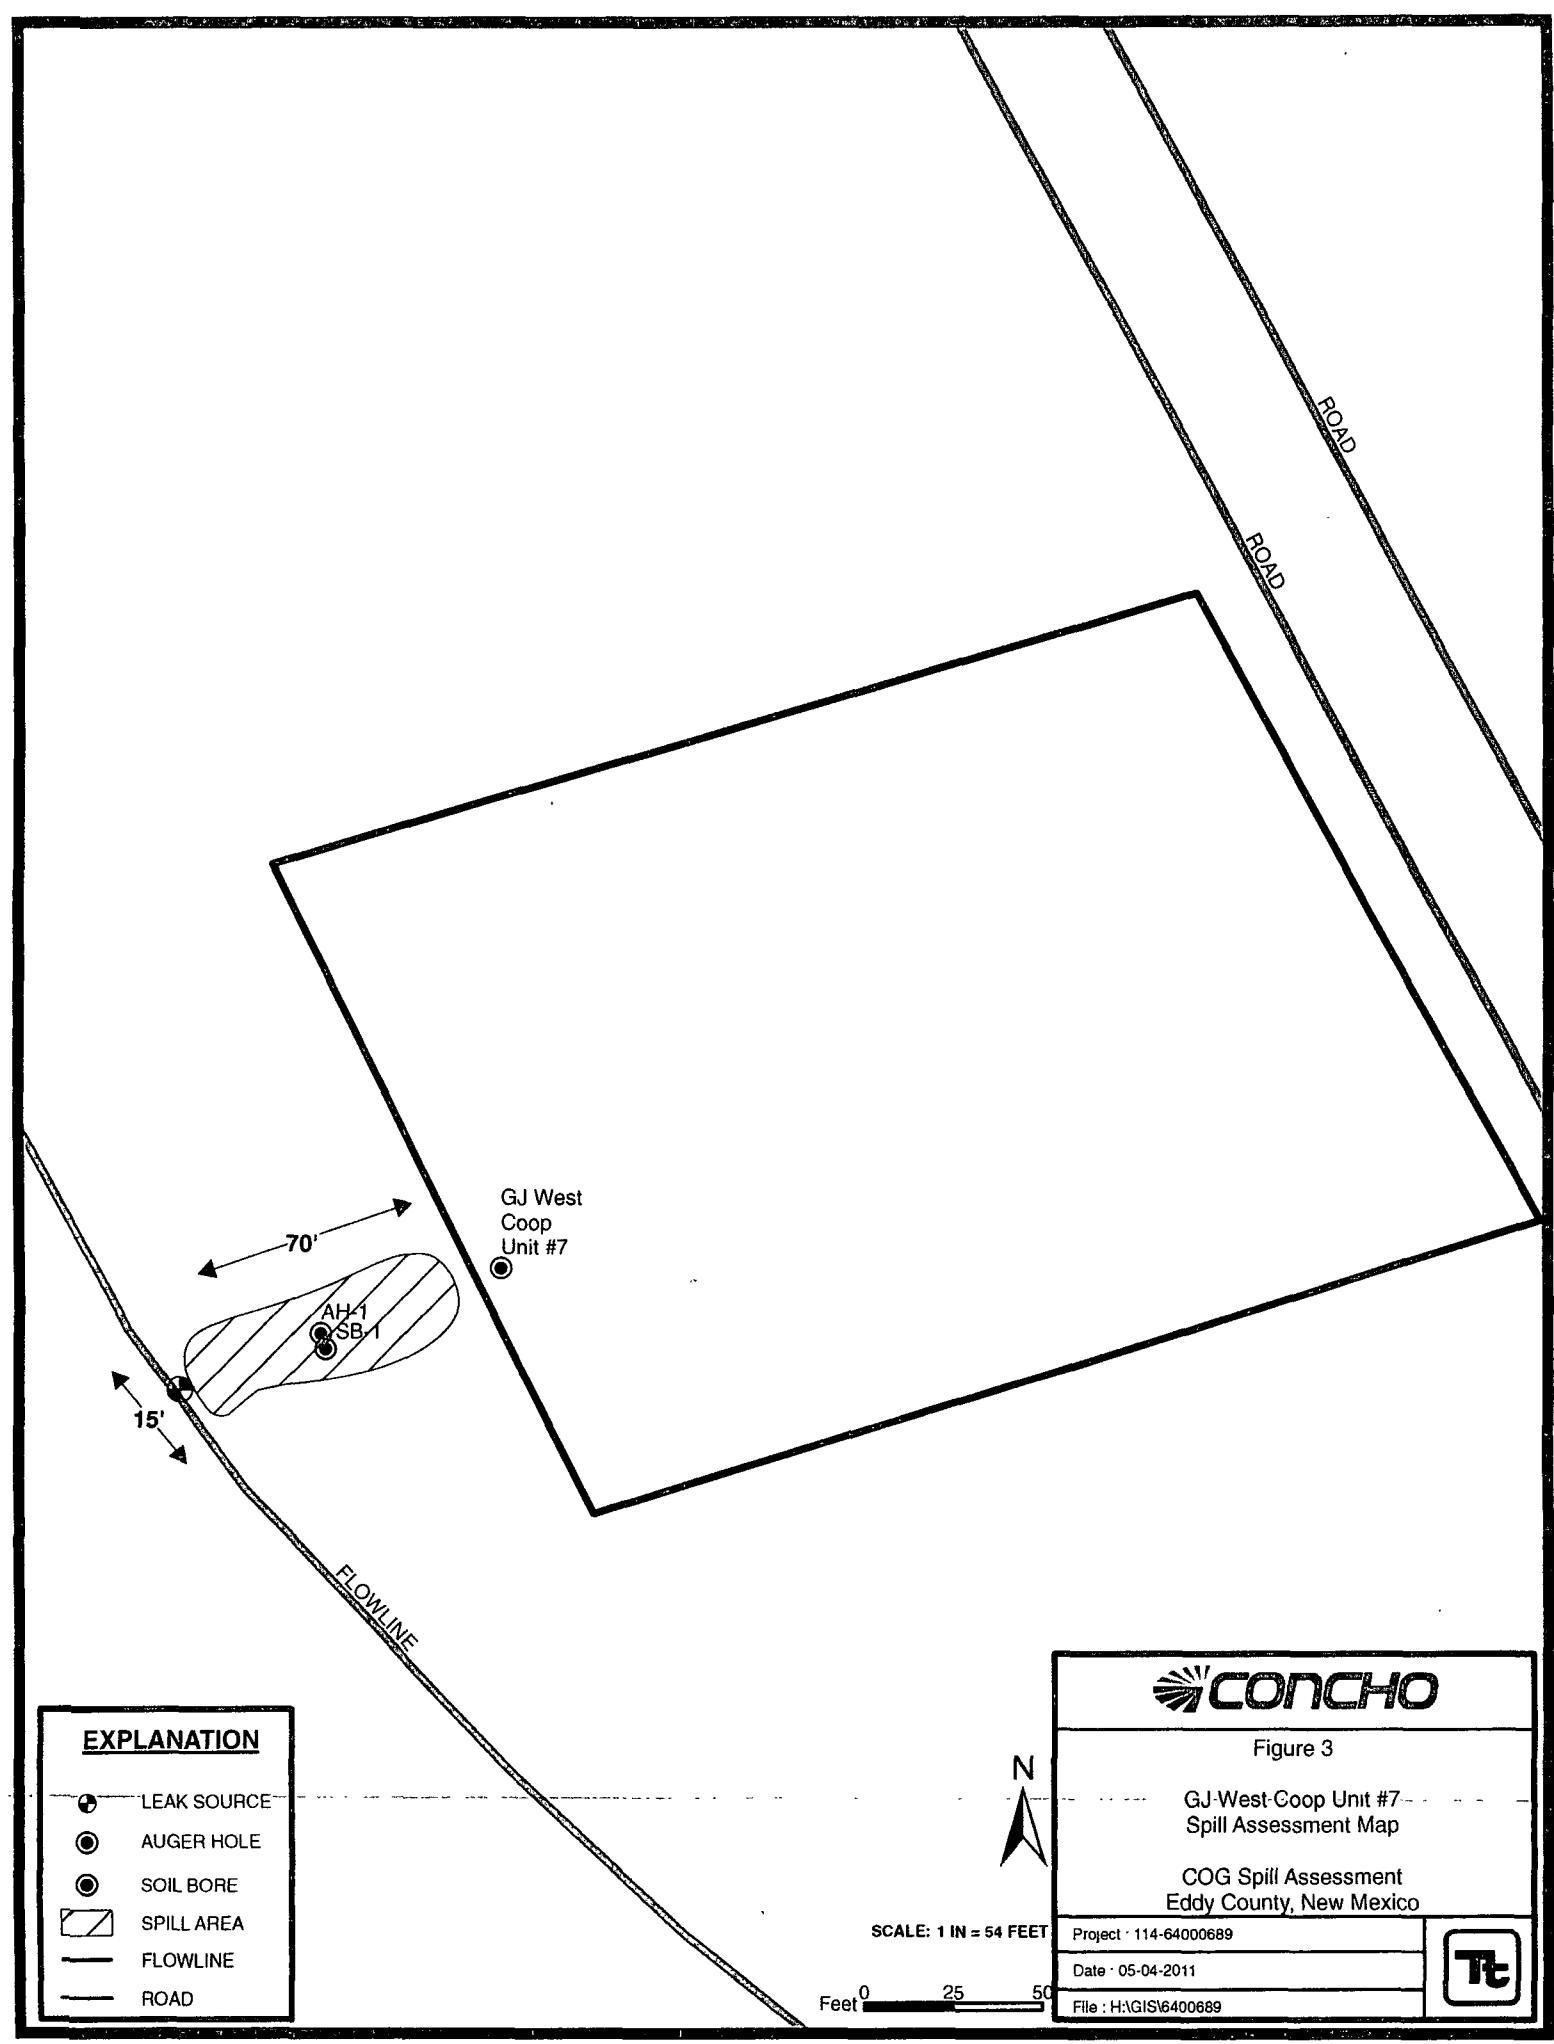
On September 1, 2010, Tetra Tech personnel inspected and sampled the spill area. One (1) auger hole (AH-1) was installed using a stainless steel hand auger to assess the impacted soils. Select samples were analyzed for TPH analysis by EPA method 8015 modified, BTEX by EPA Method 8021B and chloride by EPA method 300.0. Copies of laboratory analysis and chain-of-custody documentation are included in Appendix C. The results of the sampling are summarized in Table 1. The auger hole location is shown on Figure 3.

On February 17, 2011, Tetra Tech personnel supervised the installation of one soil boring (SB-1). Soil samples were collected to a depth of 30.0' below surface. Referring to Table 1, the soil boring did show a shallow impact to soil, compared AH-1. Elevated chloride concentrations were detected from surface to 5.0' and significantly declined to 399 mg/kg at 7.0' below surface. Copies of laboratory analysis and chain-of-custody documentation are included in Appendix-C. The soil boring results are summarized in Table 1. The soil boring location is shown on Figure 3.
