August 6, 2012

### Re: Assessment and Work Plan for the COG Operating LLC., Brigham H South Tank Battery Located in Unit C, Section 28, Township 17 South, Range 30 East, Eddy County, New Mexico.

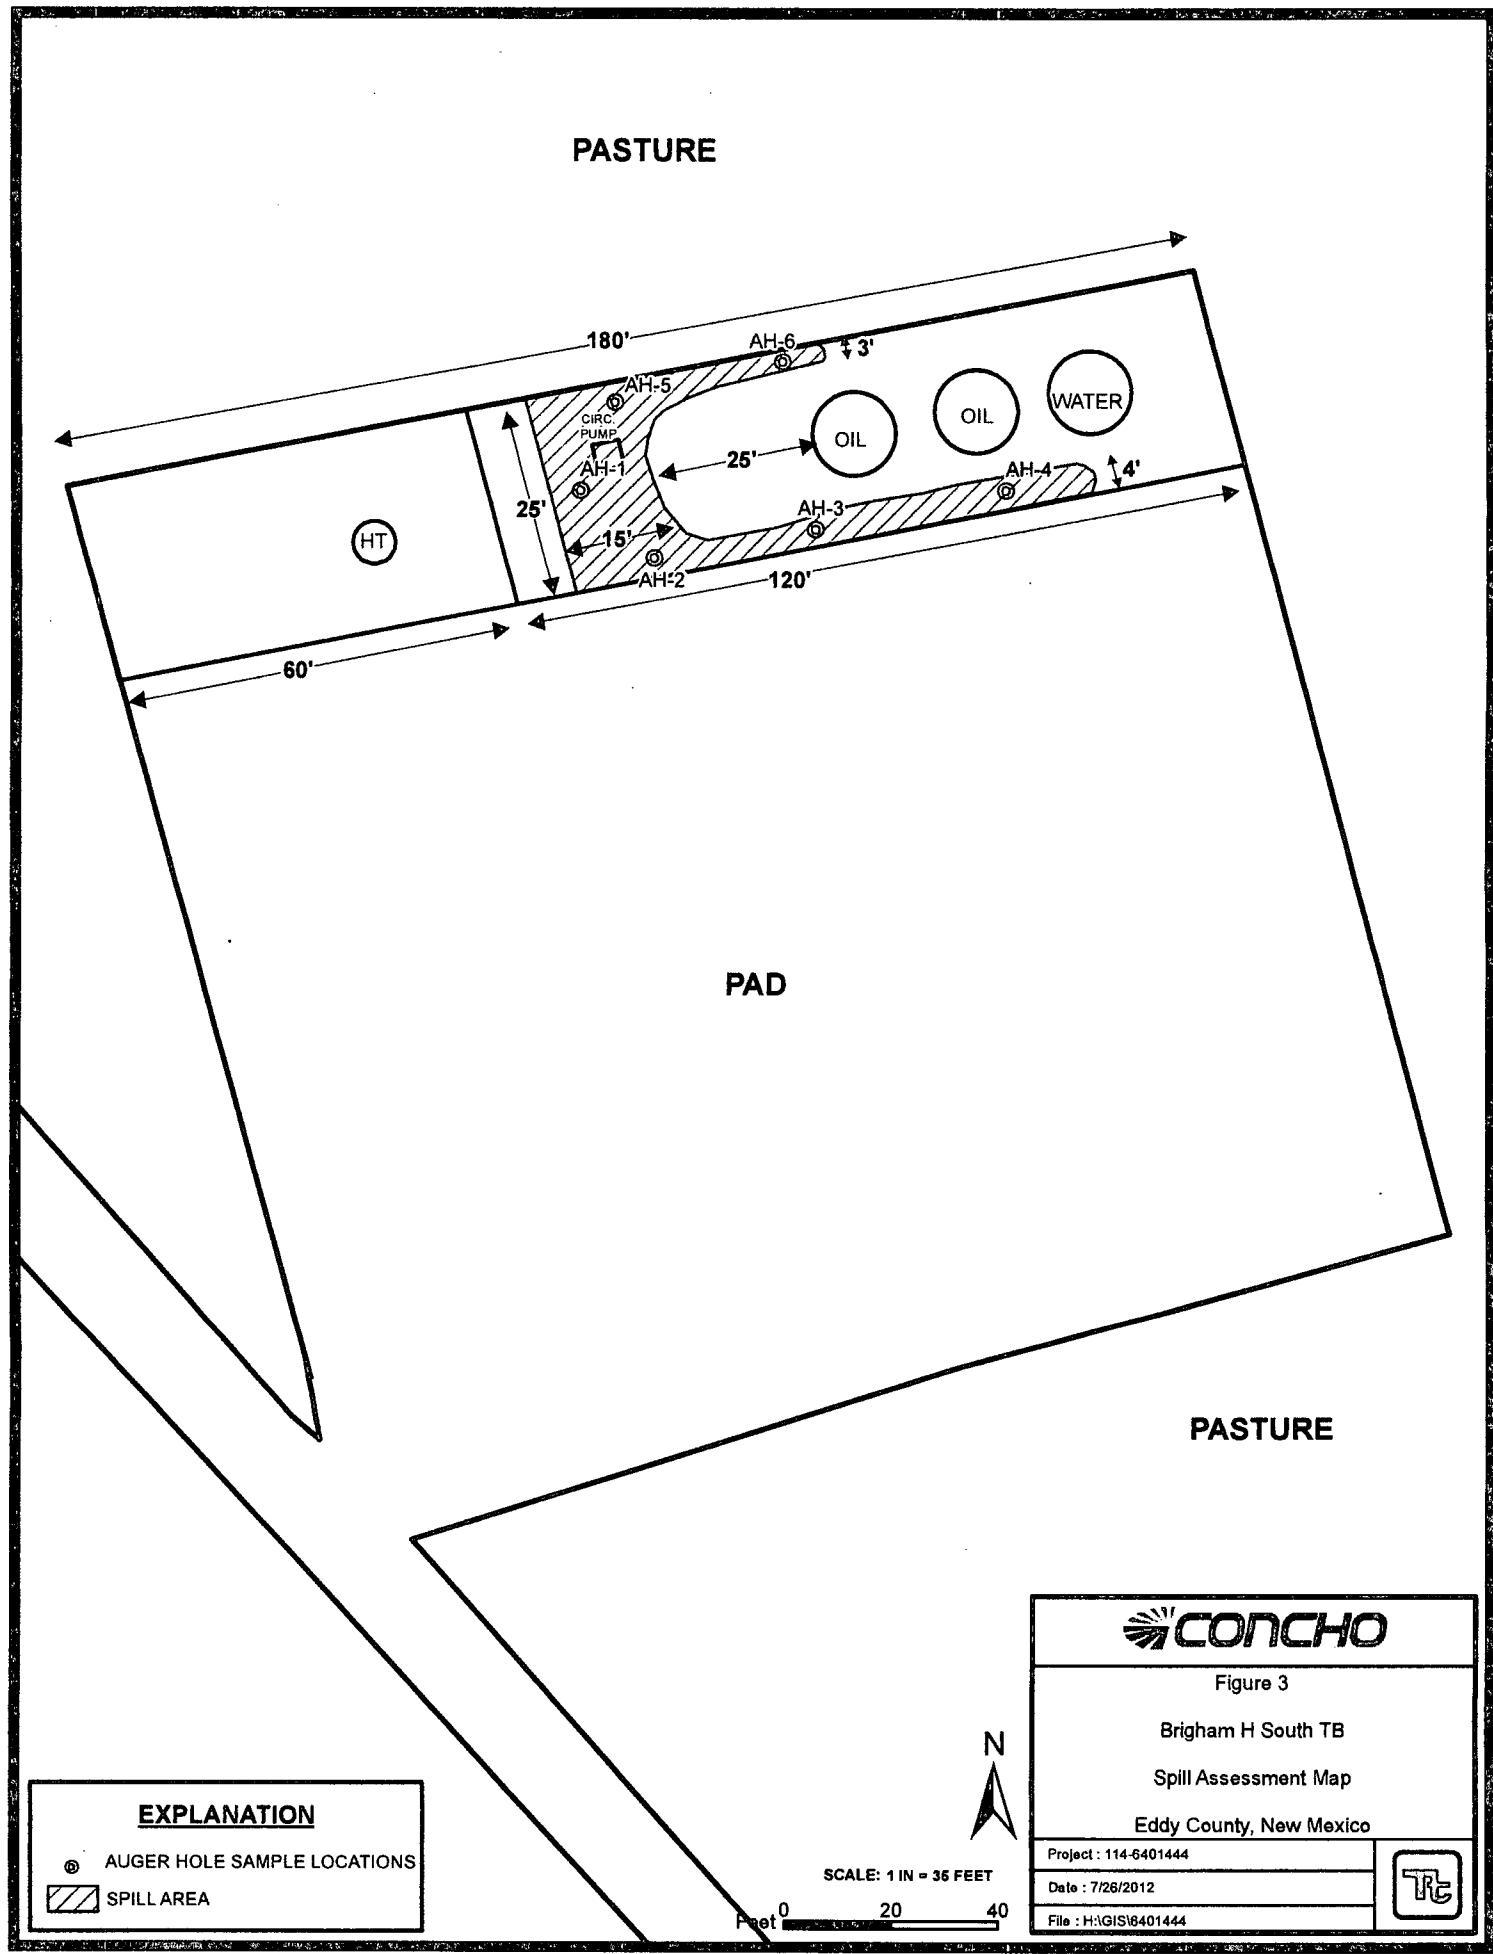
The spill initiated from the circulating pump on the west side of the tank battery. The spill remained inside the facility berms impacting along the north, west and south edge of the facility. The spill measures approximately 4' x 95' (south edge), 3' x 55' (north edge), and source area 25'x15'. The footprint of the spill is shown on Figure 3. The initial Form C-141 is enclosed in Appendix A.

Prior to sampling, COG removed approximately 3"- 6" from the spill area. On July 3, 2012, Tetra Tech personnel inspected and sampled the spill area. A total of six (6) auger holes (AH-1 through AH-6) were installed using a stainless steel hand auger to assess the impacted soils. Selected samples were analyzed for TPH analysis by EPA method 8015 modified, BTEX by EPA Method 8021B and chloride by EPA method 300.0. The sampling results are summarized in Table 1. The auger hole locations are shown on Figure 3. Copies of laboratory analysis and chain-of-custody documentation are included in Appendix C.

Referring to Table 1, auger holes (AH-1, AH-3, and AH-4) were below the RRAL for TPH and BTEX. The remaining auger holes (AH-2, AH-5 and AH-6) at 0-1' exceeded the RRAL for TPH and BTEX. Auger hole (AH-5) was vertically defined, declining below the RRAL of 4,823 mg/kg. AH-2 and AH-6 were not vertically defined. In addition, the spill area did not show a significant chloride impact to the soils. The area of AH-4 showed an elevated chloride of 4,320 mg/kg at 0-1', which was not vertically defined.
